ANNUAL ENVIRONMENTAL REPORT 2009
SUBMITTED TO ENVIRONMENTAL PROTECTION AGENCY
REPORTING PERIOD: JANUARY – DECEMBER 2009

ENVA
CLONMINAM INDUSTRIAL ESTATE
PORTLAOISE
CO. LAOIS

WASTE LICENCE NUMBER W0184-1

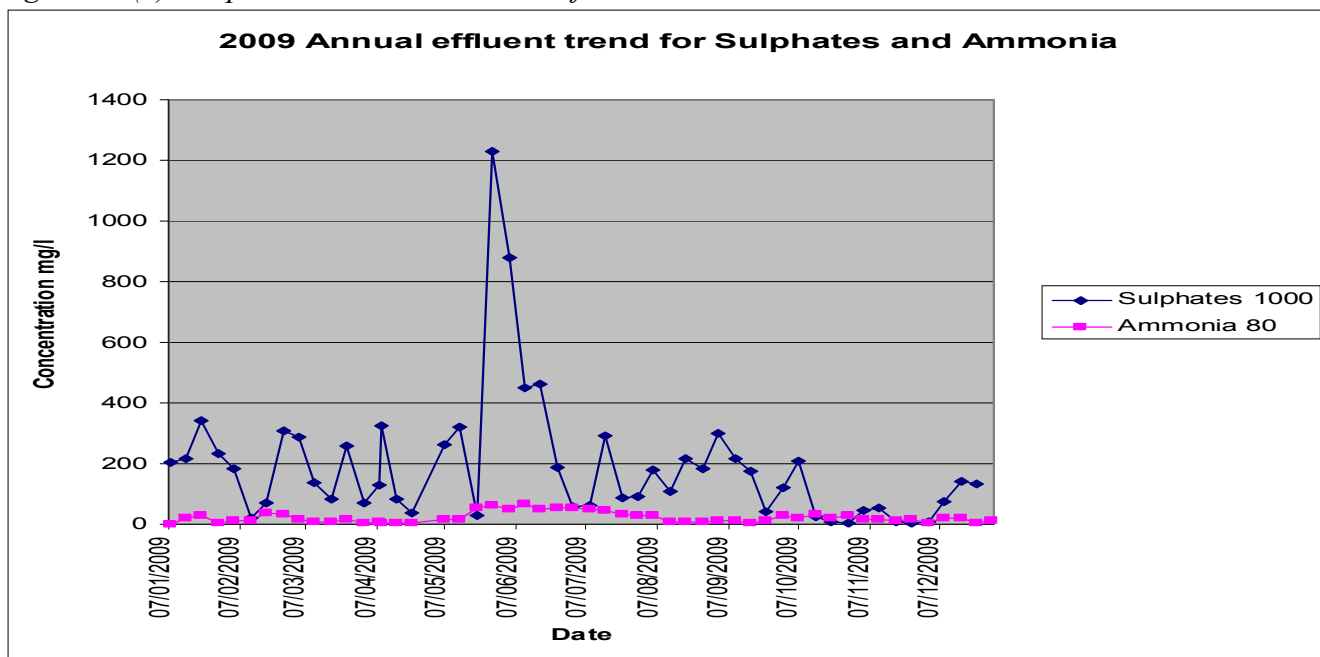
Figure 3.1(d): Sulphate and Ammonia levels for 2009

There was one exceedence in the limit value for Sulphates as can be seen in figure 3.1(d) below. Please refer to section 5 *Non Conformances* of this report for details. Monitoring results for all other parameters were below the licence limits.

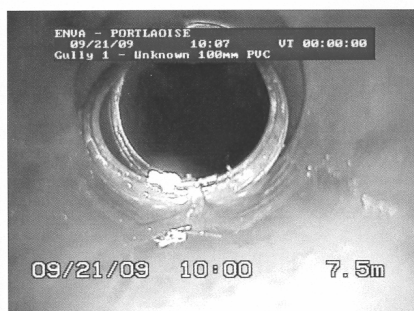
Photo: 1_2a, Tape No.: 1, 00:00:00
7.5m, Obstruction, 5 % height/diameter loss

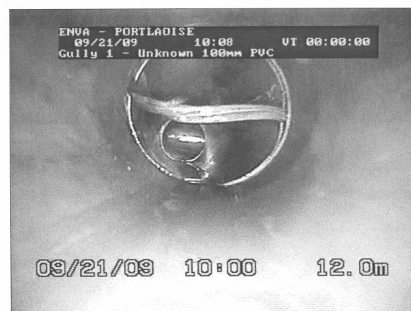
Photo: 1_4a, Tape No.: 1, 00:00:00
11.9m, Obstruction, 50 % height/diameter loss

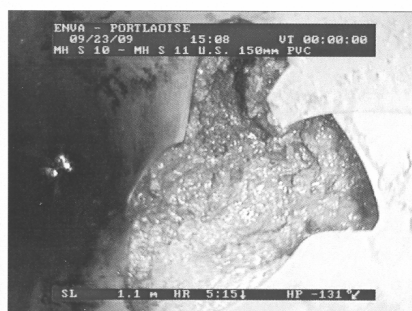
Photo: 30_2a, Tape No.: 1, 00:00:00
1m, Collapsed Pipe, 25 % cross-sectional area loss, from 12
to 04 o'clock

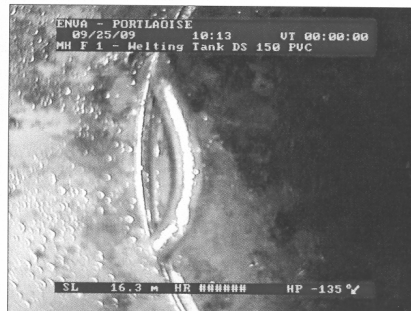
Photo: 36_2a, Tape No.: 1, 00:00:00
16.3m, Obstruction, 5 % height/diameter loss
