Site Visit Report

Licensee	
Name of Installation	Cork city
Licensee	Irish Water
Licence Register No.	D0033-01
CRO Number	
Site Address	Cork
Site Visit Reference No.	SV09830

Report Detail	
Issue Date	14/09/2016
Prepared By	Patrick Chan

Inspection of the Curraheen River in response to a call from the public about an alleged fish kill in the Curraheen River, which was being impacted by an overflow from the Curraheen Estate Pumping station.

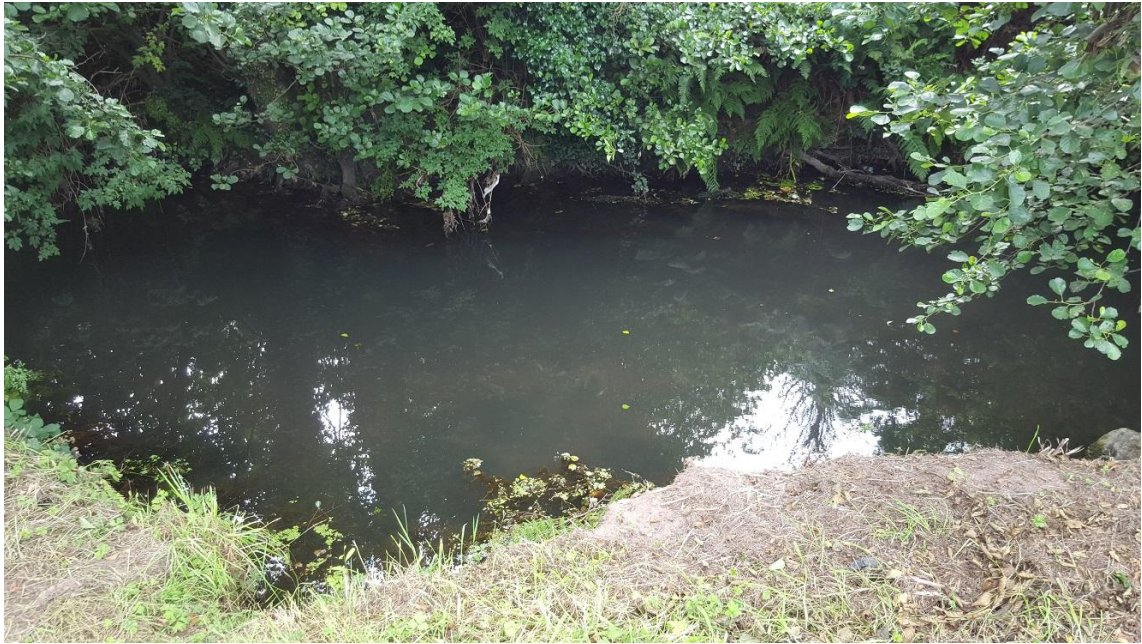
I started my inspection of the Curraheen River from Rossbrook Estate on the Model Farm Road and travelled upstream. I noted strong discolouration of the Curraheen River adjacent to the Cork Institute of Technology Sports Centre and followed the discolouration up to the discharge pipe north of the pumping station, a distance of 1 kilometre. The discharge pipe was the only source of this discolouration. I travelled 200 metres upstream of the discharge pipe to confirm that there was no other source of discharge. I did not see any dead fish during my inspection of the Curraheen River.

Photo 1. Discolouration in the Curraheen River, opposite the Cork Institute of Technology Sports Ground.

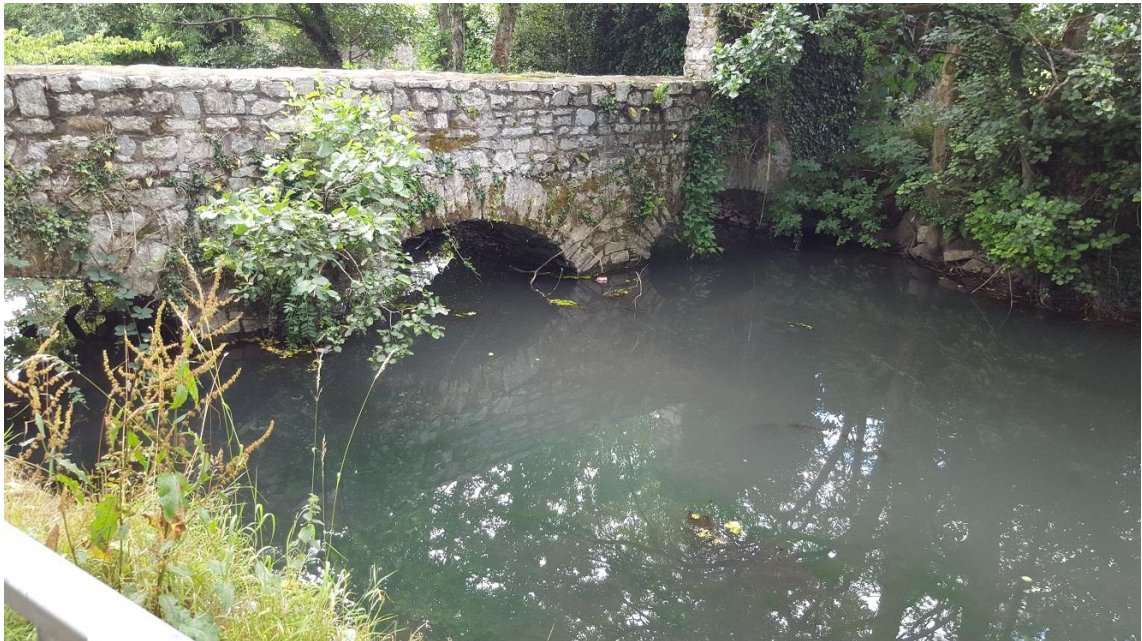
Photo 2. Discolouration in the Curraheen River, at the footbridge by Bishopstown House.

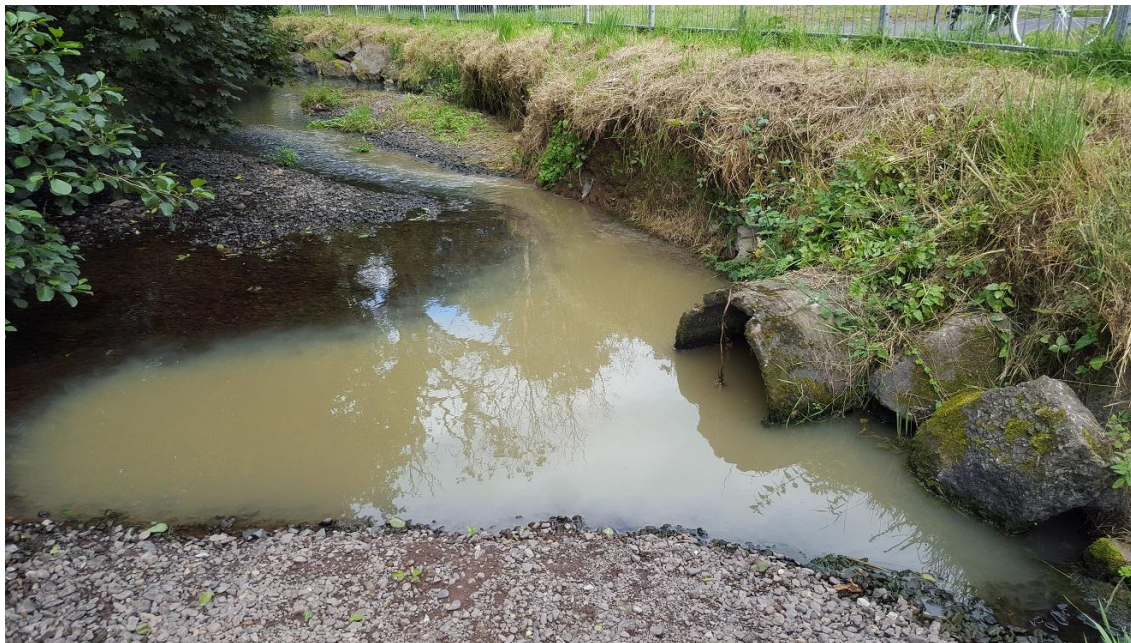
Photo 3. Discharge pipe from the Curraheen Pumping Station. Low flows at the time the photo was taken.

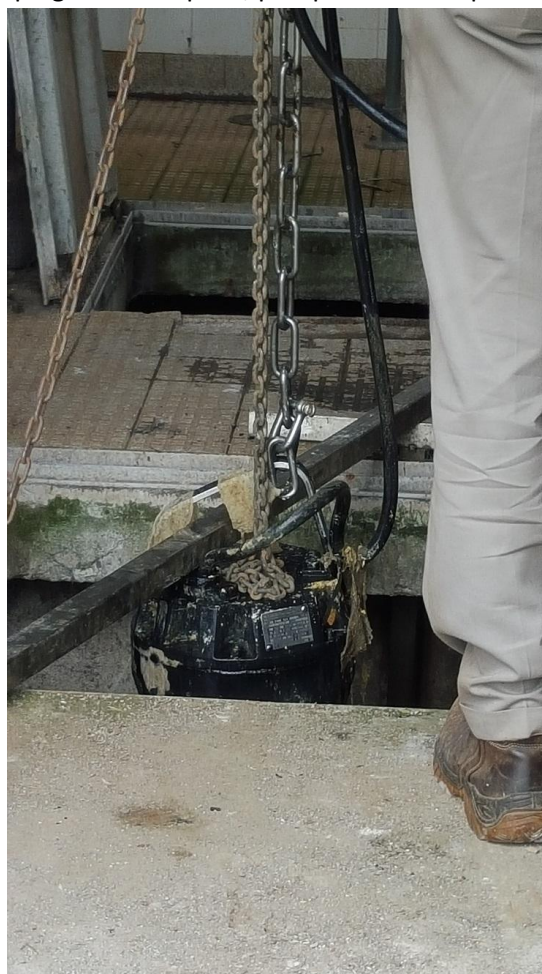
I went to the pumping station where I met staff from Cork City Council who were in the process of repairing the pumping station. I was informed that they had stopped the overflow and had repaired the two pumps but that the non-return valves had become clogged due to ragging. They informed me that Munster Drains had been called to clear the blockage and that they would also tanker waste water away from the pumping station until it was fully operational. The operators also confirmed that the discharge pipe I saw on the Curraheen River was the overflow pipe for the pumping station.

Photo 4. Curraheen Pumping station repairs, pump raised to replace seal.
