Drinking Water Audit Report

County:	Wexford	Date of Audit:	7 th July 2017
Plant(s) visited:	Glynn (3300PUB1507)	Date of issue of Audit Report:	11 th July 2017
		File Reference:	DW2017/90
		Auditors:	Mr Darragh Page
Audit Criteria:	<ul style="list-style-type: none"> • The <i>European Union (Drinking Water) Regulations 2014 (S.I. 122 of 2014)</i>. • The <i>EPA Handbook on the Implementation of the Regulations for Water Services Authorities for Public Water Supplies (ISBN: 978-1-84095-349-7)</i> • The recommendations specified in the <i>EPA Drinking Water Report</i>. • EPA Drinking Water Advice Notes No.s 1 to 15. • The recommendations of the previous audit reports.

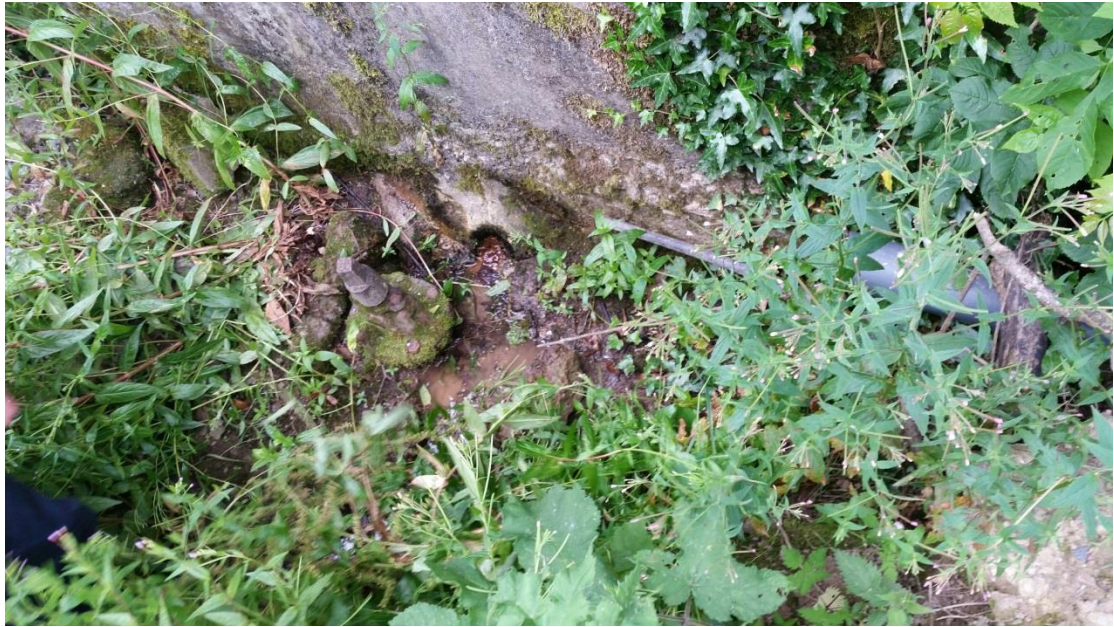
3.	<p>Treated Water Storage and Distribution Network</p> <p>a. Following disinfection, treated water is pumped into the network. From here it either feeds directly to consumers (if the demand is high) or is pumped to the reservoir.</p> <p>b. The reservoir, which was constructed in the 1960's, was inspected and there was evidence of a leak at the base of the reservoir (see Photo 1).</p> <p>c. Irish Water and Wexford County Council were unable to say when the reservoir had last been inspected or cleaned out.</p> <p>d. Since the <i>E.coli</i> contamination incident occurred, the mains have been flushed out and adequate levels of chlorine detected in the network</p>

Photo 1. Leak at the base of the Glynn Reservoir.

6. Irish Water should repair the leak at the base of the reservoir.
7. Irish Water should ensure that the service reservoir is inspected and cleaned out on a regular basis and any maintenance and repairs completed as soon as possible after the need has been identified.
