Drinking Water Audit Report

| Plant visited: | Rathangan Water Treatment Plant (WTP) Scheme Code: 1400PUB1041 | Date of issue of Audit Report: | 25/07/2017 |
| | | File Reference: | DW2017/93 |

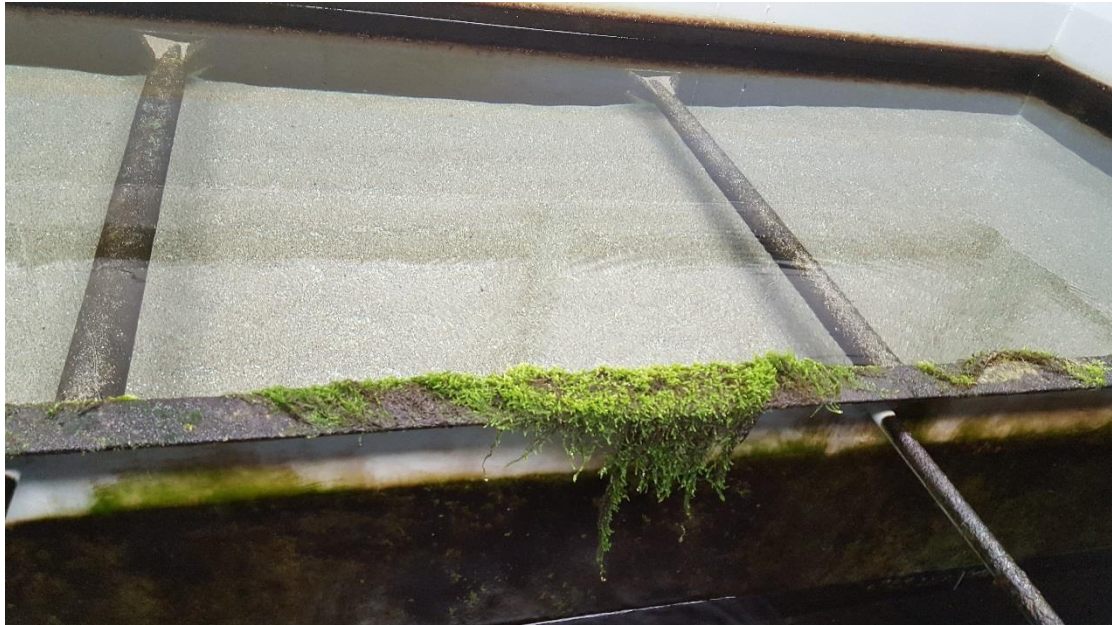
| 2. | Filtration <ul style="list-style-type: none">a. The first stage of treatment is filtration in two rapid gravity sand filters.b. Filter backwashing is initiated every 24 hours.c. A backwash of Filter No. 1 was manually triggered during the audit. The auditors observed an even air scour and backwash across the filter bed.d. There was algae growing on the weir of both filters, which was impeding the even flow of water into the decanting channel. (See photograph no. 1)e. There are 2 alarmed turbidity monitors on both filters. The turbidity monitors are calibrated every year. At the time of the audit, the turbidity monitor on Filter No. 2 was not working. |

Photograph No. 1: Algae on Weir.

3. Irish Water should ensure that the filters are cleaned on a regular basis to prevent build-up of algae on the weirs of the filter.
4. Irish Water should assess the performance of the filters in order to determine an appropriate timeframe for replacement of the filter media.

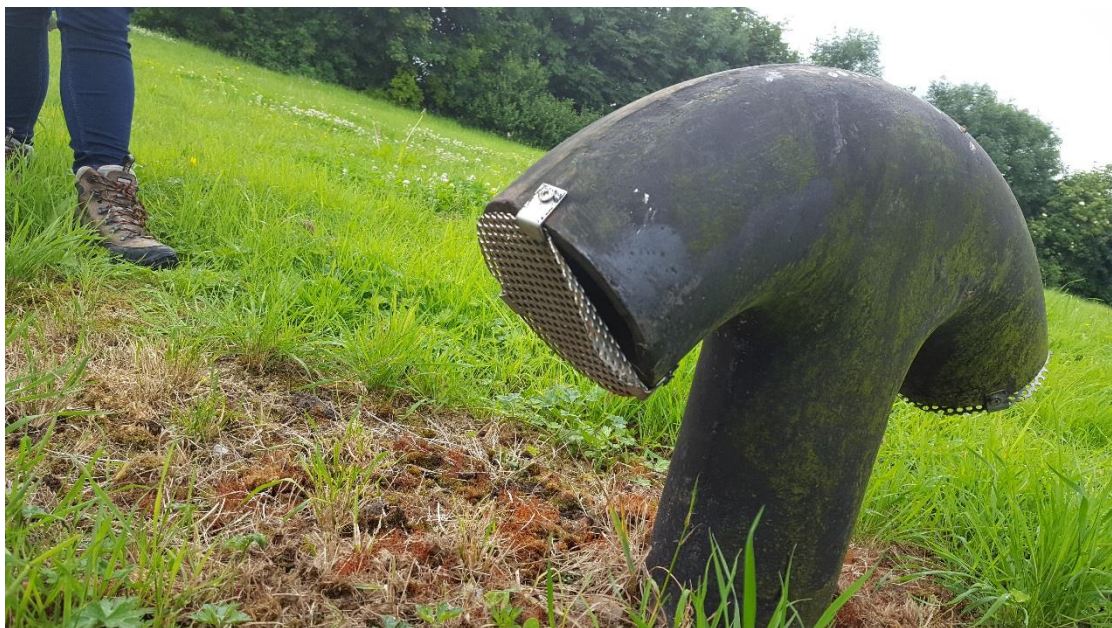
| 4. | <p>Treated Water Storage and Distribution Network</p> <p>a. Treated water is stored in the underground clear water tank on-site. The roof of the clear water tank was sealed but the mesh was peeling back from the vents. (See photograph no. 2)</p> <p>b. The clear water tank has not been cleaned out since it was built. A visual inspection at the opening of the tank showed no obvious contamination and appeared to be clean.</p> <p>c. The reservoir was not inspected during the audit. Kildare County Council advised that the reservoir has never been cleaned.</p> |

Photograph No. 2. Mesh peeling back from the vent.

5. Irish Water should ensure that all vents on the clear water tank are secured against ingress of animals or deliberate introduction of any contaminant or acts of vandalism.
6. Irish Water should ensure that service reservoirs are inspected and cleaned out on a regular basis and any maintenance and repairs completed as soon as possible after the need has been identified.
