**ASSESSMENT OF TOTAL VOLATILE ORGANIC COMPOUND SURFACE EMISSIONS AND  
LANDFILL GAS MANAGEMENT SYSTEMS FROM NEIPHIN TRADING LTD, KERDIFFSTOWN,  
NAAS, CO. KILDARE**

**PERFORMED BY ODOUR MONITORING IRELAND ON BEHALF OF THE ENVIRONMENTAL PROTECTION AGENCY  
(OFFICE OF ENVIRONMENTAL ENFORCEMENT)**

<b>PREPARED BY:</b>	Dr. John Casey & Dr. Brian Sheridan
<b>ATTENTION:</b>	Mr. Jim Moriarty
<b>WASTE LICENCE NUMBER:</b>	W0047-02
<b>DATE:</b>	12 <sup>th</sup> June 2010
<b>REPORT NUMBER:</b>	2010A111 (22)
<b>DOCUMENT VERSION:</b>	Document Ver. 001
<b>REVIEWERS:</b>

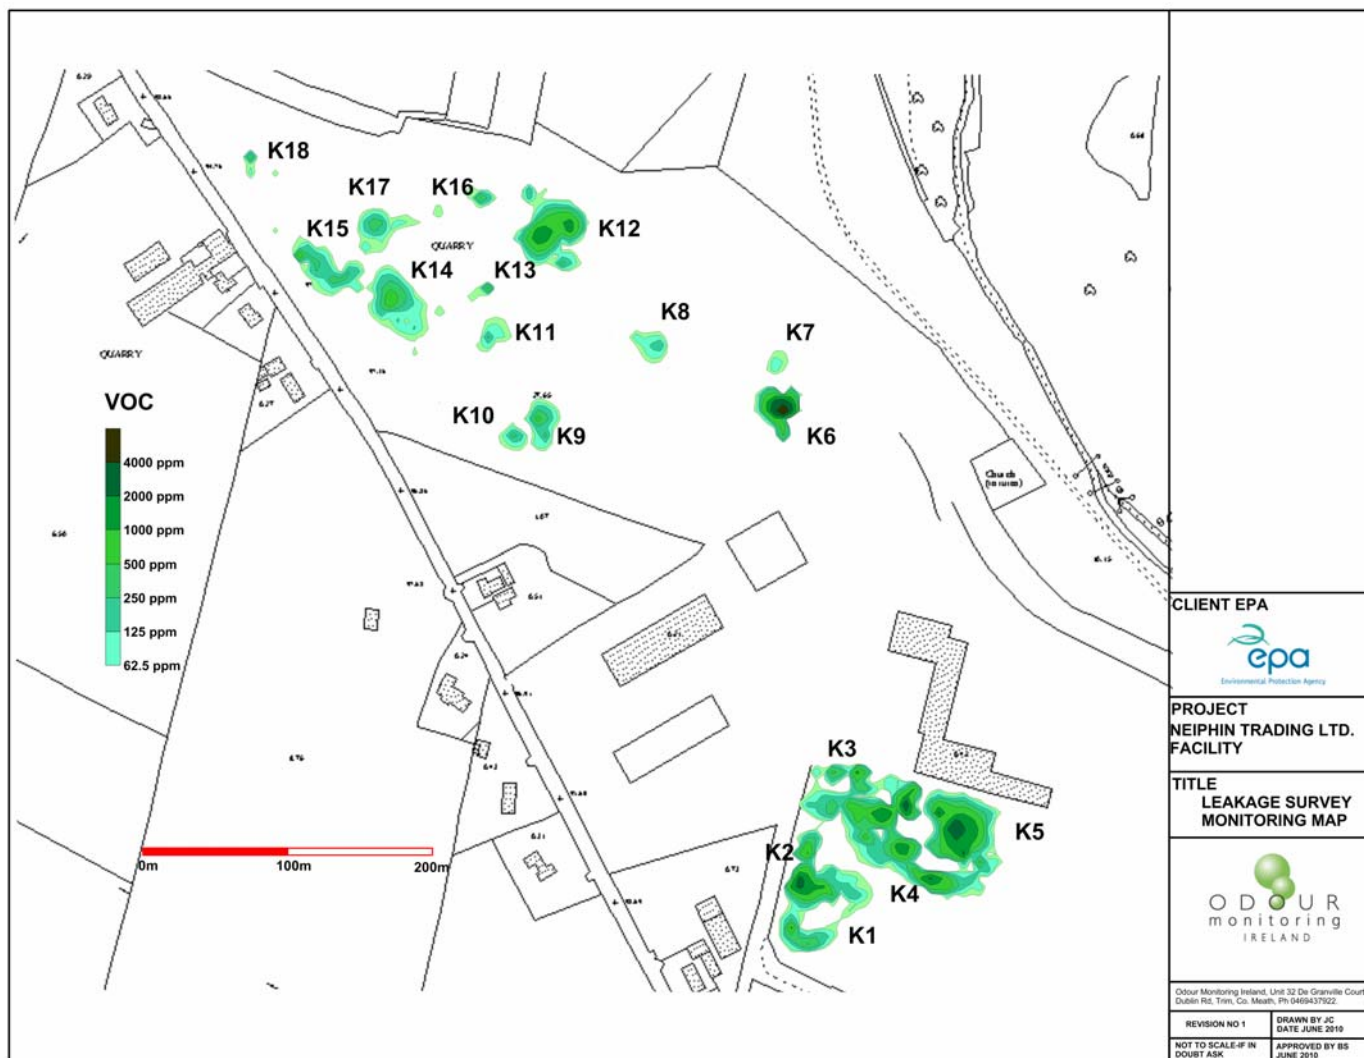
**Figure 7.1.** Landfill gas surface emissions monitoring within the operating landfill facility (colour scale area indicating TVOC gas colour scale).

*Figure 7.1 and Table 3.1* illustrates the results obtained for the landfill surface emissions survey. A total of 18 individual surface emissions zones were identified. Each surface emissions zone is discussed separately in this manner in order to allow for the development of remediation strategies to mitigate the individual surface emissions areas.

Location	Easting (m)	Northing (m)	Max. VOC conc. (ppm)	Identification and Mitigation	Recommended limits
K1	291373	222010	1,496	VOC leakage at ground surface level: Cell 1B Open area. Investigate and remediate the cause of the surface emissions having regard to the recommendations within this report.	<100 ppmv
K2	291364	221954	3,392	VOC leakage at ground surface level: Cell 1B Open area. Investigate and remediate the cause of the surface emissions having regard to the recommendations within this report.	<100 ppmv
K3	291409	222032	1,803	VOC leakage at ground surface level: Cell 1A Open area. Investigate and remediate the cause of the surface emissions having regard to the recommendations within this report.	<100 ppmv
K4	291439	221986	3,467	VOC leakage at ground surface level: Cell 1A Open area. Investigate and remediate the cause of the surface emissions having regard to the recommendations within this report.	<100 ppmv

K5	291480	221980	2,900	VOC leakage at ground surface level: Cell 1A Open area. Investigate and remediate the cause of the surface emissions having regard to the recommendations within this report.	<100 ppmv
K6	291359	222287	8,725	VOC leakage at ground surface level: Surface of material fill area in north west section of facility. Investigate and remediate the cause of the surface emissions having regard to the recommendations within this report.	<100 ppmv
K7	291350	222316	157	VOC leakage at ground surface level: Surface of material fill area in north west section of facility. Investigate and remediate the cause of the surface emissions having regard to the recommendations within this report.	<100 ppmv
K8	291268	222333	133	VOC leakage at ground surface level: Surface of material fill area in north west section of facility. Investigate and remediate the cause of the surface emissions having regard to the recommendations within this report.	<100 ppmv

K9	291184	222281	963	VOC leakage at ground surface level: Surface of material fill area in north west section of facility. Investigate and remediate the cause of the surface emissions having regard to the recommendations within this report.	<100 ppmv
K10	291168	222272	533	VOC leakage at ground surface level: Surface of material fill area in north west section of facility. Investigate and remediate the cause of the surface emissions having regard to the recommendations within this report.	<100 ppmv
K11	291150	222337	426	VOC leakage at ground surface level: Surface of material fill area in north west section of facility. Investigate and remediate the cause of the surface emissions having regard to the recommendations within this report.	<100 ppmv
K12	291187	222409	2,564	VOC leakage at ground surface level: Surface of material fill area in north west section of facility. Investigate and remediate the cause of the surface emissions having regard to the recommendations within this report.	<100 ppmv

Location	Easting (m)	Northing (m)	Max. VOC conc. (ppm)	Identification and Mitigation	Recommended limits
K13	291152	222374	529	VOC leakage at ground surface level: Surface of material fill area in north west section of facility. Investigate and remediate the cause of the surface emissions having regard to the recommendations within this report.	<100 ppmv
K14	291083	222360	877	VOC leakage at ground surface level: Surface of material fill area in north west section of facility. Investigate and remediate the cause of the surface emissions having regard to the recommendations within this report.	<100 ppmv
K15	291082	222362	1,249	VOC leakage at ground surface level: Surface of material fill area in north west section of facility. Investigate and remediate the cause of the surface emissions having regard to the recommendations within this report.	<100 ppmv
K16	291070	222415	454	VOC leakage at ground surface level: Surface of material fill area in north west section of facility. Investigate and remediate the cause of the surface emissions having regard to the recommendations within this report.	<100 ppmv

K17	291145	222434	698	VOC leakage at ground surface level: Surface of material fill area in north west section of facility. Investigate and remediate the cause of the surface emissions having regard to the recommendations within this report.	<100 ppmv
K18	290988	222461	661	VOC leakage at ground surface level: Surface of material fill area in north west section of facility. Investigate and remediate the cause of the surface emissions having regard to the recommendations within this report.	<100 ppmv

Eighteen sources of landfill gas surface emissions were identified within the landfill (see *Figures 7.1 and Table 3.1*).

Surface emission locations K1, K2, K3, K4 and K5 are a result of landfill gas emissions from the lined Cell 1A and Cell 1B. Surface emissions from locations K1, K2, K3, K4 and K5 are present due to inadequate cover material application and the absence of adequate landfill gas infrastructure.

Surface emission locations K6, K7, K8, K9, K10, K11, K12, K13, K14, K15, K16, K17 and K18 are a result of landfill gas surface emissions from the material fill area in the North West section of the facility. Surface emissions from locations K6, K7, K8, K9, K10, K11, K12, K13, K14, K15, K16, K17 and K18 are present due to the absence of adequate landfill gas infrastructure.

1. There is no adequate installed landfill gas infrastructure in operation within the facility.
2. Eighteen sources of landfill gas surface emissions were identified within the two landfill areas surveyed (*see Figures 7.1 and Table 3.1*). Sources identified were VOC leakage at ground surface level. The main sources of landfill gas surface emissions were as a result of the absence of adequate landfill gas infrastructure at the facility as well as the absence of appropriate cover material over the waste deposited in Cell 1A and Cell 1B.
3. Comparison between the surface emission survey map developed in 2009 and 2010 for the landfill demonstrate no improvements in the control of landfill gas emissions (*see Figures 7.1 and 7.2*).

- Implement the mitigation measures identified in *Section 3* of this report,
- Install and operate appropriate landfill gas management infrastructure at the facility,
- Provide appropriate cover material to waste deposited in Cell 1A and Cell 1B.
