# Drinking Water Audit Report

<b>County:</b>	Carlow	<b>Date of Audit:</b>	14 <sup>th</sup> May 2015
<b>Plant(s) visited:</b>	Borris Water Treatment Plant 0100PUB1162	<b>Date of issue of Audit Report:</b>	3 <sup>rd</sup> June 2015
		<b>File Reference:</b>	DW2013/109
		<b>Auditors:</b>	Ms. Michelle Roche Ms. Yvonne Doris
<b>Audit Criteria:</b>	<ul style="list-style-type: none"> <li>• The <i>European Union (Drinking Water) Regulations 2014 (S.I. 122 of 2014)</i>.</li> <li>• The <i>EPA Handbook on the Implementation of the Regulations for Water Services Authorities for Public Water Supplies (ISBN: 978-1-84095-349-7)</i></li> <li>• The recommendations specified in the <i>EPA Drinking Water Report</i>.</li> <li>• The recommendations in any previous audit reports.</li> </ul>

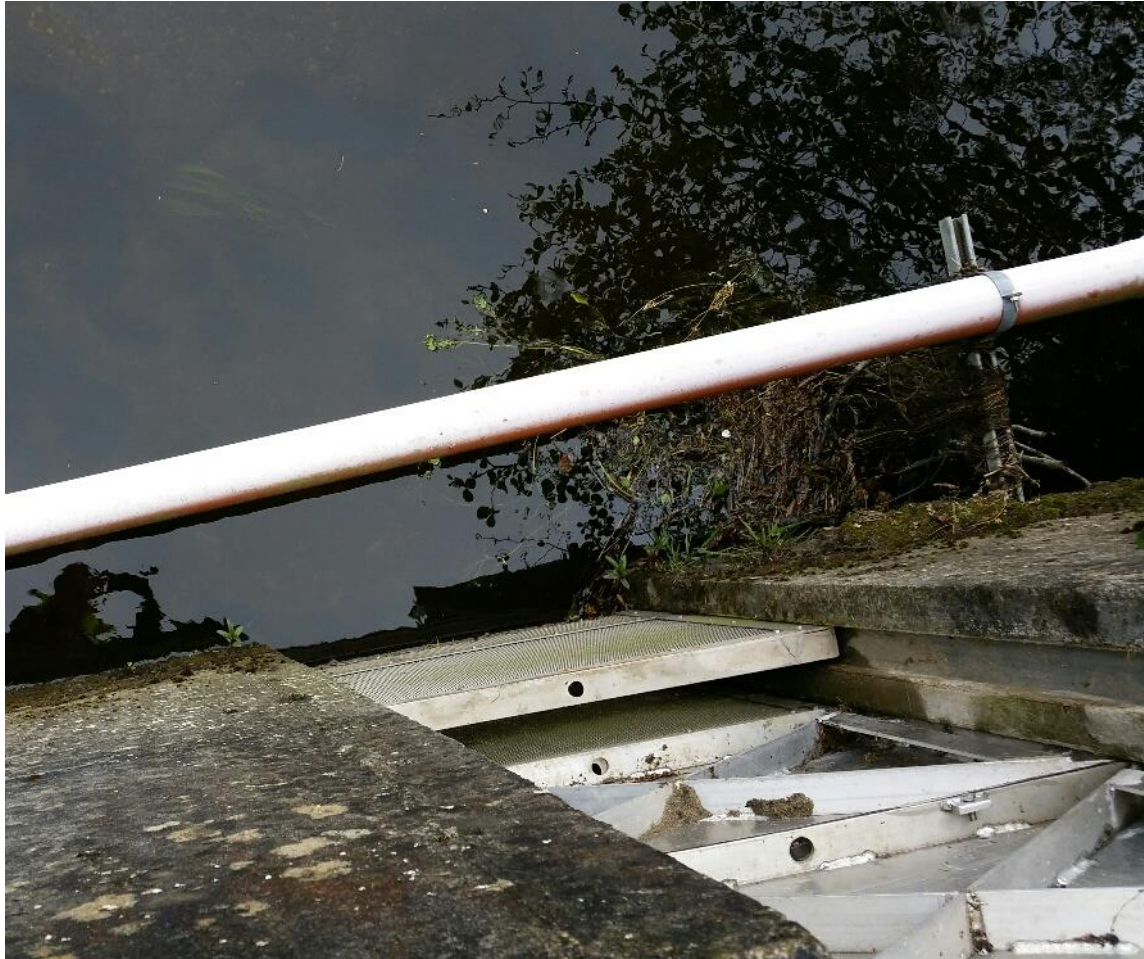
- A *Cryptosporidium* risk score of 11 (low risk) has been derived for the supply and *Cryptosporidium* is monitored once a year.
- The abstraction point on the Mountain River is double screened with a coarse and fine screen (Photograph 1). The screens are cleaned every 3 months.

Photograph 1: Abstraction point with Intake Screen

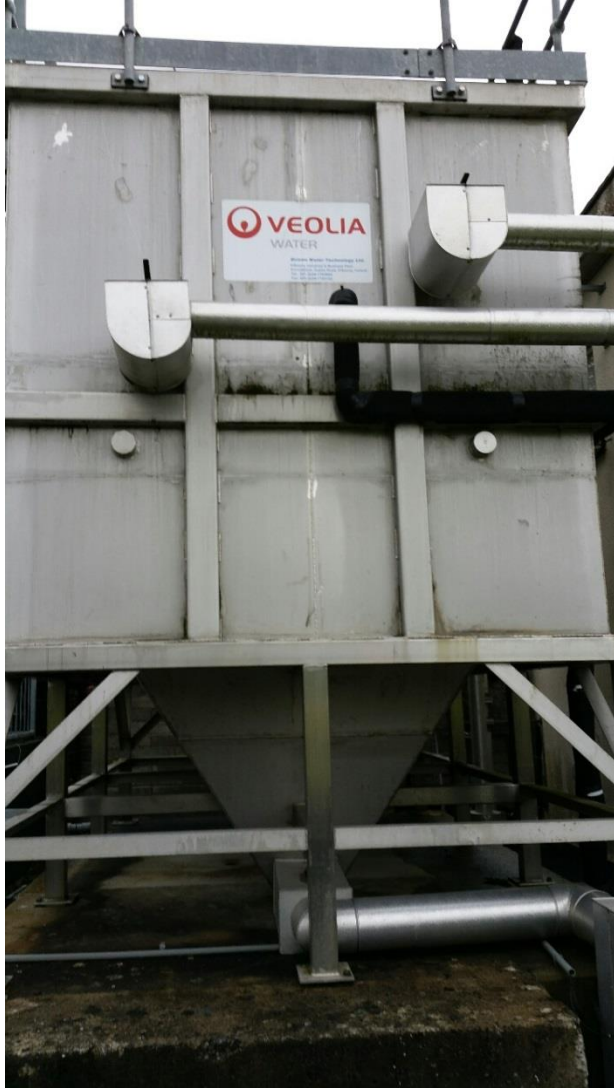
Photograph 2: Multiflo Clarifier Tank

1. Irish Water should ensure that settled water outlet channels are level, free from blockage and flow into these channels is even.

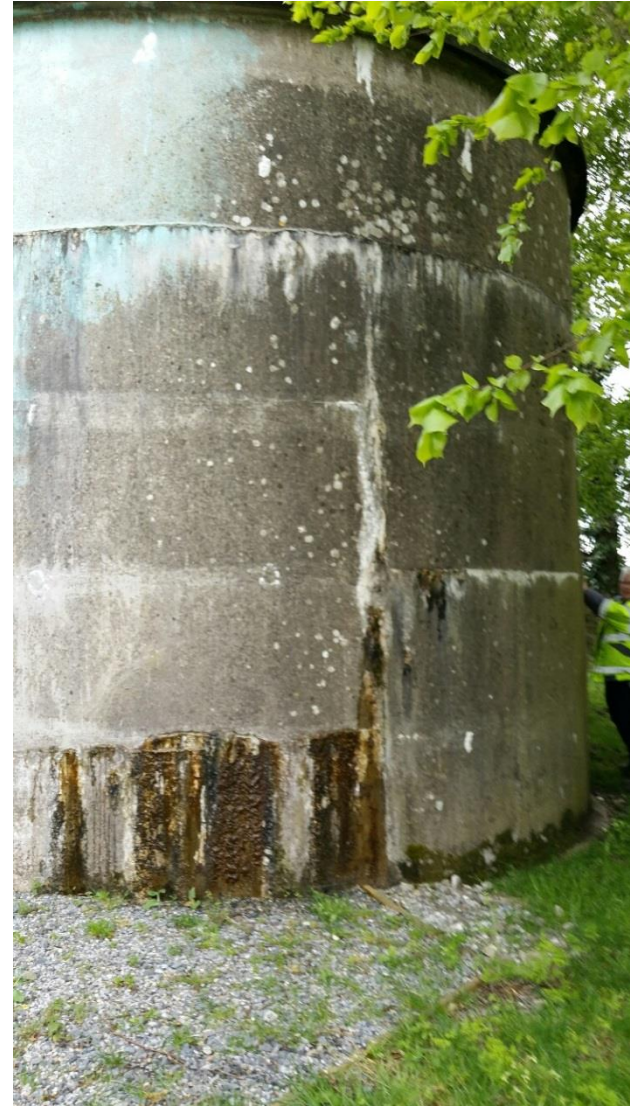
<b>5.</b>	<p><b>Treated Water Storage and Distribution Network</b></p> <ul style="list-style-type: none"> <li>a. Treated water is stored in 2 reservoirs located approximately 1km from the Borris Water Treatment Plant.</li> <li>b. Reservoir 1 was built in the 1930's and cracking in the side walls was observed during the audit (Photograph 3). The top of the reservoir could not be inspected as no ladder was present. Irish Water has received quotations to replace Reservoir 1.</li> <li>c. Reservoir 2 was built in 1999 and was inspected from the top. The reservoir has no guard rail at the top. The reservoir has two locked access hatches and vents; however the vents are not fitted with fine mesh to prevent the access of small animals or birds. Reservoir 2 has never been cleaned or inspected.</li> <li>d. The distribution network is predominantly a 4 inch cast iron main. 600m of the 4km network has currently been replaced with a HDPE pipeline and the remaining network is scheduled to be replaced by April 2016.</li> </ul>

Photograph 3: Cracking visible on the side walls of Reservoir 1

6. Irish Water should ensure that Reservoir 1 is replaced as planned.
7. Irish Water should ensure that all vents on the reservoirs are secured against ingress of animals or deliberate introduction of any contaminant or acts of vandalism.
