Drinking Water Audit Report

County:	Carlow	Date of Audit:	18/6/2014
Plant visited:	Slyguff, Bagnelstown	Date of issue of Audit Report:	4/7/2014
		File Reference:	DW2014/255
		Auditors:	Ms Yvonne Doris
Audit Criteria:	<ul style="list-style-type: none"> • The <i>European Union (Drinking Water) Regulations 2014 (S.I. 122 of 2014)</i>. • <i>The EPA Handbook on the Implementation of the Regulations for Water Services Authorities for Public Water Supplies (ISBN: 978-1-84095-349-7)</i> • The recommendations specified in the EPA Report on <i>The Provision and Quality of Drinking Water in Ireland</i>. • The recommendations in any previous audit reports.

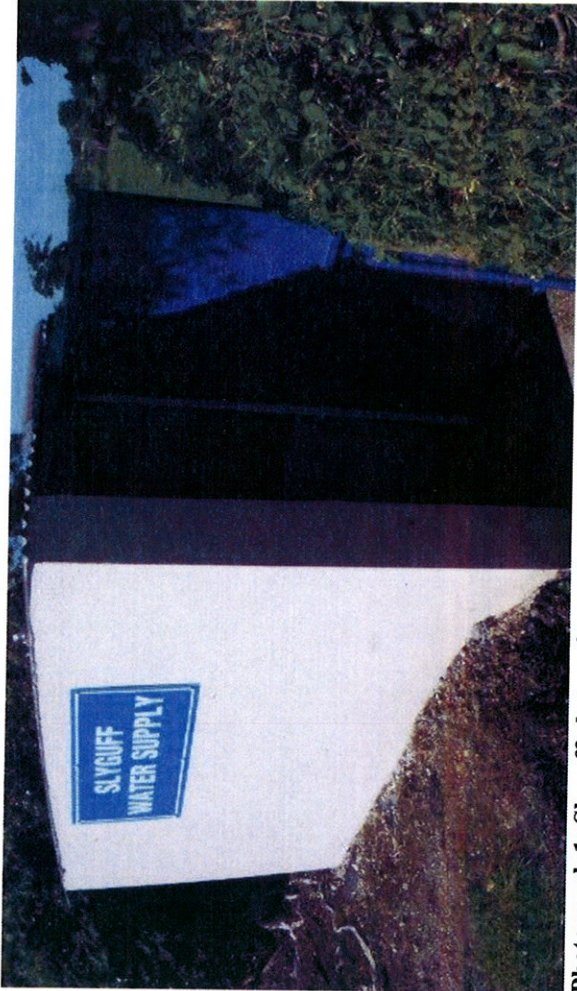
1.	Source Protection <ul style="list-style-type: none">a. The well is located on the grass verge, adjacent to the R705 Bagneslown to Graiguenemanagh road, approximately 4km from Bagneslown (photographs 1 & 2).b. No records of the source were available at the audit (drill logs, details of casing).c. The well is about 45m deep. It is covered by a concrete slab. The wellhead was not inspected as it was not possible to lift the concrete slab. Carlow County Council is procuring a new cover for the well.d. There is no evidence to demonstrate that any work has been done in the catchment to inform farmers of their responsibilities under the Good Agricultural Practice Regulations.e. Grazing animals were observed in the fields adjacent to the pumphouse at the time of the audit.f. No raw water monitoring has been carried out on the Slyguff source. No monitoring for <i>Cryptosporidium</i> has been carried out.

Photograph 1: Slyguff abstraction and treatment

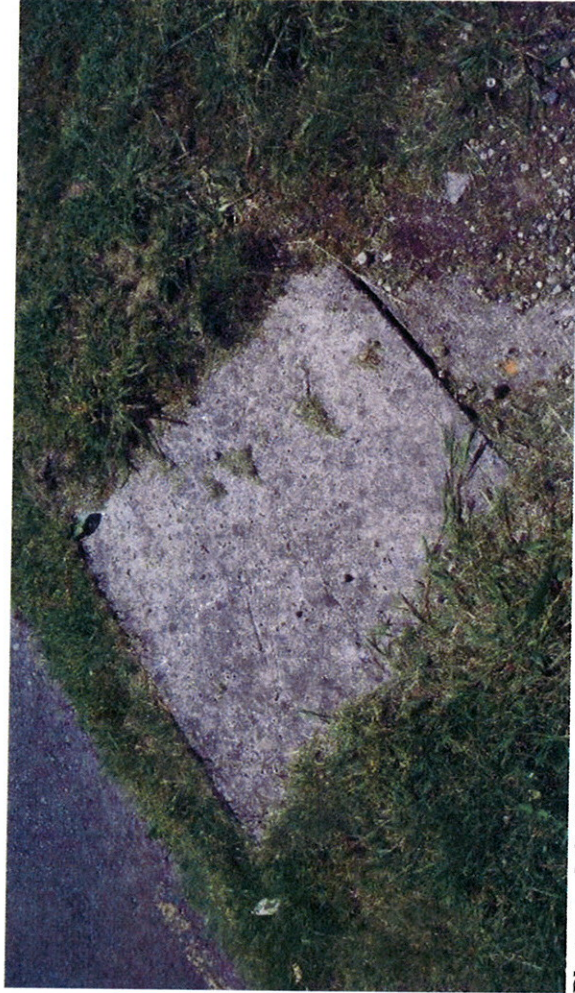
Photograph 2: Wellhead cover adjacent to road

5. The Water Services Authority should ensure that the wellhead is raised above ground level, borehole linings and seals are maintained and a lockable cover is installed.

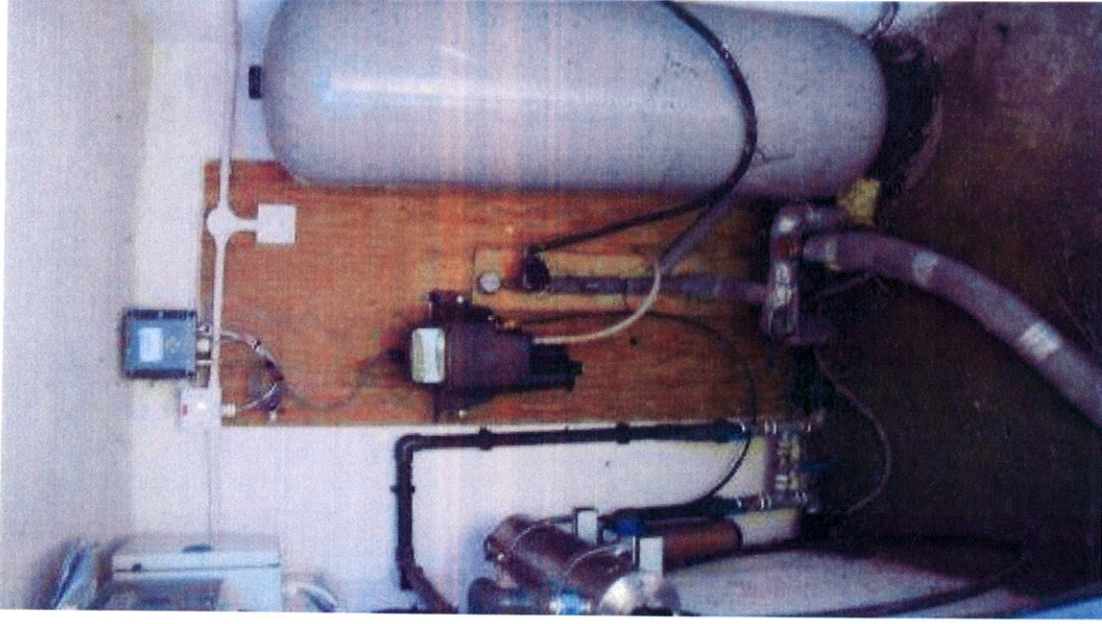
2.	Disinfection <ul style="list-style-type: none">a. A UV unit was installed in January 2014. This is the only form of disinfection on the supply (photograph 3). No Certificate of Validation of the UV unit was available at the audit. There is no Standby UV unit in place. There is no UVT monitor installed and therefore inadequate control and management of the disinfection system.b. A small membrane filter was installed prior to the UV unit. No information on the function or specification of the filter was available at the time of the audit.

5.	Management and Control <ul style="list-style-type: none">a. The disinfection system at the Slyguff supply consisting of a single UV unit does not meet the appropriate criteria set out in <i>EPA Drinking Water Advice Note No. 3: E. coli in Drinking Water</i>.b. Carlow County Council installed a turbidity meter on the raw water in January 2014. The turbidity reading at the time of the audit was 0.692NTU. A high level alarm is set at 1NTU. This is alarmed to the caretaker and water quality manager (Eamon Bolger and Michael Brennan). Carlow County Council stated that the turbidity alarm had not been triggered since January 2014.

The Slyguff supply disinfection system is inadequate and Irish Water is required to upgrade the disinfection system to meet the appropriate criteria set out in *EPA Drinking Water Advice Note No. 3: E. coli in Drinking Water* without delay. An appropriate disinfection system where UV Treatment is in place is one where the following is in exists:

Photograph 3: Treatment of Slyguff supply

1. A validated UV treatment system that operates within its validated range at all times;
2. A continuous monitoring device recording UVI or UVT. The monitor should be alarmed to notify Irish Water in the event of a drop below the validated range;
3. Duty/standby UV units in place with automatic changeover, in the event of failure of one of the UV disinfection units, or alternatively automatic shutdown if the UVT drops below its validated range.

6. The Water Services Authority should ensure that the UV disinfection system is validated in accordance with an appropriate internationally accepted validation system.
7. The Water Services Authority should ensure that the UV disinfection system operates within its validated range at all times.
8. The Water Services Authority should ensure that there are duty and standby UV disinfection arrangements with automatic changeover in the event of failure of one of the UV disinfection units.
9. The Water Services Authority should install a continuous UVI or UVT monitor at the point of disinfection and this monitor should be alarmed and linked to a recording device to ensure that any deviation of the quality of water outside the validated range for the UV treatment system or a failure of the UV disinfection system is immediately detected.
