Drinking Water Audit Report

County:	Cavan	Date of Audit:	8 July 2019
Plant(s) visited:	Swanlinbar Water Treatment Plant	Date of issue of Audit Report:	15 July 2019
		File Reference:	DW2013/36
		Auditors:	Derval Devaney Daryl Gunning
Audit Criteria:	<ul style="list-style-type: none"> • The <i>European Union (Drinking Water) Regulations 2014 (S.I. 122 of 2014)</i>, as amended. • The <i>EPA Handbook on the Implementation of the Regulations for Water Services Authorities for Public Water Supplies</i> (ISBN: 978-1-84095-349-7). • The recommendations specified in the <i>EPA Drinking Water Report</i>. • EPA Drinking Water Advice Notes No.s 1 to 15. • The recommendations in the previous EPA audit report dated 10th May 2013.

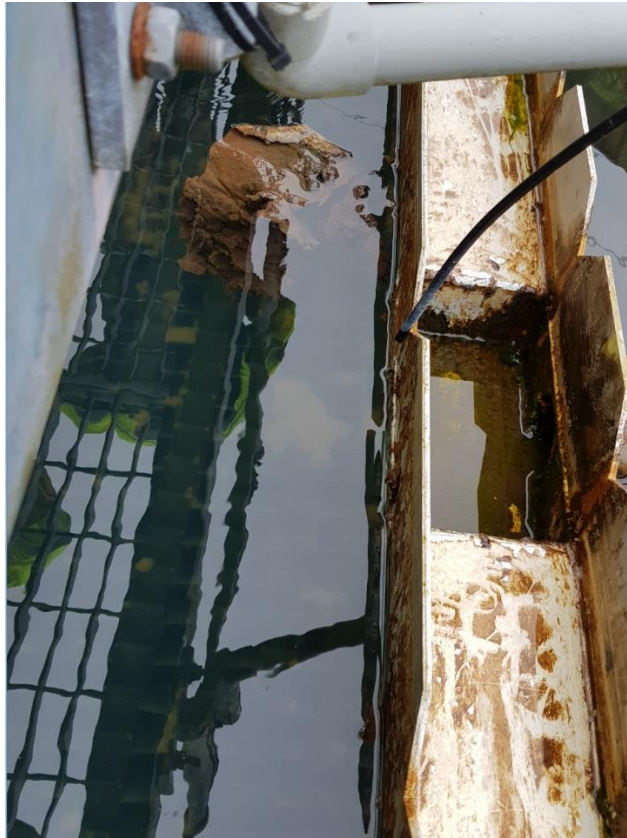
Photo 1 Sludge floating on clarifiers surface and dirty channels

3. Irish Water should undertake the following actions to ensure better management of the clarification process at Swanlinbar water treatment plant:
 - a) ensure the settled water outlet channels in the clarifier are cleaned on a regular basis to prevent build-up of sludge on the channels and internal walls of the clarifier;

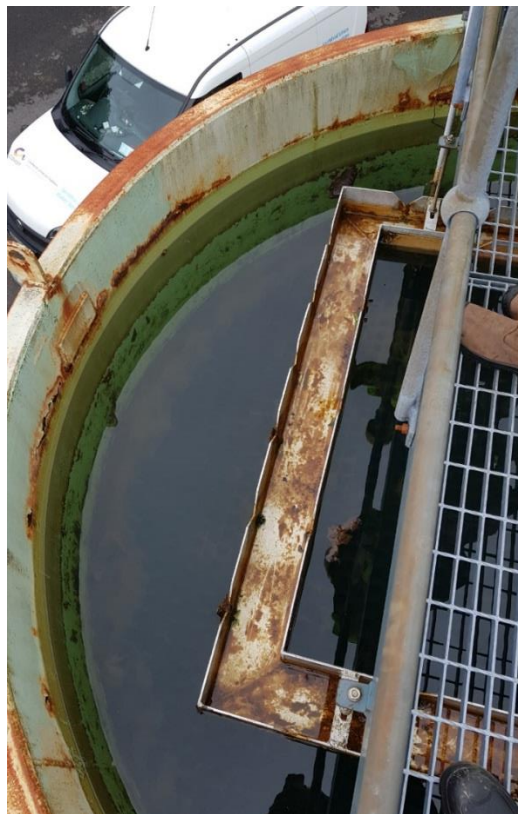
Photo 2 Sludge on channels and surface and rust on clarifier wall

- b) ensure the clarifier's internal walls are maintained to prevent rusting or flaking paint;
 - c) ensure jar testing of the raw and coagulated waters is carried out as outlined in Section 3.3.1 and Appendix C of the EPA publication "*Water Treatment Manual: Coagulation, Flocculation and Clarification*" to determine the optimum chemical coagulant dose and pH for the treatment of the water. The frequency of checks should be appropriate to the nature of supply and changing conditions. Results should be recorded at the treatment works and used for control of the treatment plant;

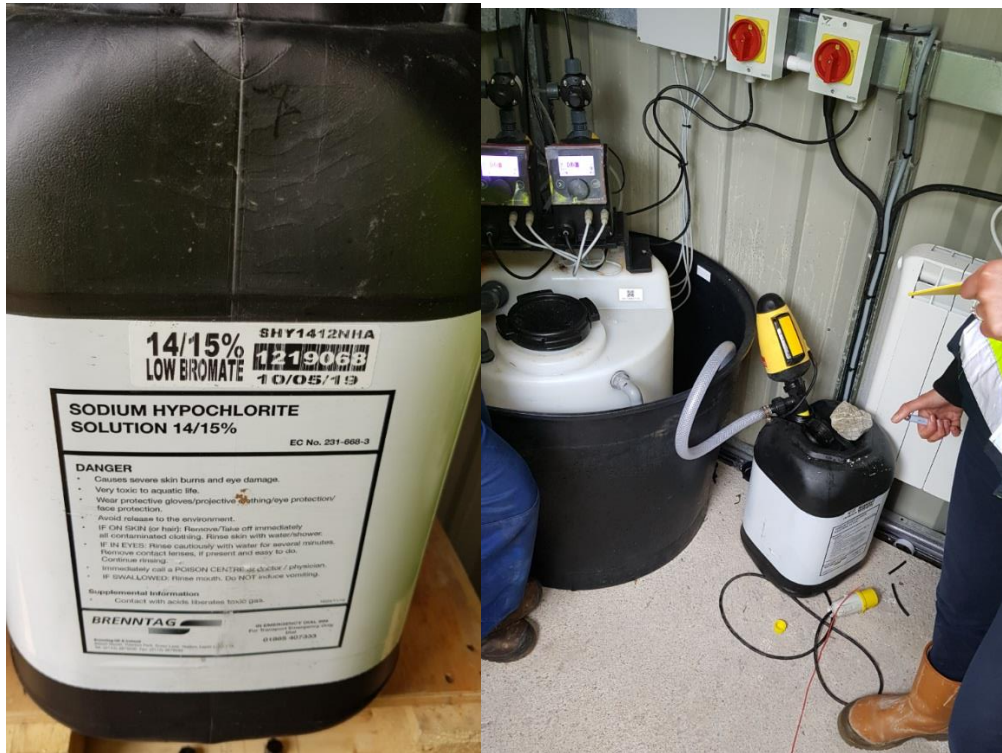
5.	<p>Disinfection</p> <ol style="list-style-type: none"> The disinfectant used is Low Bromate Sodium Hypochlorite 14% / 15% delivered to the filtered water post the onsite clearwater tank. Deliveries are by way of 25 l drums which upon inspection did not appear to have an expiry date or PCS number (See Photo 3). The drum supplying the day tank was not banded (see Photo 4). There are duty and standby chlorine dose pumps that have automated switchover, but it could not be clarified during the audit if the pumps are set to switch automatically on a timed basis, or only when one pump fails or there are issues with the chlorine residual readings on the online final water chlorine monitor. The chlorine dose administered to the final water is based on a Chemtrim system so is partially based on the residual readings from the online chlorine monitor. There were no calibration stickers on the chlorine monitor but it was stated that the next calibration is due in August 2019. The chlorine monitor low alarm is set at 0.3 mg/l and high alarm at 5 mg/l. It was stated that the target chlorine residual leaving the plant is 0.9 mg/l however this contradicted a target of 1.7 mg/l displayed on the PLC panel (see Photo 5). It was stated that the high-level alarm setting was put in place as a lower level would provide false high alarms given that the Chemtrim system initiates a spike in chlorine when the pumps start-up. Chlorine pump failure and no flow in the raw and final water also trigger an alarm. There are no plant inhibits/shut-downs based on inadequate final water quality (e.g. chlorine, turbidity, UVT, pH). The only plant inhibit is a fault on both alum dosing pumps. The plant diary for June 2019 documented many final water chlorine residual readings from the online monitor which were inadequate (0 mg/l on 19/06/19) or elevated (up to 4.99 mg/l on 28/06/19). Upon review of a print-out of chlorine alarms from SCADA presented during the audit, there were a series of low chlorine alarms on 28/07/19 – 30/06/19 but no high-level alarm, despite a high level of chlorine (11.6 mg/l) found in the network the morning of 02/07/19. It was also stated that it was likely these low-level alarms were sent to another plant operator. When plant production ceases (due to sufficient treated water in the reservoir, lack of water for backwash, backwash taking place or a sludge bleed event) it can result in the chlorine monitor reading < 0.3 mg/l, which triggers a low chlorine alarm. From the series of low chlorine alarms on 28/06/19 it could not be determined which alarms were relevant and reflective of water going into production.

Photos 3 & 4 Drum of disinfectant labelled inappropriately and unbunded

- e) inspect the final water chlorine injection point on a regular basis to ensure the pipeline is free from blockage;
 - f) ensure the label on each drum of chlorine disinfectant contains the date of authorisation, date of expiry and PCS number in accordance with Article 22 and 69 of the Biocidal Products Regulation (EU) No 528/2012;

- g) review disinfectant chemical storage arrangements at the treatment plant. All chemicals must be stored in bunded areas capable of containing at least 110% of the volume of chemicals stored therein. Fill points for storage tanks inside the bunds should be within the bunded area;

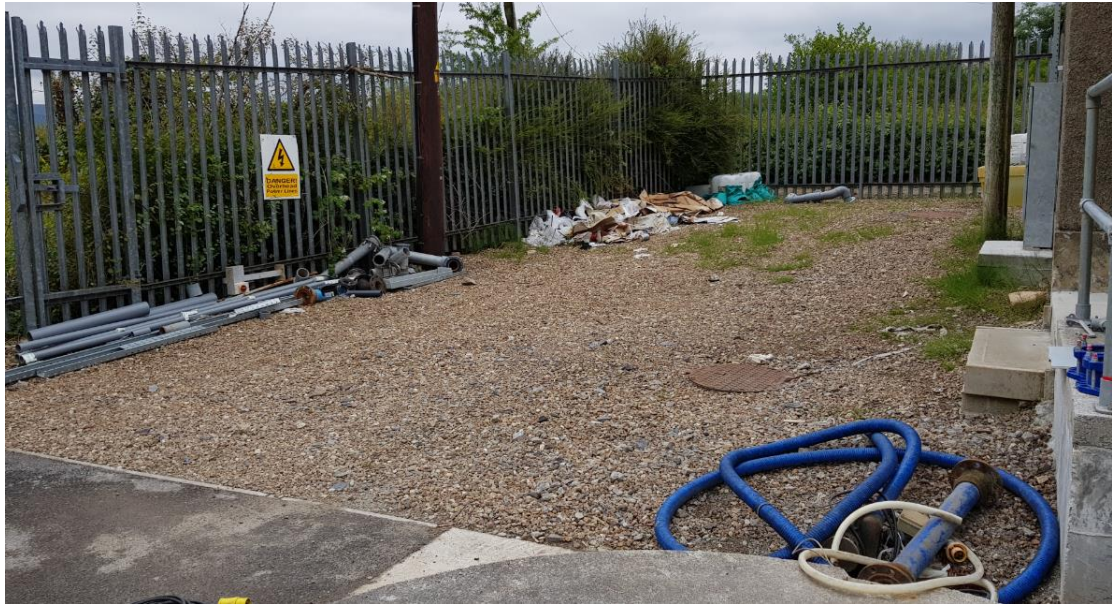
9.	Hygiene and Housekeeping <ol style="list-style-type: none"> a. The treatment plant was in an untidy condition, with PVC piping, steel, rubble, cardboard, plastic wrapping, drums etc stored on-site (see Photo 6).

Photo 6 Storage of piping and other waste at the water treatment plant

- g) ensure water quality monitoring taken at the water treatment plant and network is entered into a dedicated daily log book.
 - h) undertake a complete review of housekeeping and waste storage at the plant and take measures to ensure that the plant is kept well maintained, clean and tidy.
