**Re: Drinking Water Audit – Ballyconnell Co. Cavan Public Water Supply, File Ref.
DW2009/129**

Drinking Water Audit Report

County:	Cavan	Date of Audit:	1 st July 2014
Plant(s) visited:	Ballyconnell Drinking Water Treatment Plant and Reservoir Scheme Code 0200PUB0105	Date of issue of Audit Report:	4 th July 2014
		File Reference:	DW2009/129
		Auditor:	Ms Ruth Barrington
Audit Criteria:	<ul style="list-style-type: none"> • The <i>European Union (Drinking Water) Regulations 2014 (S.I. 122 of 2014)</i>. • The <i>EPA Handbook on the Implementation of the Regulations for Water Services Authorities for Public Water Supplies (ISBN: 978-1-84095-349-7)</i> • The recommendations specified in the EPA Report on <i>The Provision and Quality of Drinking Water in Ireland</i>. • The recommendations in the previous EPA audit report dated 31st August 2009.

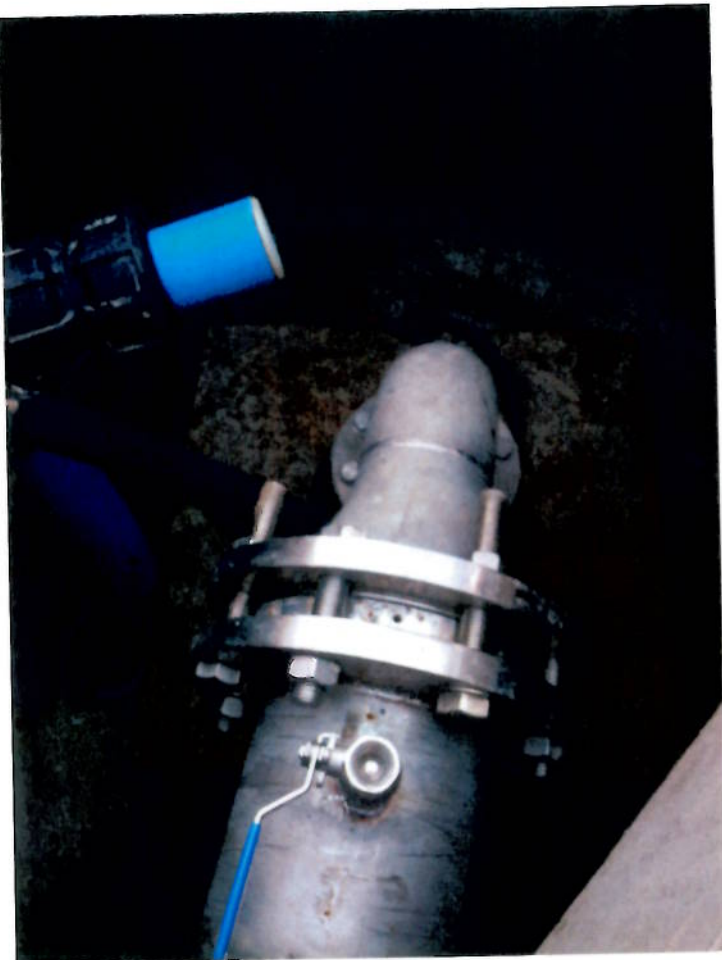
<p>1.</p>	<p>Source Protection</p> <ol style="list-style-type: none"> a. Abstraction for the supply is from two boreholes located in a secure compound adjacent to the treatment plant, refer to photographs 002.jpg and 007.jpg. b. Both wellheads are covered and located within lockable concrete chambers. The wellheads and chambers are elevated to protect them from flooding from the nearby lake. c. Information was available at the audit to indicate that at least some of the landowners within the relevant setback distances had been advised of their responsibilities under the <i>European Union (Good Agricultural Practice for the Protection of Waters) Regulations 2014</i> (SI No.31 of 2014). d. The <i>Cryptosporidium</i> risk assessment was Very High Risk, based on the old source and plant utilising chlorination only. The risk assessment has not yet been revised considering the new source and plant.

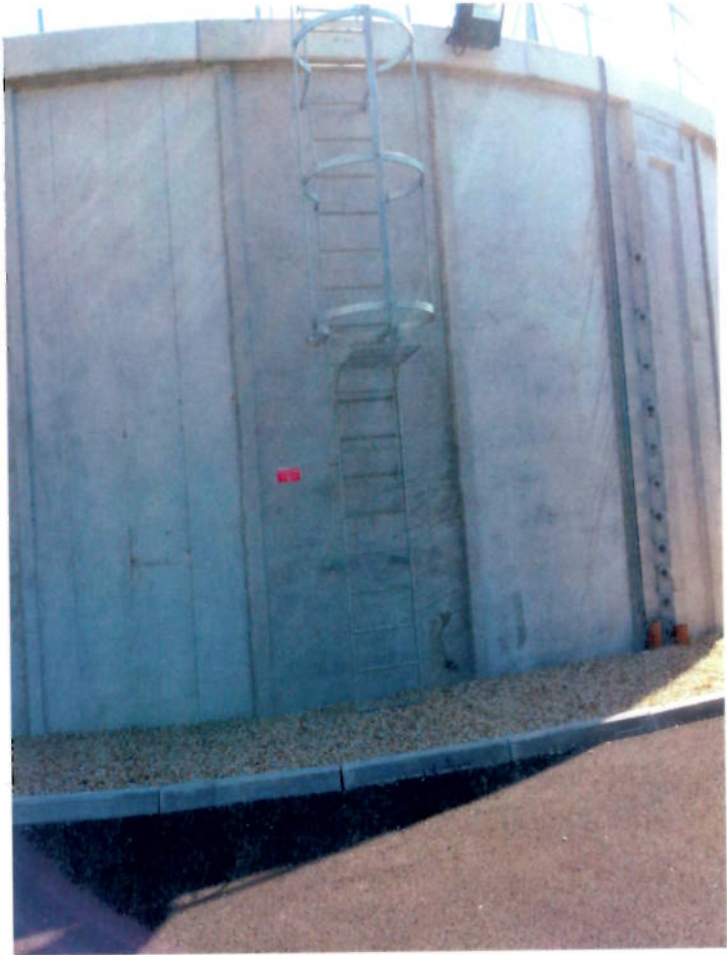
017.jpg

5.	<p>Treated Water Storage</p> <ul style="list-style-type: none"> a. Two new reservoirs were constructed as part of the upgrade of the supply (refer to photograph 017.jpg), and allow about 1.5 days storage, although there would be a pressure drop in areas of the town if this length of storage was utilised. b. The reservoirs were visited during the audit. They are above ground reservoirs located in a secure compound with a kiosk provided for monitoring equipment.
