Drinking Water Audit Report

County:	Co. Cavan	Date of Audit:	26/05/2016
Plant(s) visited:	Cootehill Water Treatment Plant (WTP) and lake source Scheme Code 0200PUB0110	Date of issue of Audit Report:	24/06/2016
		File Reference:	DW2016/54
		Auditors:	Ms Ruth Barrington
Audit Criteria:	<ul style="list-style-type: none"> • The <i>European Union (Drinking Water) Regulations 2014 (S.I. 122 of 2014)</i>. • <i>The EPA Handbook on the Implementation of the Regulations for Water Services Authorities for Public Water Supplies (ISBN: 978-1-84095-349-7)</i> • The recommendations specified in the <i>EPA Drinking Water Report</i>. • EPA Drinking Water Advice Notes Nos. 1 to 15. • The recommendations in the previous audit report dated 18/06/2010.

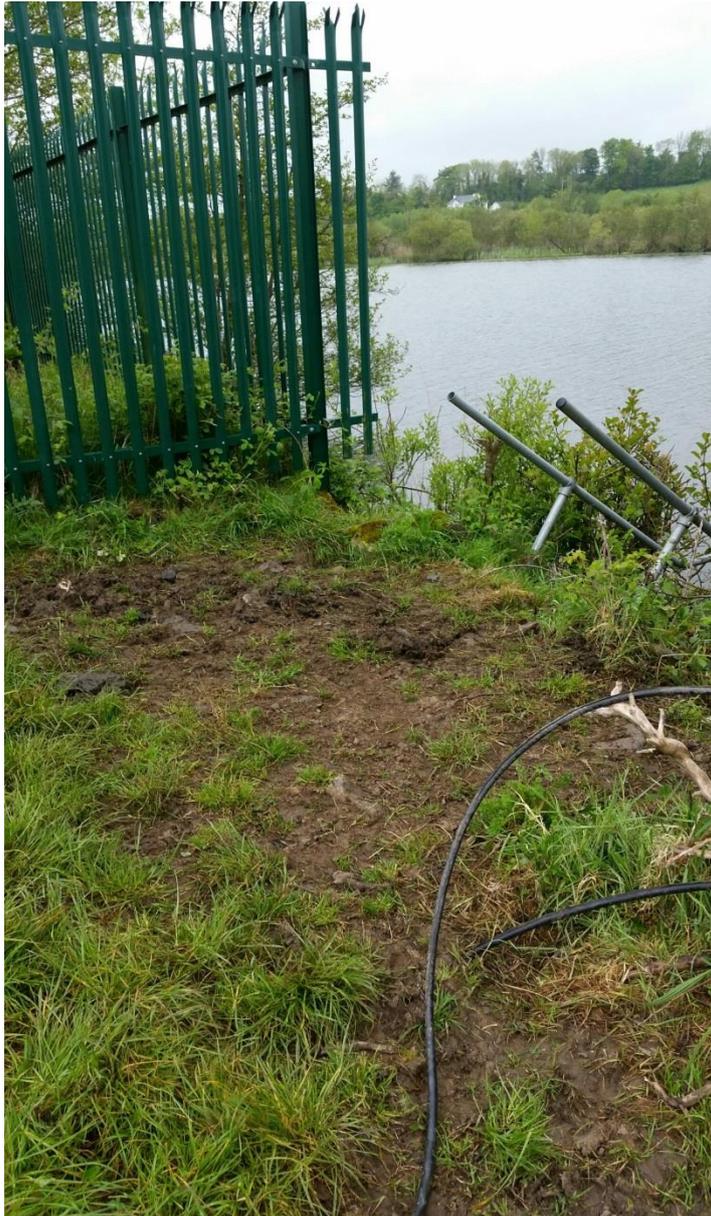
1.	Source Protection a. The vicinity of Coragh Lake is mainly in low intensity agricultural use. It was observed that there is a short section of lake shore adjacent to the pump house compound where there was no fence to prevent cattle access to the lake shore. It appeared that cattle had been in this area as there was visible poaching of the ground and cattle dung close to the water’s edge (Ref. photographs Nos. 1 and 2 attached). This area of land was said to be owned by a third party and cattle drinkers and fences have been provided elsewhere in the field to keep cattle away from the lake.

Photograph No. 1: Unfenced area of Coragh Lake shoreline adjacent to pumphouse palisade fence, showing cattle poaching and dung in foreground

1. Irish Water should liaise with Cavan County Council to minimise the risk posed to the quality of raw water near the abstraction point from cattle access to Coragh Lake adjacent to the pumphouse.

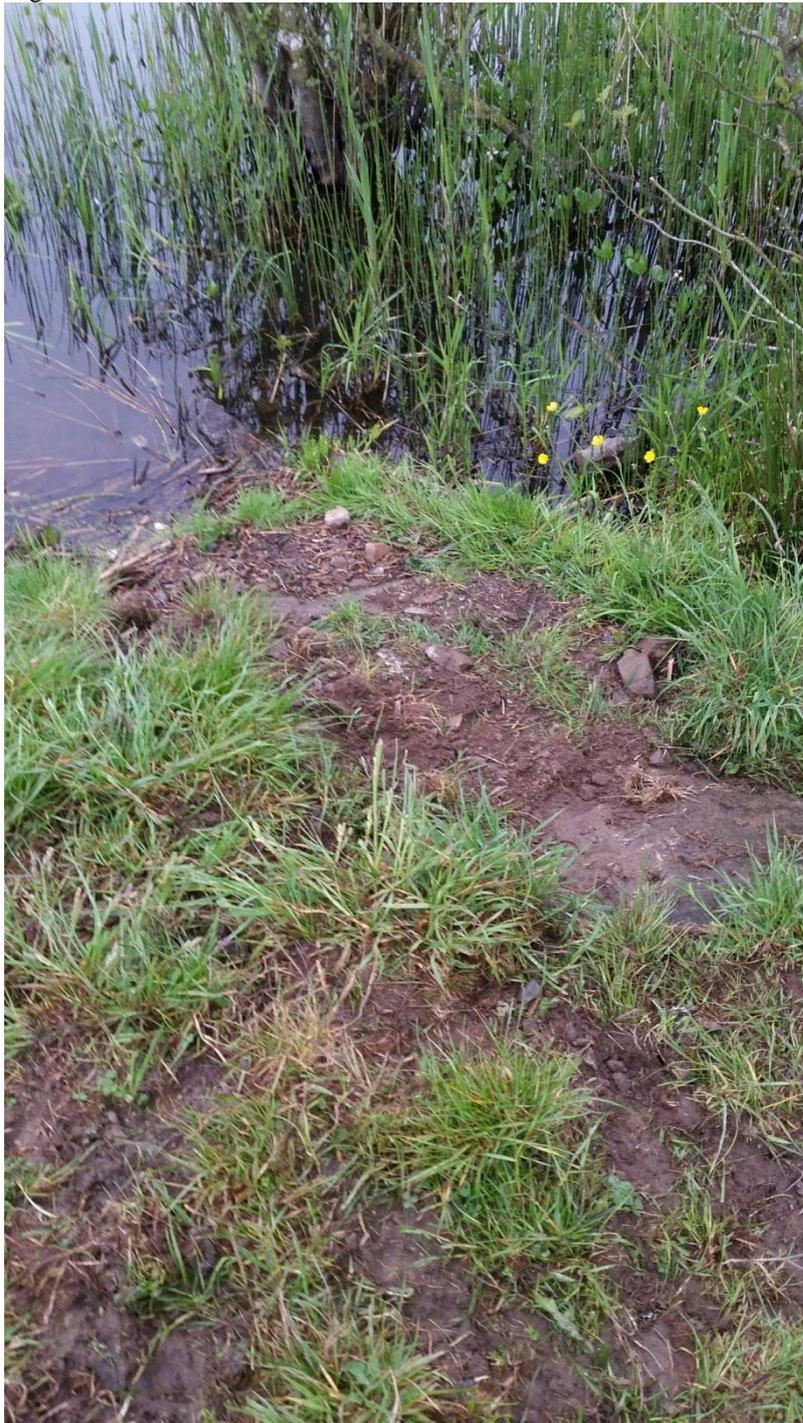
Photograph No. 2: Close-up of lake shoreline showing the proximity of poached area to the water's edge.
