Drinking Water Audit Report

County:	Cavan	Date of Audit:	13 th June 2018
Plant(s) visited:	Kingscourt Water Treatment Plant	Date of issue of Audit Report:	27 th June 2018
		File Reference:	DW2009/135
		Auditors:	Ms Derval Devaney
Audit Criteria:	<ul style="list-style-type: none"> • The <i>European Union (Drinking Water) Regulations 2014 (S.I. 122 of 2014)</i>, as amended. • <i>The EPA Handbook on the Implementation of the Regulations for Water Services Authorities for Public Water Supplies (ISBN: 978-1-84095-349-7)</i> • The recommendations specified in the <i>EPA Drinking Water Report</i>. • EPA Drinking Water Advice Notes No's 1 to 15. • The recommendations in any previous audit reports.

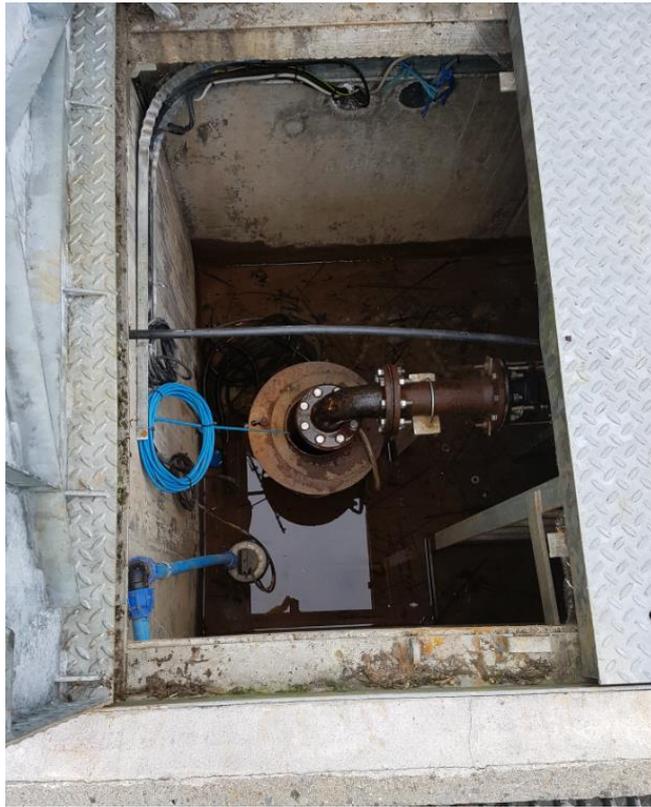
1.	<p>Source Protection</p> <ul style="list-style-type: none">a. Two groundwater abstraction sources are used for the supply, borehole PW5 and PW10 which are in Co. Monaghan, appropriately a 15 minutes’ drive from the water treatment plant. The sources were visited during the audit.b. The two new boreholes were drilled as part of advance works on the upgrade of the supply. PW5 (borehole at Cabra) was commissioned in 2005/2006 and PW10 (borehole at Descart) was drilled in 2007/2008 and over the last 4- 5 years was developed into a production well that meets Irish Water, the EPA and IGI standards under the charge of a hydrogeologist and was brought into service this year.c. PW10 has a pressure sensor, level sensor, non-return valve at the wellhead and an alarmed online turbidity monitor. A kiosk has yet to be installed to cover PW10. There is also a plug-in point at the wellhead for a generator, should it be required.d. PW5’s pump is to be refurbished and a panel installed to automate the monitoring of the raw water similar, to PW10s controls. PW5 has a chamber that is below ground and rainwater was evident at the bottom of the chamber (see Photo 1). A pump automatically pumps out water when the rainwater reaches a certain level in the chamber and this had been manually turned on during the inspection. In addition, there were loose cables and pieces of plastic on the floor of the chamber. Veolia stated it had yet to seal the wellhead, tidy up the cables and install turbidity, pressure and flow monitors on PW5 so that it is of similar standard to PW10.e. A zone of contribution study was completed for both groundwater sources and the landowners in the vicinity of PW10 were notified of their responsibilities under the

Photo 1 PW5 Borehole with standing water in its chamber

- and
- ii. Farmyard manure held in a field prior to land spreading is not placed within 250 m of the abstraction point.
2. Irish Water should complete the works planned for PW5 and PW10 to ensure that the boreholes are maintained in accordance with EPA Advice Note No. 14: Borehole Construction and Wellhead Protection. Such measures include installing a kiosk to cover PW10 and PW5 wellhead is to be sealed, pump refurbished, online monitors installed and other works to ensure the chamber's contents are waterproof and free from contamination.

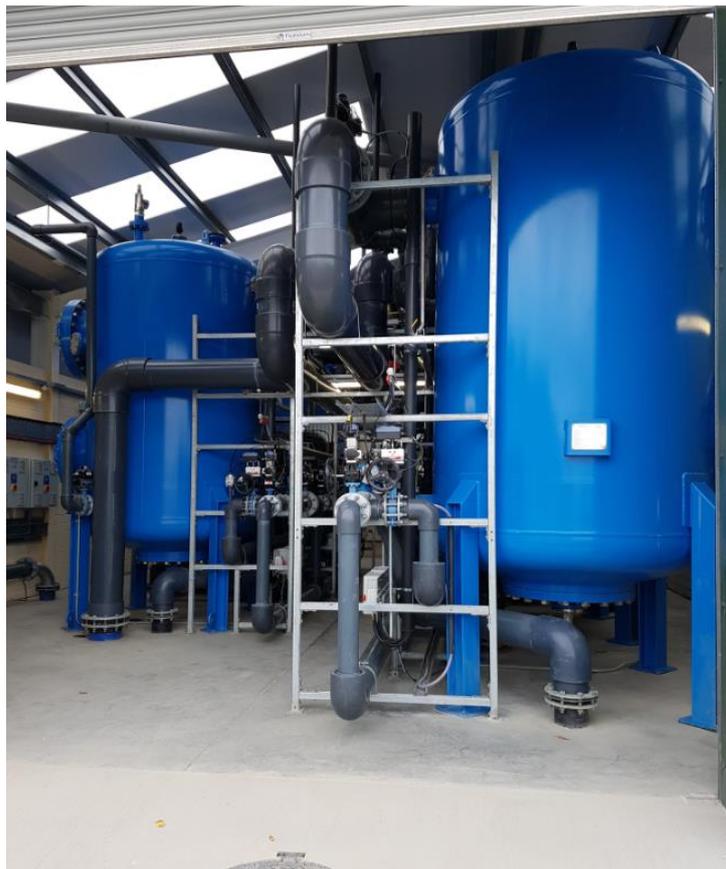
Photo 2 New Pressure Filters (Stage 1 on RHS & Stage 2 on LHS)
