Drinking Water Audit Report

County:	Clare	Date of Audit:	16 th & 28 October 2015
Plant(s) visited:	Broadford 0300PUB1027	Date of issue of Audit Report:	04/11/2015
		File Reference:	DW2015/179
		Auditors:	Mr Niall Dunne
Audit Criteria:	<ul style="list-style-type: none"> • The <i>European Union (Drinking Water) Regulations 2014 (S.I. 122 of 2014)</i>. • The <i>EPA Handbook on the Implementation of the Regulations for Water Services Authorities for Public Water Supplies (ISBN: 978-1-84095-349-7)</i> • The recommendations specified in the <i>EPA Drinking Water Report</i>. • The recommendations in any previous audit reports.

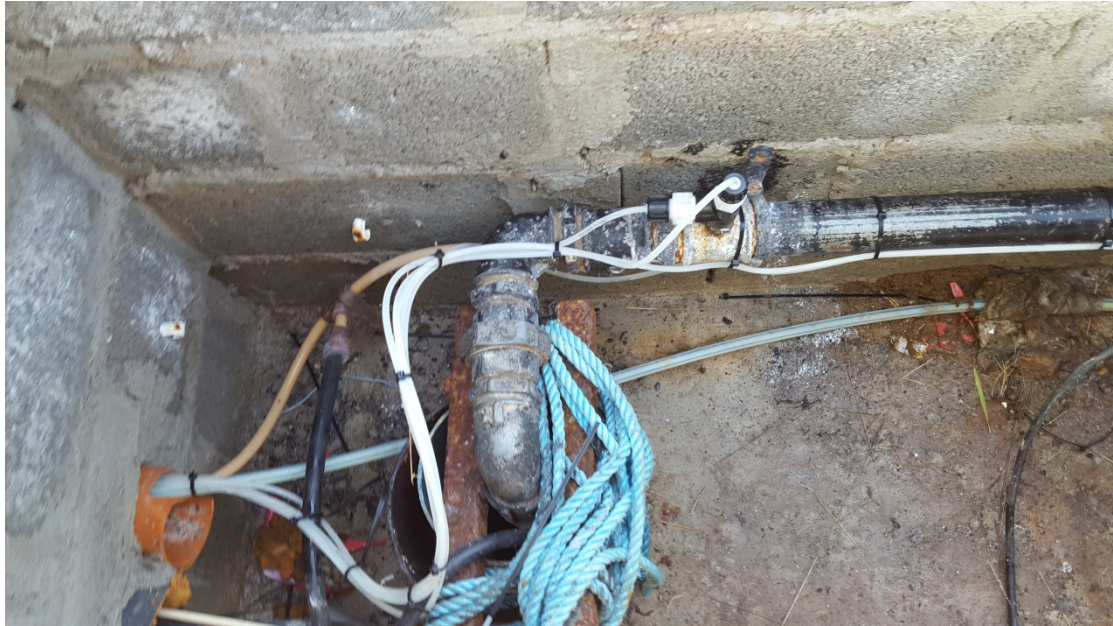
1.	Source Protection <ul style="list-style-type: none">a. There are two boreholes on this supply, one supplies the villages of O Callaghan's Mills and Tulla and the other supplies the village of Broadford. The well heads for either borehole were not in compliance with the EPA guideline and the covers were not sufficient to prevent surface water ingress, (see photograph 1).b. Clare County Council (CCC) stated that no farm surveys had been carried within the vicinity of the borehole.

Photograph 1; Inadequate borehole construction (susceptible to surface water ingress).

1. Irish Water should ensure that the construction of each borehole is in accordance with the EPA Advice Note No 14: *Borehole Construction and Wellhead Protection*.
2. Irish Water should liaise with Clare Country Council in carrying out farm surveys within the vicinity of the borehole.

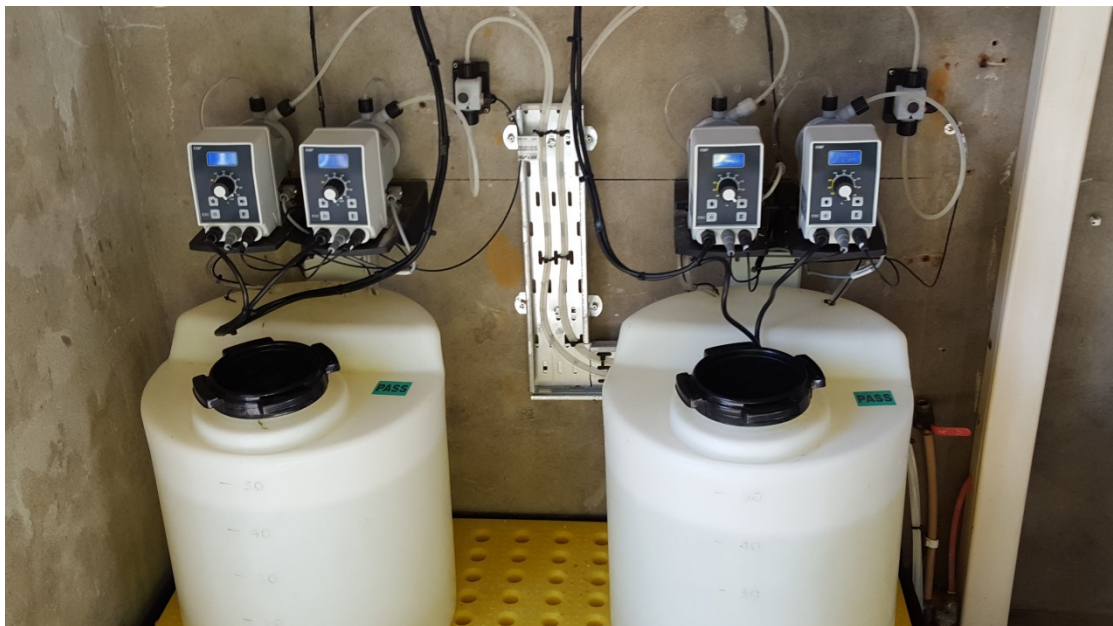
2.	Chlorination and Disinfection <ul style="list-style-type: none">a. There are separate duty standby chlorine dosing pumps on the Tulla and the Broadford networks, (see photograph 2). CCC stated that there is auto switch over between the duty and standby pumps.b. On the Broadford network there is a chlorine monitor prior to the Broadford reservoir. This chlorine monitor at the time of the audit was not operational and was disconnected from the supply, (see photograph 3). According to CCC the monitor was never operational. CCC estimated that the monitor was installed approximately 7- 8 years ago.c. Prior to the Tulla reservoir there is booster chlorination with duty standby chlorine dosing pumps, (these chlorine pumps were not visited as part of the audit, as at different location). There is a chlorine monitor at the reservoir but was not operational at the time of the audit. According to CCC it was never operational, (see photograph 4).d. New replacement duty standby dosing pumps were observed at the Tulla reservoir; according to IW these pumps are to be operational by the Q1 2016.e. Caretakers tests for chlorine levels within the network on a daily basis.

Photograph 2; Separate duty and standby pumps on the Broadford and Tulla supplies.

3. Irish Water should ensure that the chlorine dosing pumps are regularly maintained and calibrated in accordance with the manufacturer's instructions.
4. Irish Water should install a chlorine sampling point on the final water of each network.

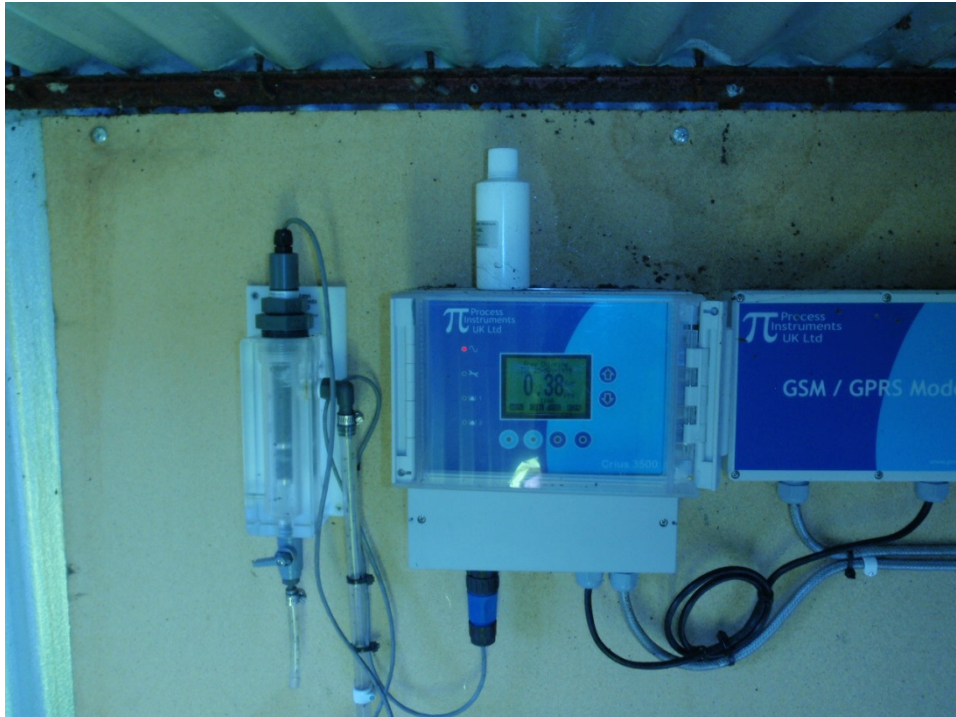
There is no operational chlorine monitor on this supply, either on the Broadford or Tulla networks. It is essential that there is an operational chlorine monitor at all chlorine dosing points; this includes booster chlorination points. These chlorine monitors should be alarmed and linked to a recording device to ensure that either a sudden increase in chlorine demand or a failure of the chlorine dosing system is immediately detected and notified to a competent person. A direction separate to this audit report has issued for the installation of the chlorine monitors and alarms and so this issue is not included in the recommendations of this report.

Photograph 3: Chlorine monitor at the Broadford reservoir (not operational).

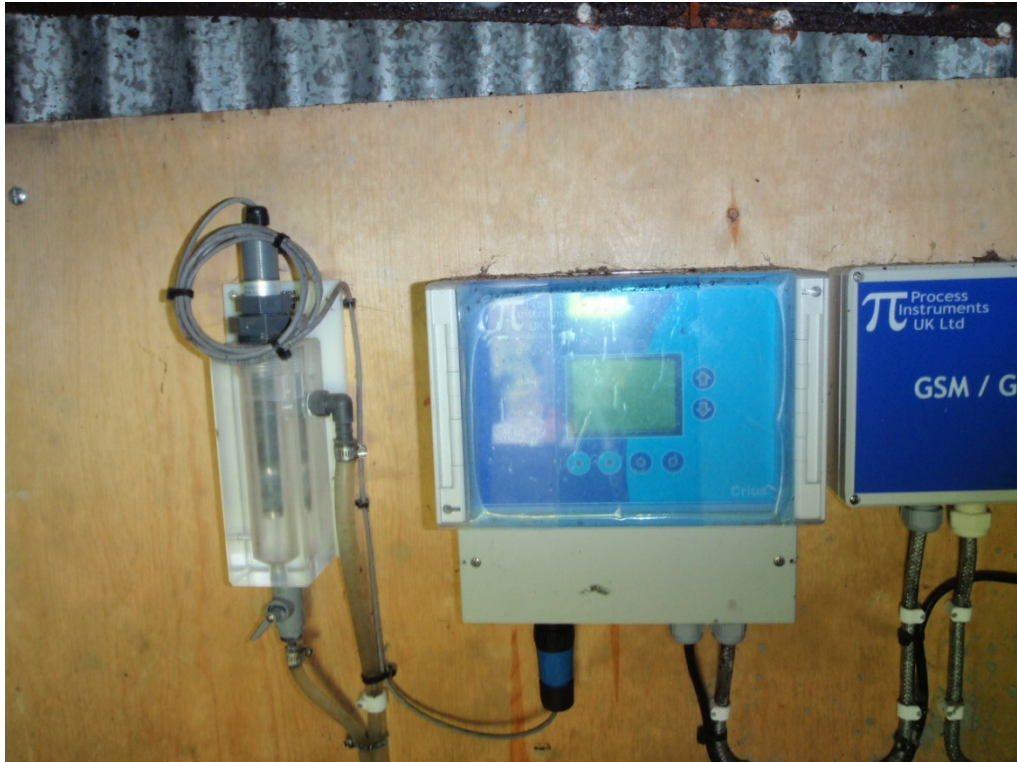
Photograph 4: Chlorine monitor at the Tulla reservoir (not operational).
