<h1 style="margin: 0;">Drinking Water Audit Report</h1>
---	---

Local Authority:	Clare County Council	Date of Audit:	10/12/2013
Plant(s) visited:	Corofin Public Water Supply (0300PUB1010)	Date of issue of Audit Report:	10/01/2014
		File Reference:	DW2012/17
		Auditors:	Mr Niall Dunne
Audit Criteria:	<ul style="list-style-type: none"> • The <i>European Communities (Drinking Water) (No. 2) Regulations, 2007.</i> • The <i>EPA Handbook on the Implementation of the Regulations for Water Services Authorities for Public Water Supplies (ISBN: 978-1-84095-349-7)</i> • The recommendations specified in the EPA Report on <i>The Provision and Quality of Drinking Water in Ireland.</i> • The recommendations in any previous audit reports.

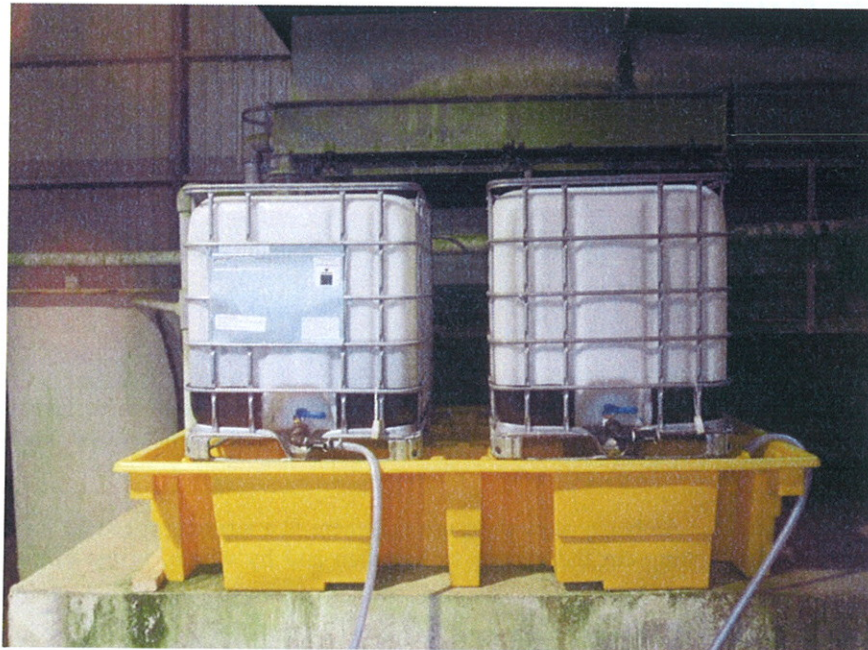
2.	Coagulation, Flocculation, Clarification and Filtration <ul style="list-style-type: none">a. Treatment at this plant consists of dissolved air flotation with integrated rapid gravity filtration.b. Liquid alum is stored in two intermediate bulk containers (IBCs) (see photograph 1). There is four weeks alum storage in each tank. Alum is also stored in two day tanks, a duty and standby tank each with a single dosing pump. There is manual switch over between the two tanks. CCC stated that the alum in the day tank is prepared every two days. The bulk IBCs appear to be of a temporary nature

<p>and the piping from the tanks is not secured against accidental damage (see photograph 1).</p> <ul style="list-style-type: none"> c. CCC had written procedures in place for the coagulation preparation process. CCC stated that the required alum dose is 120 mg/l, which was determined in May 2013 by jar tests carried out by an external contractor when CCC switched from kibbled alum to liquid alum. CCC stated that they themselves do not carry out jar tests at the plant. (A recommendation of the last audit was that regular jar tests should be carried out). The alum used is 10% concentration. d. On observation the alum dosing point was observed not to be secured against accidental damage. e. CCC stated that the poly is delivered prepared to site. Poly is stored at the treatment plant in a single day tank with a single duty pump. f. Poly is dosed approximately 1 minute after the alum is dosed. CCC had not calculated the coagulant mixing time within the mixing chamber. g. A backwash cycle of the DAFF plant was observed. The unit does not drain down as part of the backwash process. h. There was no written filter maintenance procedure or no filter maintenance log book onsite. CCC stated that this logbook would be in place by February 2014. i. It was observed that the final water from the DAFF unit flows into an open channel adjacent to the plant prior to entering the clear water tank (see photograph 2). j. The DAFF unit itself was noted to be unclean and have accumulated rust and debris on its surfaces. (see photograph 3) k. There is no turbidity monitor after the DAFF plant; however, there is a turbidity monitor after the GAC filter.

8.	<p>Chemical storage and bunds</p> <ul style="list-style-type: none"> a. Alum is stored in IBCs (see photograph 1).The fill points are now located within the bunding. The IBCs are situated on top of the bunds and not within the bunds. b. The alum day tanks were in a bunded area, but the capacity of the bund did not appear to be 110% of the volume of the two tanks within it. c. Chemicals used were to IS:EN standard and this documentation was on site. d. CCC stated that there is now a protocol and procedure in place for the delivery of chemicals. e. The empty drums of sodium hypochlorite observed on site, during the last audit, were removed. f. CCC stated that there is now a procedure in place to check whether the stocks of chemicals are in date. g. Chemicals were observed to be stored adjacent to the treated water tank (see photograph 5).

Picture 1: Alum contained in IBCs, these were not adequately banded. The IBC's should be within the bunding. The IBCs seem to be of a temporary nature and the piping from the tanks is not secure against accidental damage.

6. The Water Services Authority should ensure that all chemical dosing points are secured against accidental damage.
7. The Water Services Authority should review the operation of the DAFF plant to ensure that adequate coagulation and filtration is being achieved.

19. The Water Services Authority should review chemical storage arrangements for the alum bulk and the alum day tanks. The Water Services Authority should ensure that the chemicals must be stored within bunded areas capable of containing at least 110% of the volume of chemicals stored therein.
20. The Water Services Authority should investigate the possibility of installing a permanent bunded bulk storage tank for the alum. The Water Services Authority should also ensure that the piping from the tanks is secured against accidental damage.

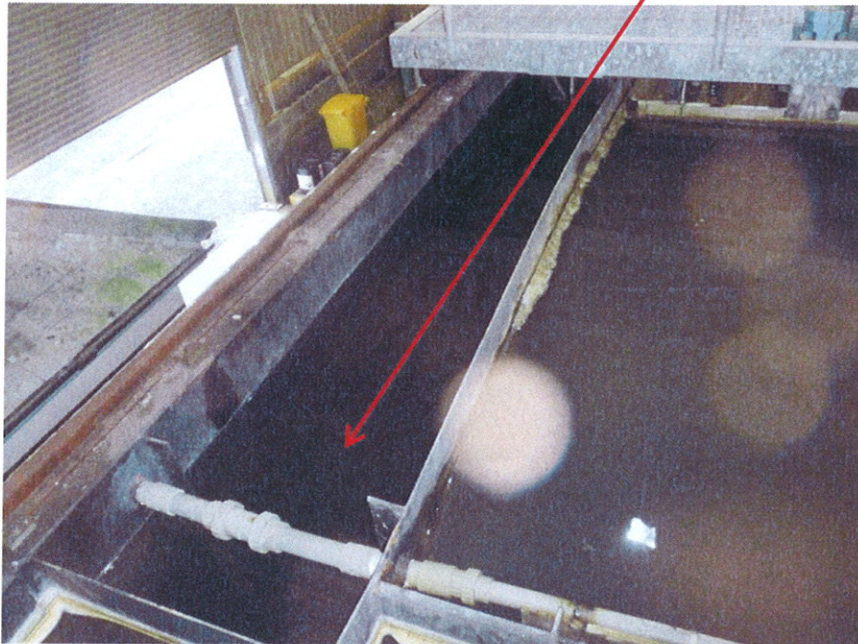
Picture 2: Treated water in exposed open channel beside DAFF unit.

9. The Water Services Authority should ensure that the treated water in the open channel adjacent to the DAFF plant is fully covered against the ingress of animals and insects.

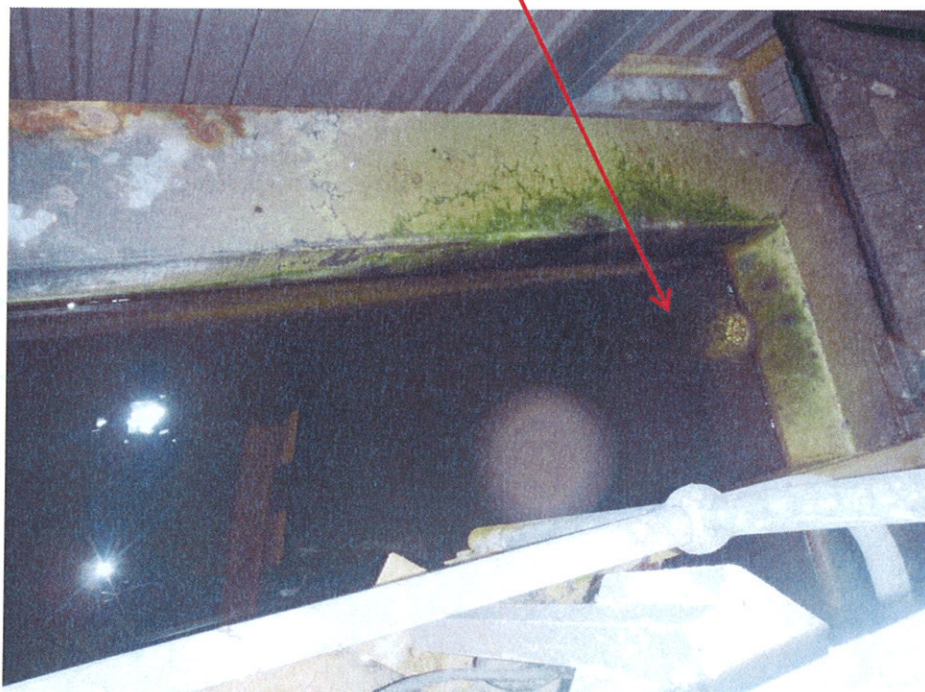
Picture 3: Daff plant was observed not to be clean.

10. The Water Services should ensure that the DAFF plant is thoroughly cleaned on a regular basis.
11. The Water Services Authority should develop documented management and maintenance programs for the GAC filter media to ensure that the media is regularly tested and replaced.

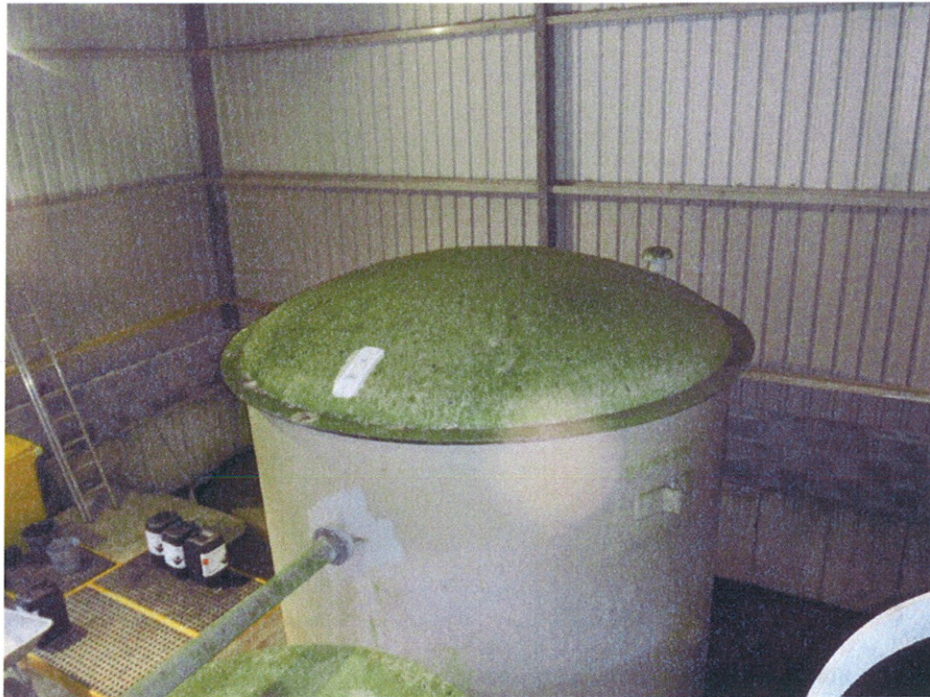
5.	<p>Treated Water Storage</p> <ul style="list-style-type: none"> a. Treated water is stored on site in a freestanding clear water tank. The holes observed in the top cover of the tank during the last audit appeared to be covered, but this seemed to be of a temporary nature (see photograph 4). No inspection/maintenance hatch was observed in the clear water tank. b. The clear water storage tank is located in a retention basin, where decanted sludge from the sludge holding tanks is held prior to percolation (see photograph 5). CCC stated that remedial works to resolve this issue will be completed by March 2014. Standing water was also observed in the retention basin.

Picture 4: Treated water tank, patching in unit seems to be of a temporary nature and no access point for maintenance purposes was observed in the tank.

15. The Water Services Authority should carry out an integrity assessment of the clear water tank and should ensure that the cover to the tank is properly sealed and that any holes in the cover are permanently repaired. The Water Services Authority should also ensure that the tank is inspected internally and cleaned out regularly and that appropriate access in the tank is provided to allow this.
16. The Water Services Authority should ensure that the clear water tank is fully protected against the decanted water from the sludge holding tank and from the chemicals stored within its vicinity.

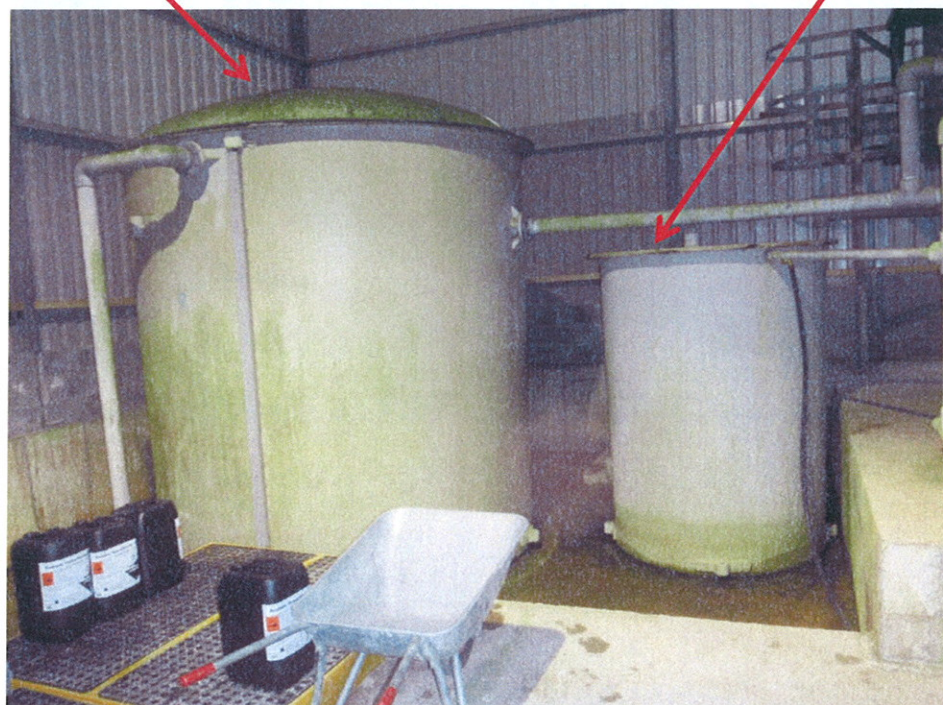
9.	<p>Sludge Management</p> <ul style="list-style-type: none"> a. According to CCC the sludge tank is undersized and water from the tank is decanted into the percolation area via the floor of a retention basin. The sludge tank is not bunded and is located adjacent to the clear water tank. CCC stated that this is to be reviewed and measures to be put in place by March 2014.

Picture 5: Clear water tank, adjacent to the sludge holding tank. These are in a retention basin where decanted sludge is held prior to the percolation area. Standing water was observed in the retention basin. Chemicals are also stored adjacent to the clear water tank.

21. The Water Services Authority should review the current sludge holding and decanting arrangements and should put measures in place to ensure that the storage capacity of the sludge holding tanks is adequate for the through-put of the treatment works.
22. The Water Services Authority should ensure that the sludge holding tank is bunded to 110% of the capacity of the tank.
