<h1>Drinking Water Audit Report</h1>
---	--------------------------------------

County:	Clare County	Date of Audit:	07/08/2014
Plant(s) visited:	Ennistymon PWS 0300PUB1004	Date of issue of Audit Report:	08/09/2014
		File Reference:	DW2014/277
		Auditors:	Mr Niall Dunne
Audit Criteria:	<ul style="list-style-type: none"> • <i>The European Union (Drinking Water) Regulations 2014 (S.I. 122 of 2014).</i> • <i>The EPA Handbook on the Implementation of the Regulations for Water Services Authorities for Public Water Supplies (ISBN: 978-1-84095-349-7)</i> • <i>The recommendations specified in the EPA Report on <u>The Provision and Quality of Drinking Water in Ireland.</u></i> • <i>The recommendations in any previous audit reports.</i>

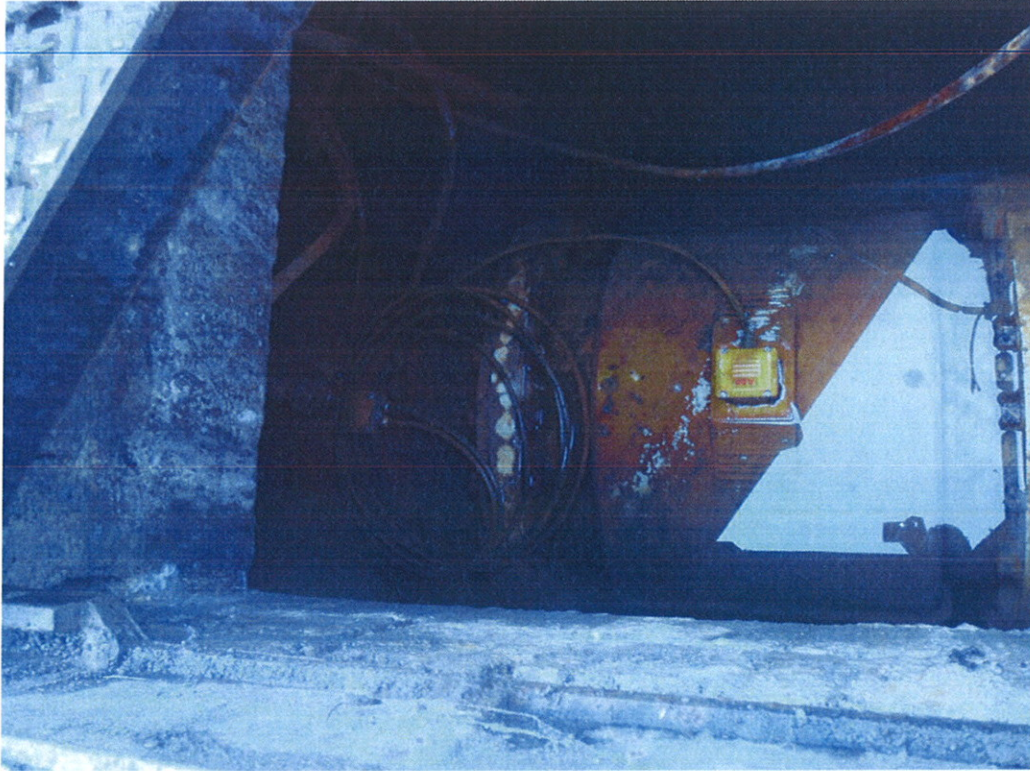
2.	<p>Coagulation, Flocculation and Clarification</p> <ul style="list-style-type: none"> a. According to CCC the plant was designed for 4,800 m³/day and is currently producing 6,000 - 7,500 m³/day. Flow through the plant is set at 300 m³/hr. b. The ferric dosing point chamber was observed to be full of water; (see photograph 1), ferric is dosed flow proportionally. Poly is dosed at approximately 0.17 mg/l; the dose is manually set. c. CCC were not aware of the contact time within the mixing chamber; but stated that there were baffles within the chamber to assist with mixing of the poly and the coagulant. d. Lime is dosed automatically based on pH. e. The walls of the clarifier were observed not to be clean. The decanting channels were observed to be clean and in good condition; but the main channel was showing signs of rust; (see photograph 2). f. CCC stated that Chemifloc under take jar tests approximately twice a year off site; and that no jar tests are done on site. g. Sludge bleeds are on a timer and are set for every 6-8 minutes; each bleed lasts for approximately 1-2 minutes. A bleed was observed to run clear. Sludge bleed run offs are sent to a picket fence thickener; to a centrifuge and then to land fill.

Photograph 1: Ferric dosing point submerged.

15. The Water Services Authority should carry out an integrity assessment of the ferric bulk storage tank.
16. The Water Services Authority should ensure that the water is removed from the ferric dosing chamber so that the dosing points can be inspected.

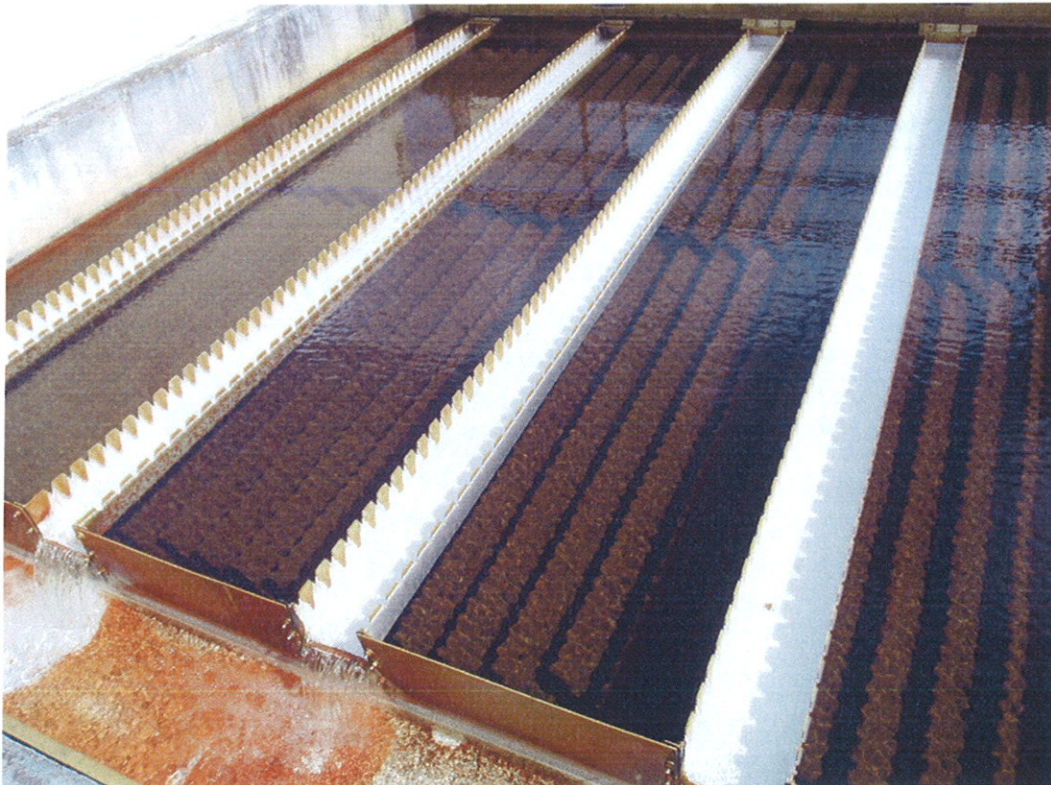
Photograph 2: Channels in clarifier showing signs of rust.

17. The Water Services Authority should ensure that the clarifier and the filters are cleaned on a regular basis to prevent build-up of algae and residue on the walls and that rust on the weirs is removed.

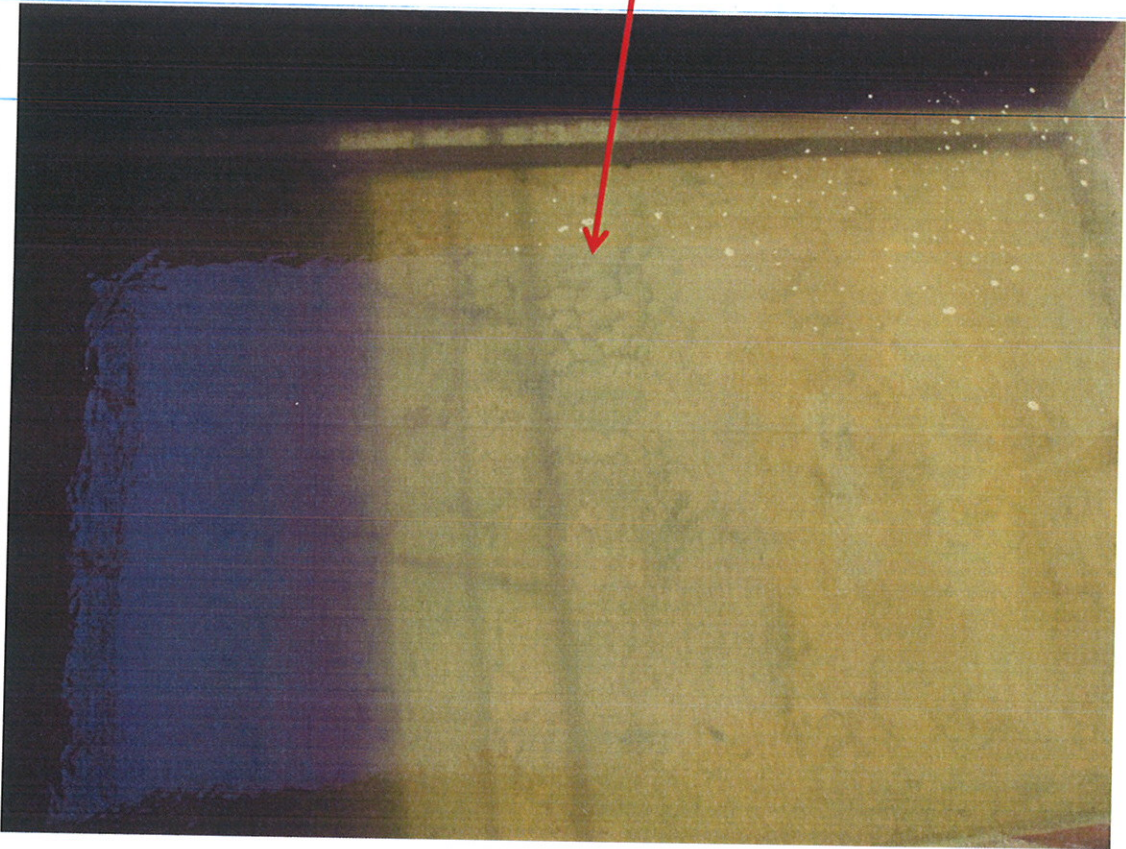
<ul style="list-style-type: none"> d. Mudballing and cracking was observed in the filter; (see photograph 3). e. The backwash cycle appeared to be even across the filter. f. Some sand was observed within the filter channel. g. The length of the backwash cycle is determined by visual observations and is not based on turbidity. Turbidity readings are not taken following the cycle and the monitors are not connected to SCADA and are not linked to a dial out alarm. The turbidity reading on the filter following backwashing was observed by the auditor to be 0.3 NTU. h. The turbidity readings on the other filters were observed to be 4.16 and 0.01 NTU, i. CCC stated that the filters following backwash are brought back into service with a slow start. j. The walls of the filter were observed to be stained and did not appear to be recently washed. k. Wash water from the filters is sent to a settling chamber; decanted water is sent to river and sludge is sent to landfill.

Photograph 3: Mudballing and cracking in the filter.

11. The Water Services Authority should investigate the cause of the mud balling /cracks in the filter media and should take appropriate action to optimise the operation of the filter and should review the operation and condition of the sand filter and ensure that any of the abnormal operating conditions (as outlined on pages 43 to 45 of the EPA publication "*Water Treatment Manual on Filtration*") are urgently rectified.

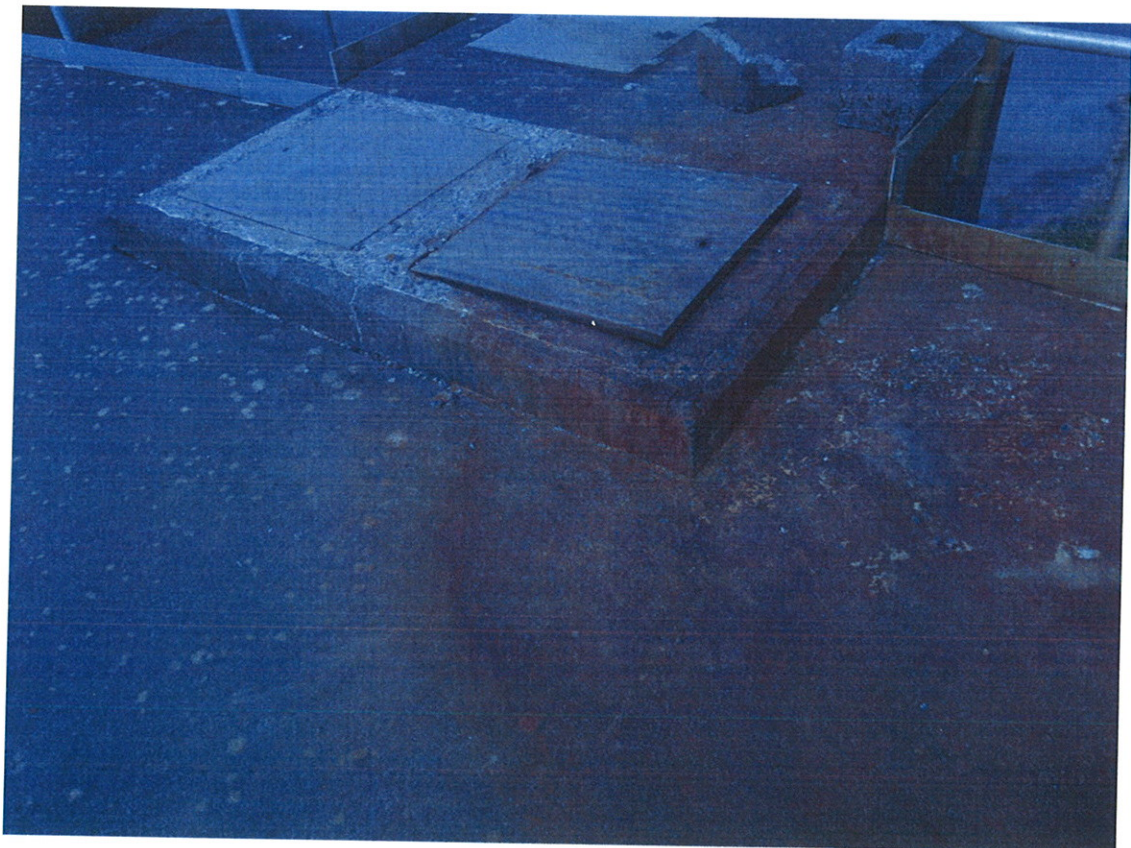
7.	<p>Chemical storage and bunds</p> <ul style="list-style-type: none"> a. Covers on the ferric bulk storage tank were observed not to be sealed properly and staining was observed around the cover; (see photograph 4). b. Cracks were observed in the ferric storage tank; (see photograph 5). There was no spill tray or lock observed on the ferric delivery point; (see photograph 6).

Photograph 4: Cover on ferric bulk tank not sealed and showing signs of spillage.

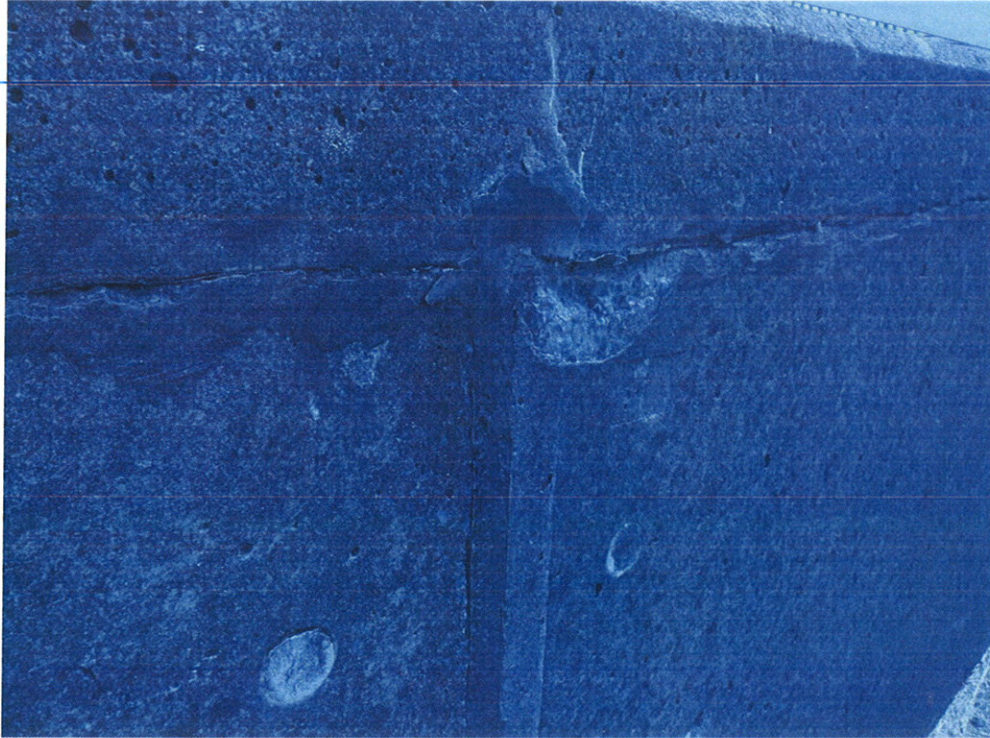
Photograph 5: Crack in the ferric bulk storage tank.

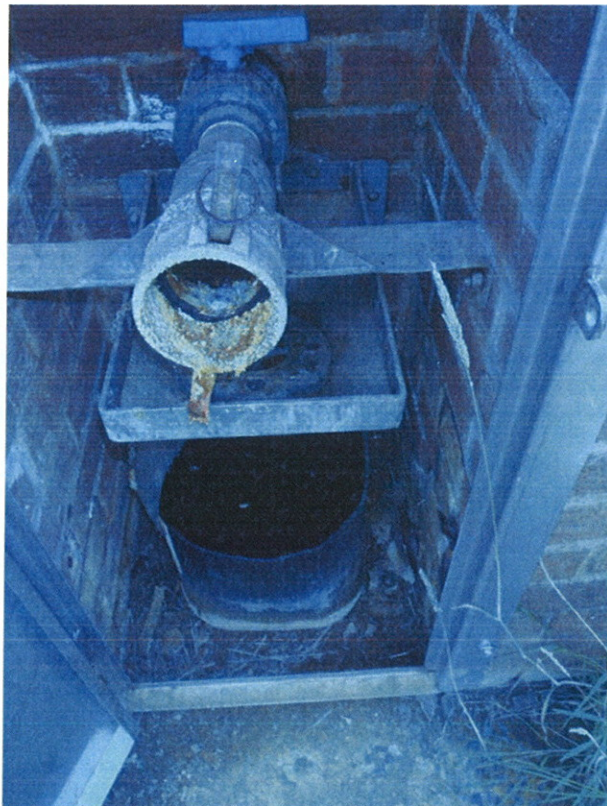
Photograph 6: Ferric delivery point; no cover or spill tray in place.

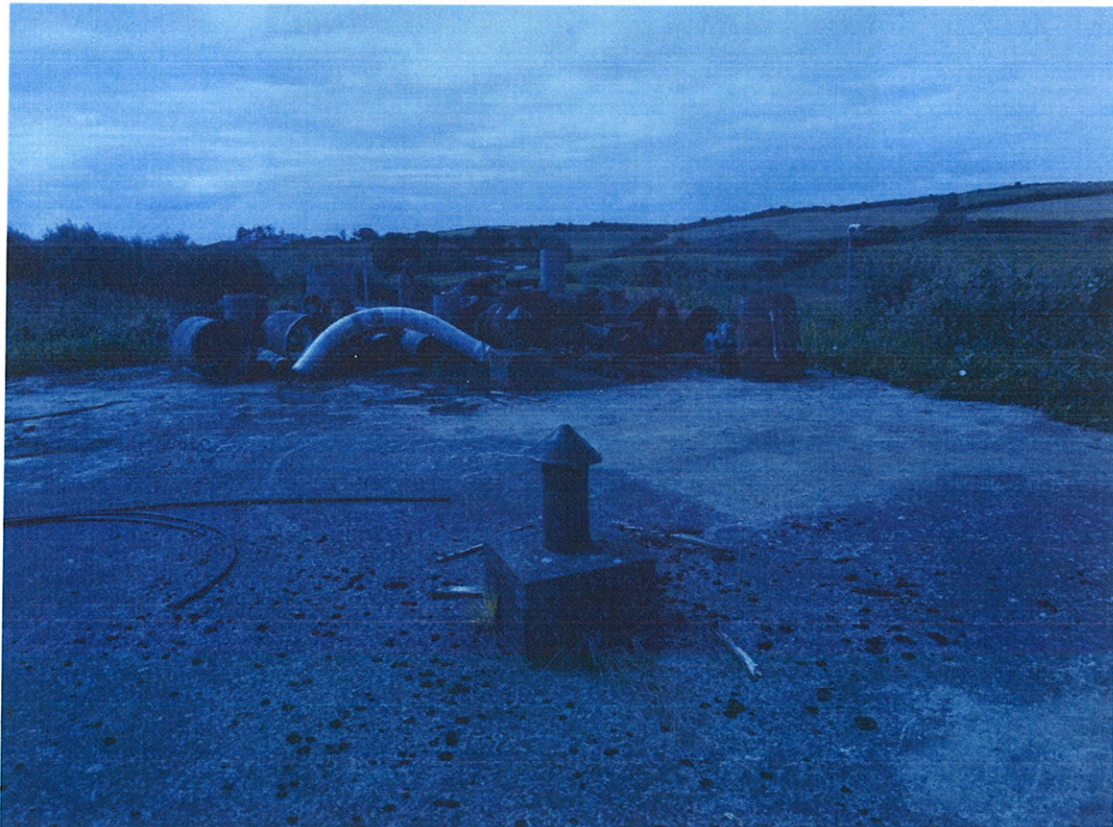
8.	<p>Hygiene and Housekeeping</p> <p>a. The plant is generally clean but old pipes and waste was being stored on the reservoir; (see photograph 7).</p>

Photograph 8: Pipes and waste material stored on reservoir;

18. The Water Services Authority should undertake a complete review of housekeeping and waste storage at the plant and take measures to ensure that the plant is kept well maintained, clean and tidy and that the pipes and the waste material are removed from the reservoir.
