Drinking Water Audit Report

County:	Clare	Date of Audit:	23/03/2017
Plant visited:	Kilkeedy PWS (0300PUB1039)	Date of issue of Audit Report:	07/04/2017
		File Reference:	DW2013/47
		Auditors:	Mr Niall Dunne Ms Criona Doyle
Audit Criteria:	<ul style="list-style-type: none"> • The <i>European Union (Drinking Water) Regulations 2014 (S.I. 122 of 2014)</i>. • <i>The EPA Handbook on the Implementation of the Regulations for Water Services Authorities for Public Water Supplies (ISBN: 978-1-84095-349-7)</i> • The recommendations specified in the <i>EPA Drinking Water Report</i>. • EPA Drinking Water Advice Notes No.s 1 to 15. • The recommendations in any previous audit reports.

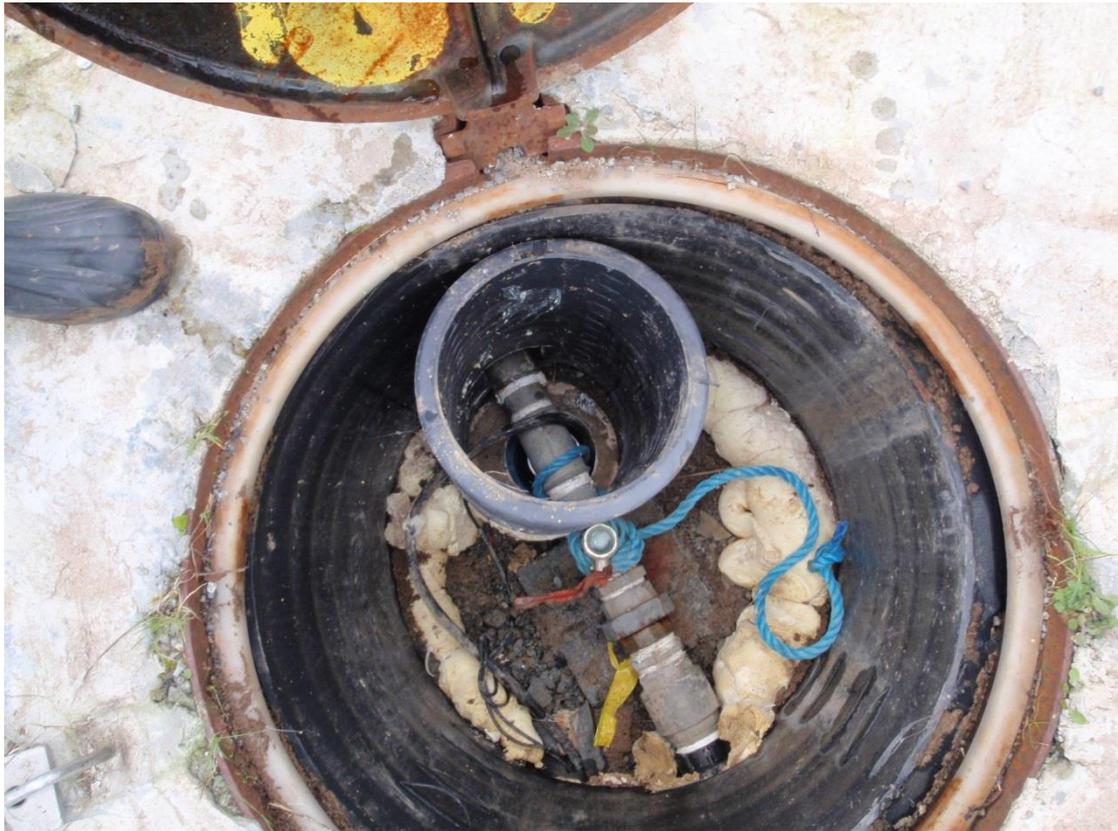
Photograph No. 1: Inadequate Wellhead Protection

1. Irish Water should submit a copy of the revised *Cryptosporidium* Risk Assessment to the Agency.
2. The borehole chamber should be constructed in accordance with EPA Advice Note No. 14: Borehole Construction and Wellhead Protection. Irish Water should ensure that the wellhead is raised above ground level and that it is securely capped to address the risk of ingress into the borehole shaft and that the chamber is sealed with a lockable manhole cover.
