# Drinking Water Audit Report

<b>Local Authority:</b>	Clare County Council	<b>Date of Audit:</b>	10/12/2013
<b>Plant(s) visited:</b>	Kilkeedy Public Water Supply (0300PUB1039)	<b>Date of issue of Audit Report:</b>	10/01/2014
		<b>File Reference:</b>	DW2013/47
		<b>Auditors:</b>	Mr Niall Dunne
<b>Audit Criteria:</b>	<ul style="list-style-type: none"> <li>• The <i>European Communities (Drinking Water) (No. 2) Regulations, 2007</i>.</li> <li>• The <i>EPA Handbook on the Implementation of the Regulations for Water Services Authorities for Public Water Supplies (ISBN: 978-1-84095-349-7)</i></li> <li>• The recommendations specified in the EPA Report on <i>The Provision and Quality of Drinking Water in Ireland</i>.</li> <li>• The recommendations in any previous audit reports.</li> </ul>

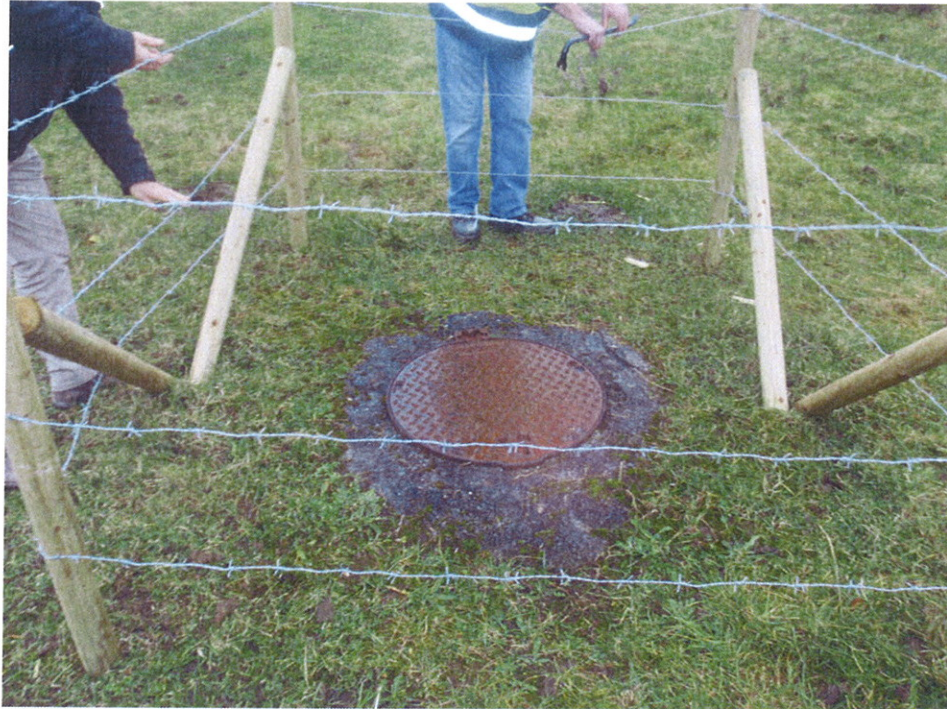
<b>1.</b>	<p><b>Source Protection</b></p> <ul style="list-style-type: none"> <li>a. The source for the Kilkeedy PWS is a borehole located in a karst limestone area. The surrounding land is used for low intensity dry stock grazing. Clare County Council (CCC) has erected a temporary fence around the borehole (see photograph 1). The borehole chamber is to be upgraded by the end of March 2014.</li> <li>b. CCC stated that farm surveys are to be carried out in the 2014/2015 programme.</li> <li>c. Farmers are to be written to by February 2014 with regard to their obligations under the <i>European Communities (Good Agricultural Practice for the Protection of Waters) Regulations 2010 (SI No.610 of 2010)</i>.</li> <li>d. CCC confirmed that they have some borehole data but that this information is limited.</li> <li>e. CCC stated, based on monitoring results, that the source water is not influenced by surface water, but that their resident geologist is to carry out a visual survey of the surrounding area for features associated with the karst landscape, such as swallow holes.</li> <li>f. The <i>Cryptosporidium</i> risk score for this supply is 36.8 indicative of low risk.</li> </ul>

**Photograph No. 1: Temporary fence around borehole. Head of borehole below ground level and chamber not of adequate construction.**

- Source Protection:** The Water Services Authority should take action should to ensure that the area in the immediate vicinity of the borehole is permanently secured and fenced off to prevent unauthorised and livestock access.

- Source Protection:** The Water Services Authority should ensure that the well head is raised above ground level and that it is securely capped to address to reduce the risk of ingress into the borehole shaft and that the chamber is sealed with a lockable manhole cover. The borehole chamber should be constructed as per EPA Advice Note No 14: Borehole Construction and Wellhead Protection.

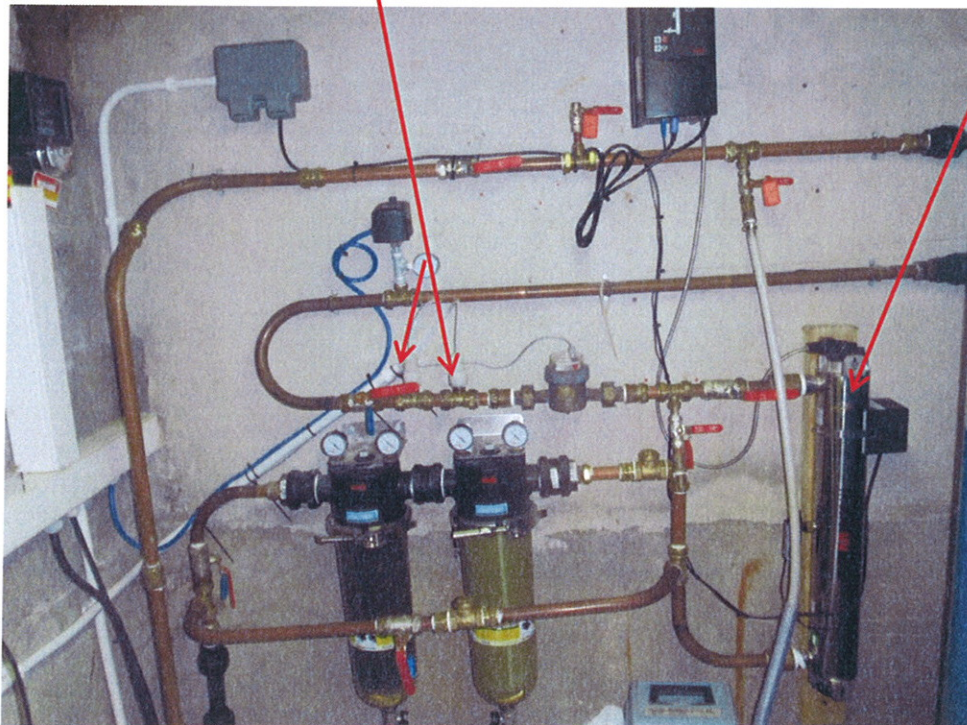
<b>2.</b>	<p><b>Chlorination and Disinfection</b></p> <ul style="list-style-type: none"> <li>a. In a Direction issued to CCC on the 19/07/2013, CCC was directed to; <ul style="list-style-type: none"> <li>i. Install an operational continuous chlorine residual monitor on the final water. This was to be alarmed and linked to a recording device;</li> <li>ii. Install automatic switch over between the duty and standby chlorination pumps; and</li> <li>iii. To submit the chlorine contact time calculations.</li> </ul> </li> <li>b. The chlorine monitor is in place and is alarmed and linked to a recording device. However, CCC could not confirm whether the data could be downloaded.</li> <li>c. CCC confirmed that there is automatic switch over in place, and that there is also an automatic 24hr switch over in place between the two pumps.</li> <li>d. CCC submitted chlorine calculation of 21.93 mg.min/l on the 20/08/2013, however, the contact time was revised to 19.32 mg.min/l on the 16/12/ 2013. These revised calculations have yet to be submitted.</li> <li>e. The low and high alarm levels are set at 0.25 and 1.0 mg/l respectively. Currently only the caretaker receives the alarms for this supply.</li> <li>f. The caretaker monitors chlorine residual levels within the network on a daily basis.</li> <li>g. Chlorine dosing is flow proportional and is linked to the chlorine monitor.</li> <li>h. CCC have installed a single UV unit, there is no standby unit. The UV unit is not connected to UVI/UVT monitor or alarm, and it is not validated. (See photograph 2). CCC stated that,</li> </ul>

<p>based on previous monitoring results, the UVT of the water is in the region of 90%.</p> <p>a. CCC has installed two Cintropur filters, 50 µm and a 75µm filter, prior to the UV unit.</p> <p>b. The chlorine dosing points were observed not to be secure (see photograph 2).</p>
<b>3.</b>	<p><b>Chemical storage and bunds</b></p> <p>a. CCC has chemical delivery procedures now in place and all deliveries are logged and signed off.</p> <p>b. The chlorine day tank was observed to be banded.</p>
<b>4.</b>	<p><b>Management and Control</b></p> <p>a. CCC stated that the plant manual for this supply is currently being compiled.</p> <p>b. While the chlorine monitor is connected to a recording device, the display unit on the recording device is small and does not lend itself to reading historical results in graph form easily or accurately.</p> <p>c. The treatment plant is not connected to SCADA.</p>

CCC installed a single UV unit on this supply, there is no stand by unit and it is not connected to a UVT/UVI monitor or alarm. The unit is not validated. This current system is not acceptable as it does not meet the requirements of EPA Advice Note No 3. The Water Services Authority must as a priority ensure that the UV unit is upgraded to meet the requirement of the EPA Advice Note No 3.

**Photograph 2: Chlorine dosing points not adequately protected. Single UV unit in place.**

9. **Disinfection:** The Water Services Section must ensure that the UV treatment system meets the requirements of the EPA Advice Note No 3. There should be duty standby UV units in place with automatic switch over between the units. The UV units must be validated to an appropriate international validation standard; the Water Service Authority should also submit a copy of the validation certificate. The UV unit should be connected to a UVI/UVT monitor to ensure that it is operating within its validation range at all times and so that the data can be achieved and reviewed on a regular basis.

10. **Disinfection:** The Water Services Authority should ensure chlorine dosing points are secured against accidental damage.
11. **Management and Control:** The Water Services Authority should investigate the possibility of linking the treatment works to a SCADA system, so that the performance of the treatment works can be viewed remotely and that historical data can easily be retrieved and examined.
