Re: Drinking Water Audit –Killadysert Public Water Supply (DW2014/282)

Drinking Water Audit Report

County:	County Clare	Date of Audit:	07/08/2014
Plant(s) visited:	Killadysert (0300PUB1008)	Date of issue of Audit Report:	22/08/2014
		File Reference:	DW2014/282
		Auditors:	Mr Niall Dunne
Audit Criteria:	<ul style="list-style-type: none"> • The <i>European Union (Drinking Water) Regulations 2014 (S.I. 122 of 2014)</i>. • The <i>EPA Handbook on the Implementation of the Regulations for Water Services Authorities for Public Water Supplies (ISBN: 978-1-84095-349-7)</i> • The recommendations specified in the EPA Report on <i>The Provision and Quality of Drinking Water in Ireland</i>. • The recommendations in any previous audit reports.

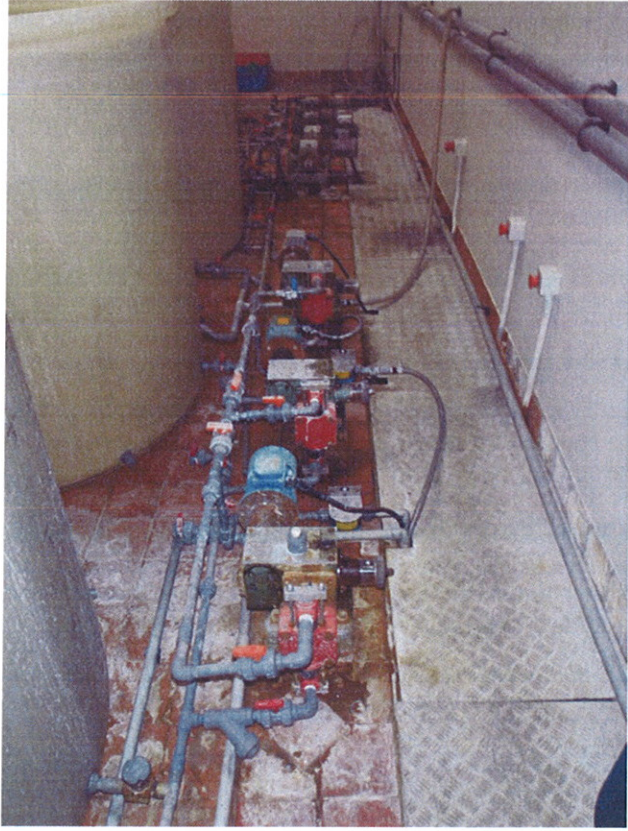
7.	<p>Management and Control</p> <ul style="list-style-type: none"> a. CCC stated that the distribution mains were scoured the first week of July 2014. b. There was no documented sign off procedure for the deliver of chemicals. c. Record keeping at the site was good. d. CCC stated that there were no alarms on the turbidity monitors. e. The plant was tidy but some housekeeping could be improved (see photograph 1).
----	---

Photograph 1: No bunding observed on chemical dosing day tanks.

16. The Water Services Authority should review chemical storage arrangements at the treatment plant. Chemicals must be stored in banded areas capable of containing at least 110% of the volume of chemicals stored therein. Fill points for storage tanks inside the bunds should be within the banded area. Refer to EPA guidance document – "*IPC Guidance Note on Storage and Transfer of Materials for Scheduled Activities*".
17. The Water Services Authority should ensure that there are lockable covers on all chemical delivery points and that they are in an appropriate location so as to prevent spillage.

19. The Water Services Authority should commence daily monitoring of the final treated water for turbidity and chlorine.
20. The Water Services Authority should ensure that the site is kept clean and tidy.

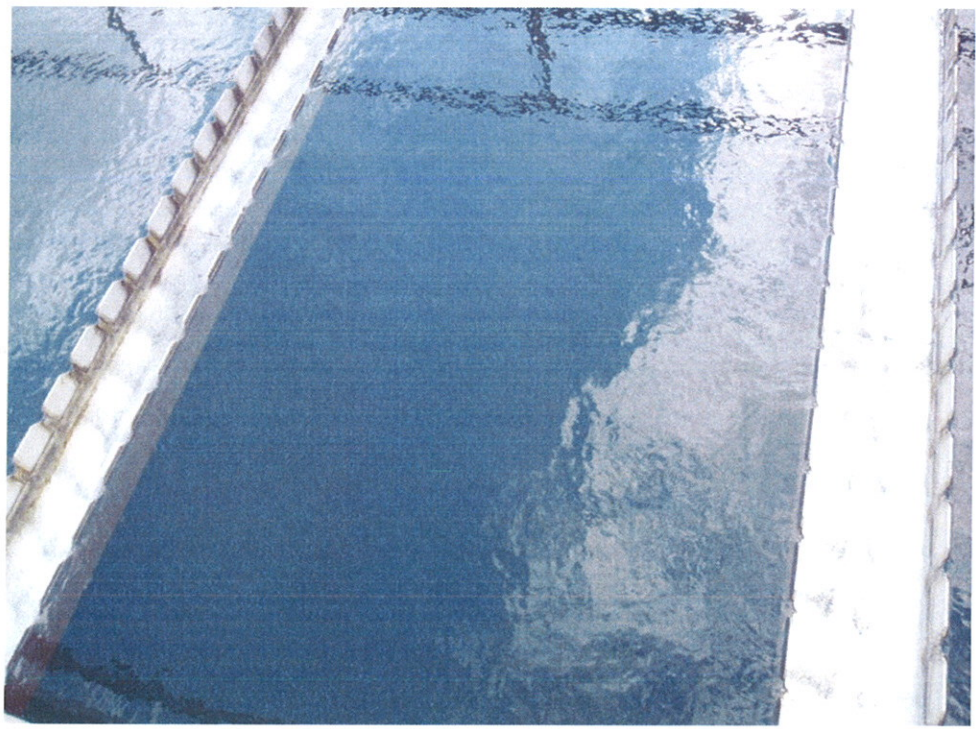
<ul style="list-style-type: none"> f. CCC is dosing soda ash prior to filtration to assist in the removal of manganese. g. According to CCC jar tests are carried out every 2-3 months and chemical dosing is manually adjusted. h. Pin floc was observed in the clarifier (see photograph 2). i. Sludge bleeds are carried out every 30 minutes for one minute.

Photograph 2: Pin floc observed in clarifier.

3. The Water Services Authority should carry out an investigation to identify the cause of pin floc formation and floc carryover. In this regard the Water Services Authority shall consult Table 2 on Page 41 of the EPA publication "*Water Treatment Manual: Coagulation, Flocculation and Clarification*" and investigate the use of polyelectrolyte and pH correction in line with the designed plant's operating procedures.
4. The Water Services Authority should investigate the efficiency of the sludge bleeds and should establish the optimum regime of sludge draw-off.
5. The Water Services Authority should ensure that all there is duty standby dosing in place for all essential chemical dosing systems.

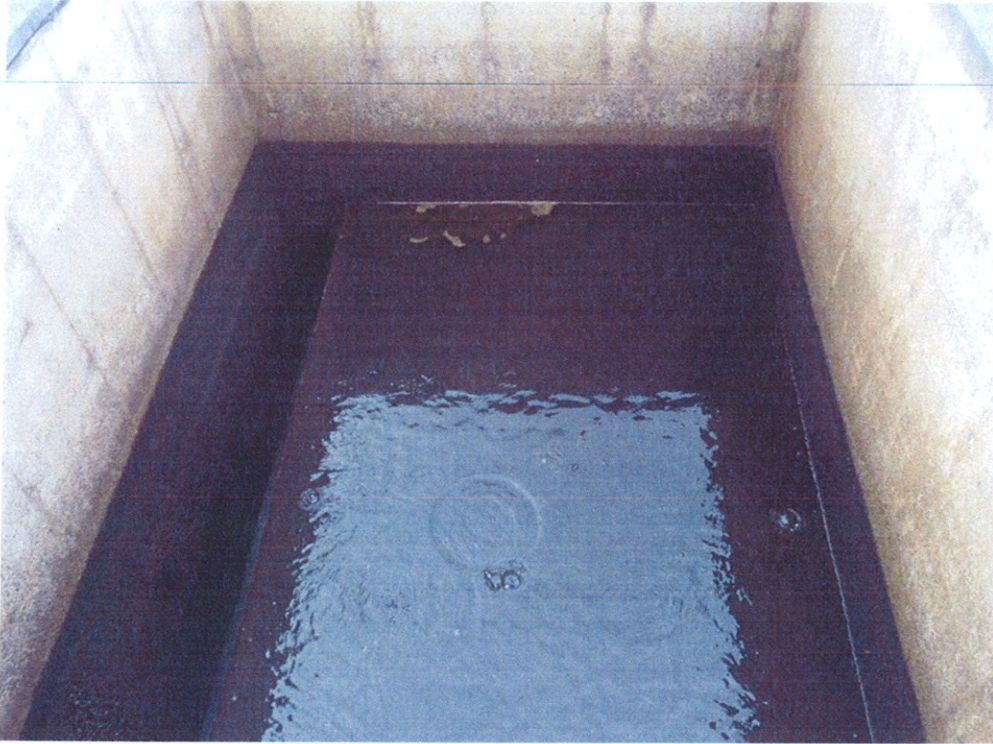
3.	<p>Filtration.</p> <ul style="list-style-type: none"> a. Filtration consists of two rapid gravity filters (see photograph 3), the filtration rate through each filter is estimated at 35m³/hr. b. According to CCC sand is topped up within the filters every few months. It was last replaced two years ago, no sand depth gauge was observed within the filter. c. CCC stated that the back wash cycle consists of 3 mins to drain; 5-10 min air and 5-10 mins water; back washing is carried out twice a day, the length of the cycle is based on visual observations. d. CCC could not confirm the backwash rate on the day of the audit. e. Back wash water is run to waste for a period of 20 mins before the filter is brought back into service. f. A back wash cycle on filter no 2 was observed by the auditor. g. In response to the manganese exceedance; 50 mm of greensand was placed on each filter; the nominal size of the green sand is 0.6 mm with a specific gravity of 3.8. Additional layers of green sand are to be placed on the filters; CCC is awaiting delivery of green sand. h. There are turbidity monitors on each filter, the observed turbidity results on filter 1 and filter 2 were 0.081 NTU and 0.032 NTU respectively; there are no dial out alarms on the turbidity monitors. i. A black scum was observed on the walls of the filter (see photograph 3).

Photograph 3: Black scum observed on walls of Rapid gravity filter.

8. The Water Services Authority should ensure that the walls of the filter are washed down regularly; especially after this manganese exceedance.
9. The Water Services Authority should ensure that filter backwash durations take into account post-filter turbidity results.

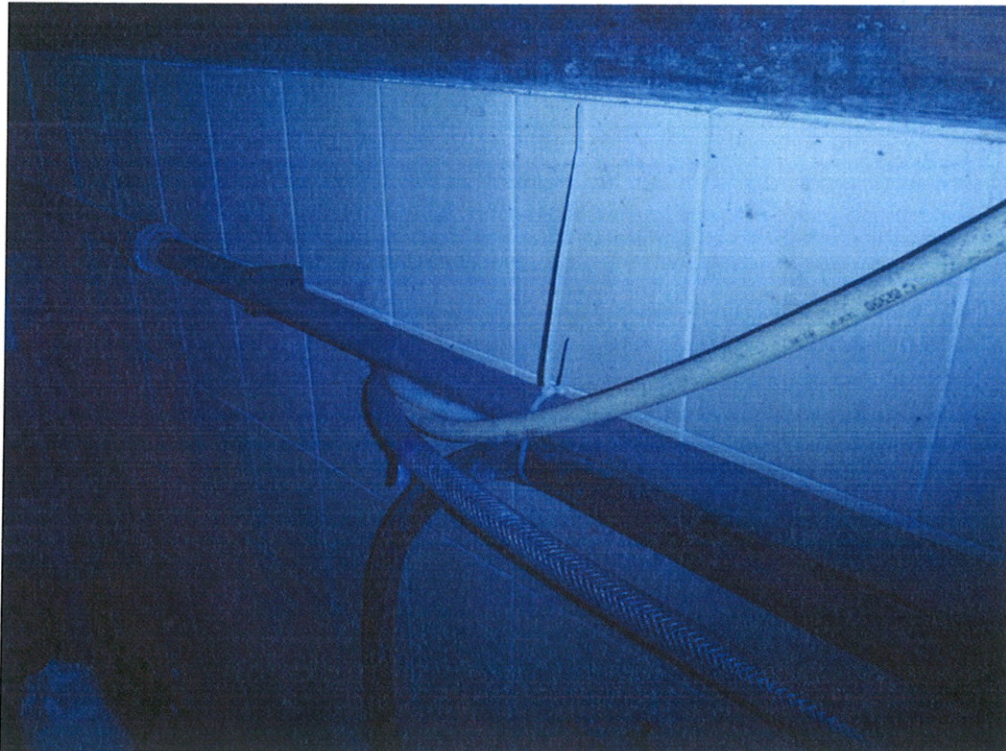
Photograph 4: chlorine dosing point unsecure.

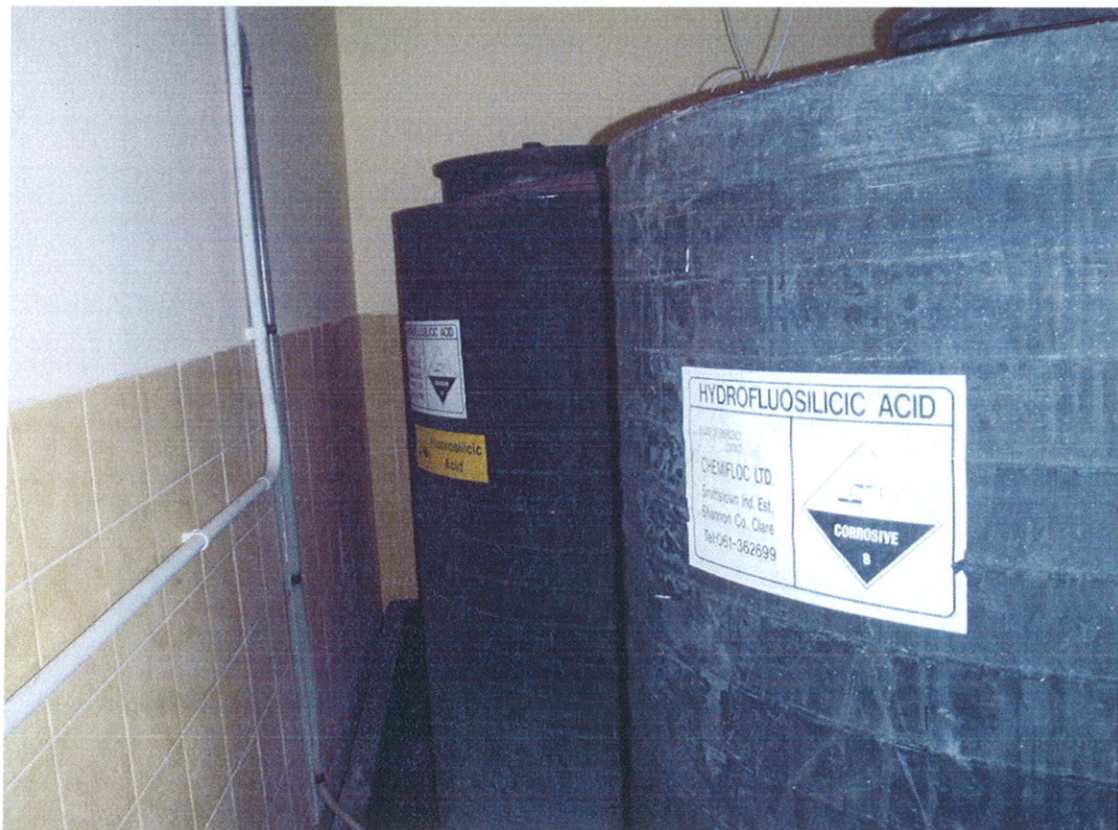
5.	<p>Fluoridation</p> <ul style="list-style-type: none"> a. Two bulk hydrofluosilicic acid storage tanks were observed on site (see photograph 6); CCC stated that hydrofluosilicic is delivered every six months and that there is three days storage within the day tanks. The volume of the bunded area did not appear to be 110% of the volume of the bulk tanks. b. There was no lockable cover on the fill point. c. Fluoride is dosed at 0.7 mg/l and there are duty standby dosing pumps with auto switch over. d. No proper extraction vent was observed within the room containing the day tank.

Photograph 6; Hydrofluosilicic acid bulk storage tanks.
