<h1>Drinking Water Audit Report</h1>
---	--------------------------------------

County:	Clare County	Date of Audit:	20/05/2014
Plant(s) visited:	Killaloe (03000PUB 1002)	Date of issue of Audit Report:	18/06/2014
		File Reference:	DW2014/215
		Auditors:	Mr Niall Dunne
Audit Criteria:	<ul style="list-style-type: none"> • The <i>European Union (Drinking Water) Regulations 2014 (S.I. 122 of 2014)</i>. • The <i>EPA Handbook on the Implementation of the Regulations for Water Services Authorities for Public Water Supplies (ISBN: 978-1-84095-349-7)</i> • The recommendations specified in the EPA Report on <i>The Provision and Quality of Drinking Water in Ireland</i>. • The recommendations in any previous audit reports.

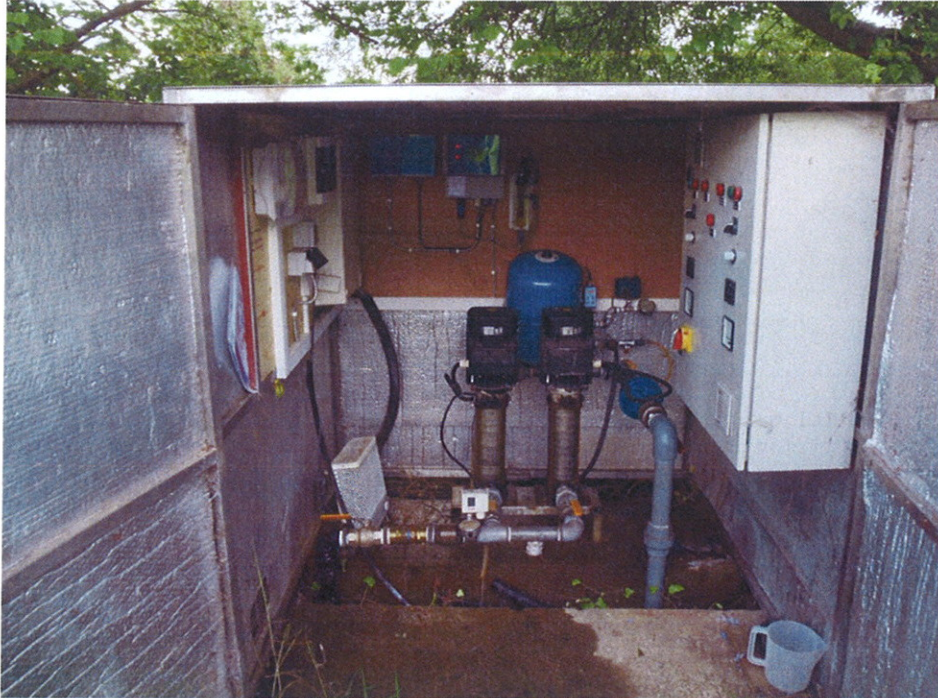
2.	<p>Chlorination and Disinfection</p> <ul style="list-style-type: none"> a. Chlorine is dosed prior to the reservoir. b. The chlorine monitor is not on site but is located approximately 0.5 miles away. On inspection the monitor was not working properly and was displaying a reading of 1.99mg/l. A sample taken by CCC staff on the day of the audit returned a result of 0.88 mg/l total and 0.8 mg/l free chlorine. The chlorine monitor was last calibrated on the 16/04/2014 and was due to be calibrated on the 16/06/2014. There are no dial out alarms in place and the monitor is not connected to a recording device, (see photograph 1). c. The hut where the chlorine monitor was located was also of poor construction and was not sealed against vermin (see photograph 1). The sampling point located at the chlorine monitoring hut was also not secure against vermin access and contamination. d. Chlorine dosing is fixed. There are duty and standby dosing pumps in place but there is no automatic switch over between the pumps (see photograph 2). e. CCC stated that chlorine readings are not taken at the plant, as there is no available sampling point there. Chlorine samples are taken daily within the network, but not at the end of the network.

Photograph 1: Hut where the chlorine monitor was located. The chlorine monitor was reading 1.99mg/l. The hut was of poor construction and was not secure against vermin access. The chlorine sampling point was also not secure against vermin access or contamination.

- The Water Services Authority should ensure that the chlorine monitor is working appropriately. This monitor should be alarmed and linked to a recording device to ensure that either a sudden increase in chlorine demand or a failure of the chlorine dosing system is immediately detected.

- The Water Services Authority should ensure that chlorine samples are regularly taken from the treatment plant and from the end of the network and that these are regularly documented.

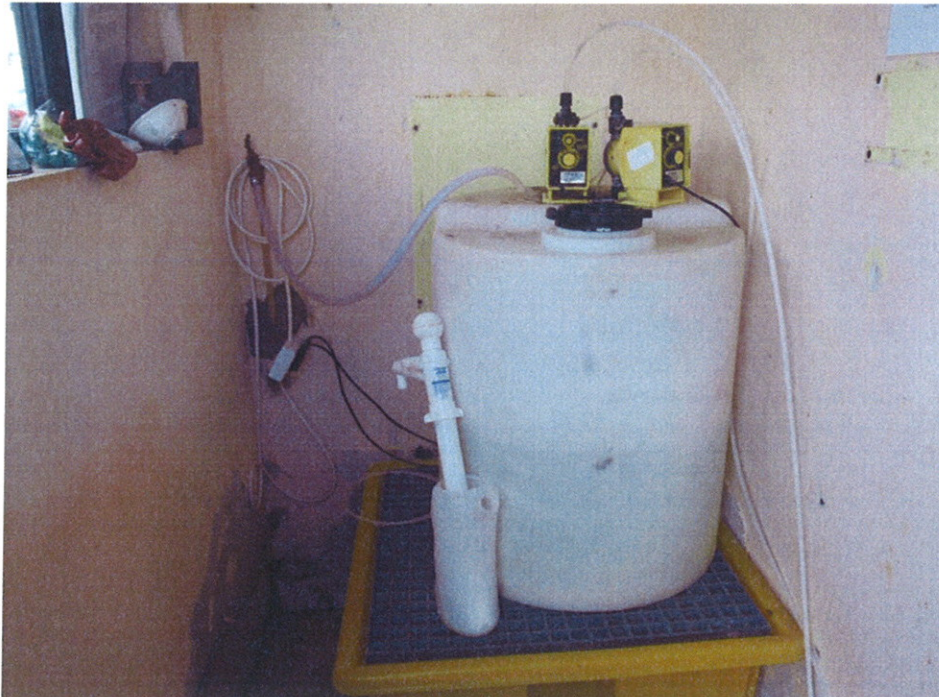
The disinfection system at this plant is not in accordance with the *EPA Advice Note Number 3. E.coli in Drinking Water*. At the time of the audit the chlorine monitor was not working properly and there were no dial out alarms in place to alert staff of this. The chlorine monitor is located approximately 0.5 miles from the dosing point. At this location the monitor will not detect any significant changes to chlorine levels within an appropriate timeframe so as to allow an effective response from staff. The monitor was also not connected to a recording device. There is no auto switch over between the dosing pumps. Chlorine dosing is by fixed dosing.

Photograph 2: Duty standby chlorine dosing pumps. There is no auto switch over between the pumps. Dosing is also fixed. There is no alarm on the dosing pumps.

- The Water Services Authority should ensure that there is automatic switch over between dosing pumps in the event of the failure of one of the pumps.
- The Water Services Authority should ensure that dosing of chlorine is flow proportional or is linked to the residual chlorine monitor. Where the dosing pump is fixed the Water Services Authority should replace the pump(s) with flow proportional pumps or pumps capable of dosing based on the residual chlorine monitor.

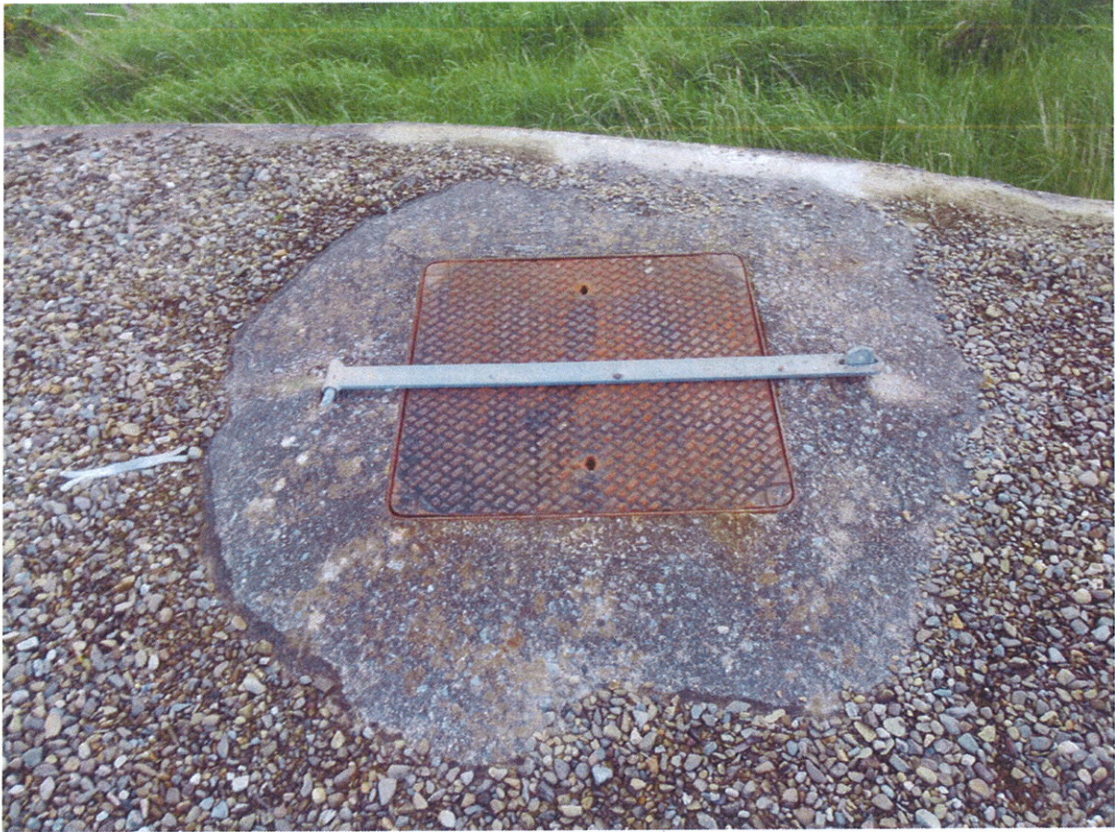
3.	Treated Water Storage <ol style="list-style-type: none"> CCC staff stated that there is approximately 24 hours storage within the reservoir. The reservoir has not been integrity tested or cleaned out recently. The vents on the reservoir were not adequate against the ingress of vermin or insects and the covers were not adequately against the ingress of surface water (see picture 3).
4.	Distribution Network <ol style="list-style-type: none"> CCC stated that there were substantial leaks within the distribution system.
5.	Management and Control <ol style="list-style-type: none"> There is no treated water monitoring point on site. There is a tap on site, but this is fed with raw untreated water. There was no sign at the tap stating that the water was not fit for human consumption. There were no documented raw or treated water monitoring results on site.

See Photograph 3: Covers to reservoir not of the type to fully stop the ingress of surface water.

9. The Water Services Authority should develop leak detection and repair program for this supply.
10. The Water Services Authority should carry out an integrity assessment of the clear water tank/service reservoir and carry out any repair work required to ensure that there is no ingress into the reservoir. The reservoir should also be cleaned out on a regular basis. All the vents on the reservoirs should be secured against ingress of animals or deliberate introduction of any contaminant or acts of vandalism. All covers on the reservoir should be of the type that are fully secure against surface water ingress and lockable.
