Drinking Water Audit Report

County:	Clare County	Date of Audit:	20/05/2014
Plant(s) visited:	O'Brien's Bridge (03000PUB 1020)	Date of issue of Audit Report:	29/05/2014
		File Reference:	DW2013/83
		Auditors:	Mr Niall Dunne
Audit Criteria:	<ul style="list-style-type: none"> • The <i>European Union (Drinking Water) Regulations 2014 (S.I. 122 of 2014)</i>. • <i>The EPA Handbook on the Implementation of the Regulations for Water Services Authorities for Public Water Supplies (ISBN: 978-1-84095-349-7)</i> • The recommendations specified in the EPA Report on <i>The Provision and Quality of Drinking Water in Ireland</i>. • The recommendations in any previous audit reports.

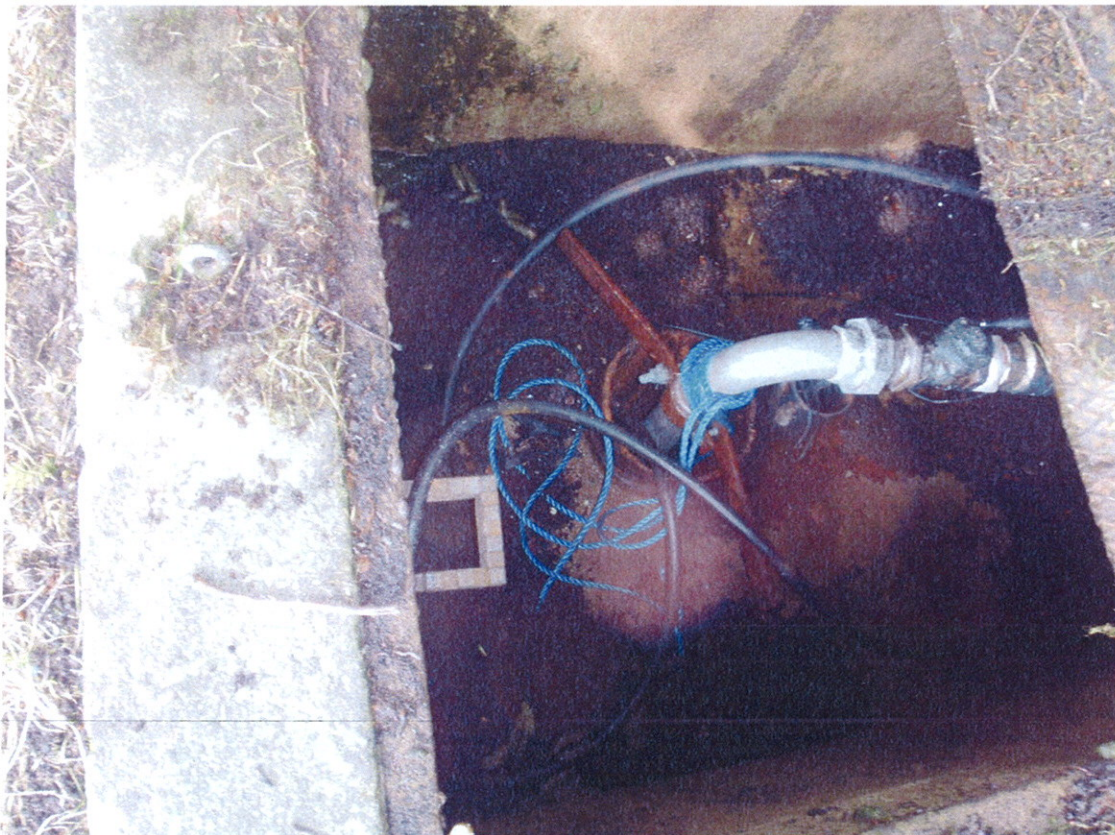
1.	<p>Source Protection</p> <p>a. A finding of the previous audit was that the well chamber should be upgraded to ensure that the borehole is made secure from surface water runoff and that the well head and chamber is constructed as per the Institute of Geologists of Ireland 'Water Well Guidelines'. This work was observed not to be initiated (see photograph 1). It was indicated by CCC (Clare County Council) staff that this would be completed by November 2014.</p> <p>b. A bored well was observed adjacent to the Ardtaggle reservoir. According to CCC staff this well is used to maintain water levels within the reservoir. CCC staff were unaware of water quality of the well and whether farm surveys had been carried out within the vicinity of the well. The well was located below ground level and the well head cover was observed not to be effective against surface water runoff (see photograph 2 &3). CCC staff were also unaware of the depth of the well.</p>

Photograph 1: Well head at O Briensbridge located below ground level and not constructed as per appropriate guidelines.

4. The Water Services Authority should put procedures in place to ensure that all chemicals used in the treatment of water are within the expiry date.
5. The Water Services Authority should ensure that the source chambers and the well heads at both the main source and at the Ardtaggle source are made secure from surface water runoff and that they are constructed as per the *EPA Drinking Water Advice Note No. 14: Borehole Construction and Wellhead Protection*.

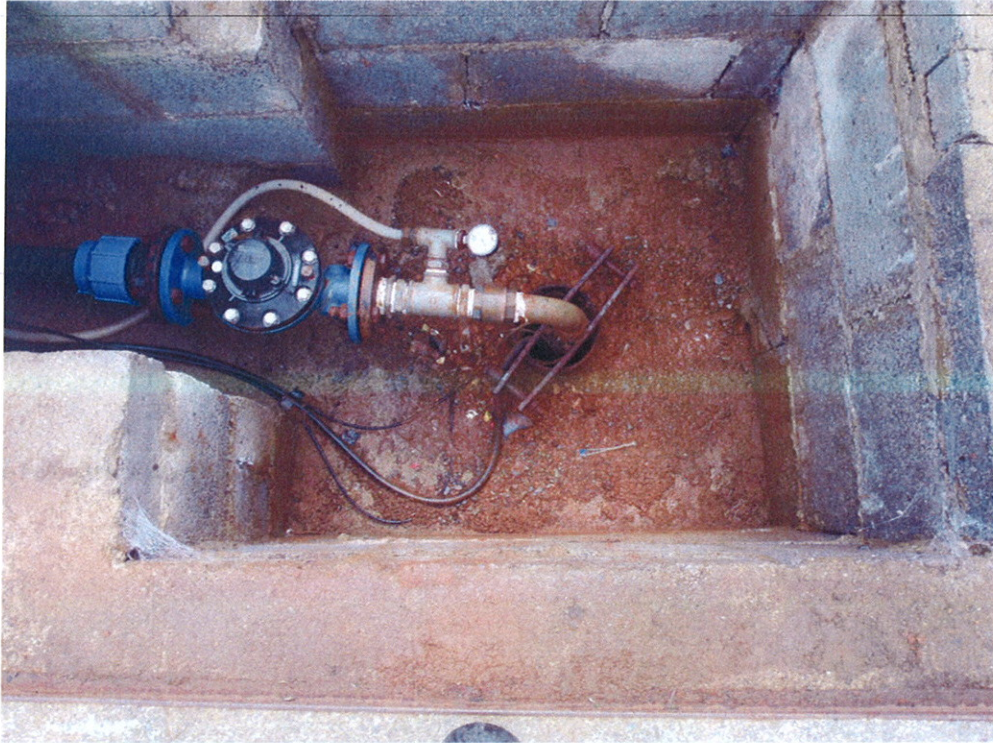
Photograph 2: Well head at Ardtaggle not constructed as per appropriate guidelines.

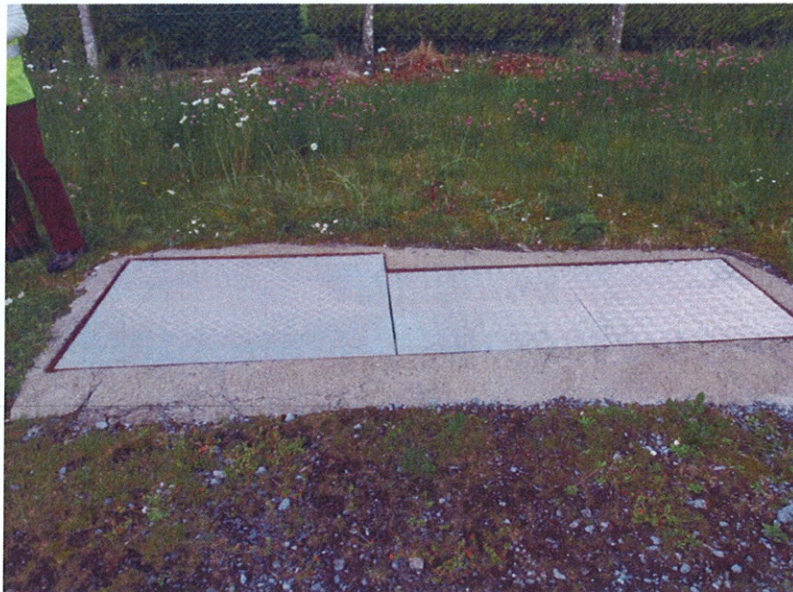
Photograph 3: The cover on the Ardtaggle reservoir was also observed not be effective against surface water ingress.

10. The Water Services Authority should ensure that all vents on the reservoirs are secured against ingress of animals or deliberate introduction of any contaminant or acts of vandalism and that all covers on the reservoir and the borehole are of the type that are fully secure against surface water ingress and are lockable.

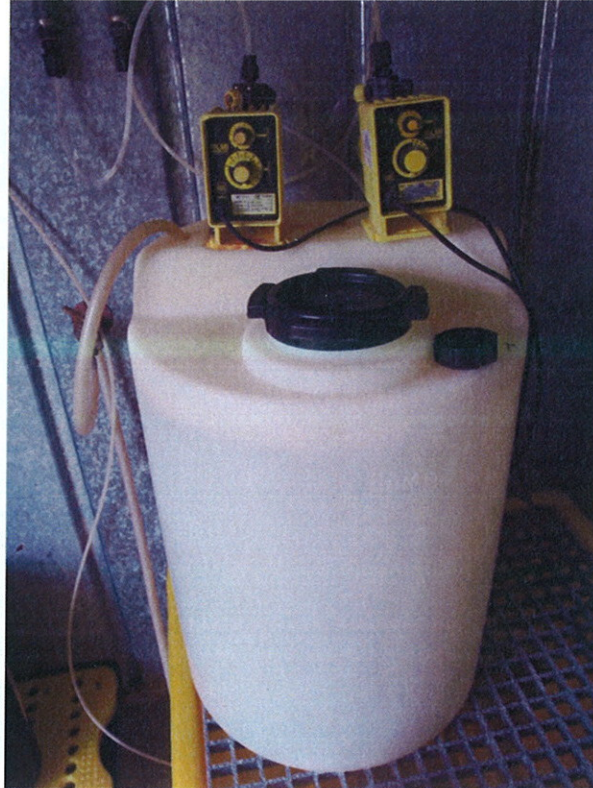
- ii. The chlorine dosing at the Ardtaggle reservoir consists of duty standby dosing. There is no chlorine monitor; no alarm and no automatic switch over between the dosing pumps. IW must ensure that all chlorine dosing systems meet the criteria set out *EPA Drinking Water Advice Note No 3. E.Coli in Drinking Water*.

<p>Authority to resolve these issues by the 31/12/ 2013. It was noted during this audit of the 20/05/2014 that works to comply with the Direction were not started. IW stated that they had given approval for work to commence. CCC indicated that the works to comply with the Direction would not be complete until November 2014.</p> <p>d. CCC staff stated that there was no automatic switch over between the duty and standby pumps at the main chlorine dosing point.</p> <p>e. The reading on the chlorine monitor at the end of the network was 0.09 mg/l.</p> <p>f. It was observed that the use by date on the chlorine drums at the dosing plant had expired.</p> <p>g. The water from the bored well adjacent to the Ardtaggle reservoir is chlorinated prior to entering the reservoir. Chlorination consists of duty standby chlorination there is no alarm; no monitor and no auto switchover in place at this dosing point (see photograph 4).</p>

It was also observed that there was only duty standby dosing at the Ardtaggle source, there was no chlorine monitor and no dial out with alarms in place at this site. Irish Water must ensure that chlorine dosing points met the criteria set out in *EPA Advice Note Number 3 E.Coli in Drinking Water*.

Photograph 4: Chlorine dosing at the Ardtaggie reservoir consists of duty standby dosing only. There is no chlorine monitor no auto switch over or no dial out alarms.

1. The Water Services Authority must ensure that the works required by the Direction are completed as a priority and without delay.
2. The Water Services Authority should install a continuous chlorine residual monitor on the Ardtaggle dosing point. This monitor should be alarmed and linked to a recording device to ensure that either a sudden increase in chlorine demand or a failure of the chlorine dosing system is immediately detected. The Water Services Authority should ensure that there is automatic switch between all dosing pumps in the event of the failure of one of the pumps.

3. The Water Services Authority should ensure that dosing of chlorine at the Ardtaggle site is flow proportional or is linked to the residual chlorine monitor. Where the dosing pump is fixed the Water Services Authority should replace the pump(s) with flow proportional pumps or pumps capable of dosing based on the residual chlorine monitor.

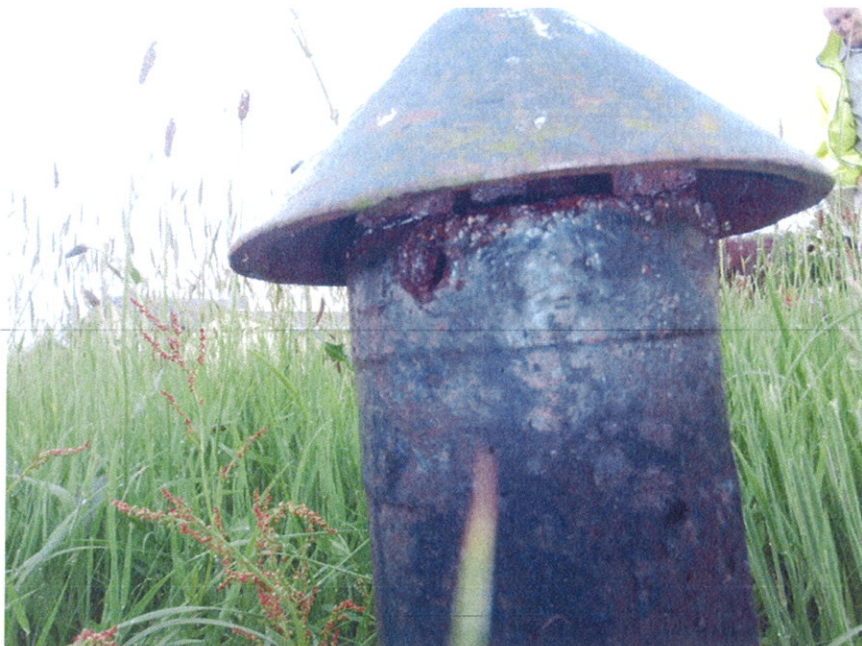
<p>3.</p>	<p>Treated Water Storage</p> <p>a. Treated water is stored in the Ardtaggle reservoir. CCC staff stated that no integrity test had been carried out on the reservoir but that it has been cleaned out. CCC staff were not sure of date it was cleaned out.</p> <p>b. The vents on the reservoir were observed not to be secured against ingress of insects etc. and the covers on the reservoir were not secured against surface water ingress (see photograph 5 & 6).</p> <p>c. The reservoir was fully covered with grass and vegetation (see photograph 6).</p>
<p>4.</p>	<p>Management and Control</p> <p>a. Written procedures were observed to be on site.</p> <p>b. Calibration stickers were on equipment but the writing on some stickers was illegible.</p> <p>c. There were no raw or treated water monitoring results on site.</p>

Photograph 5: Vents on reservoir were observed not to be secure against insects etc.

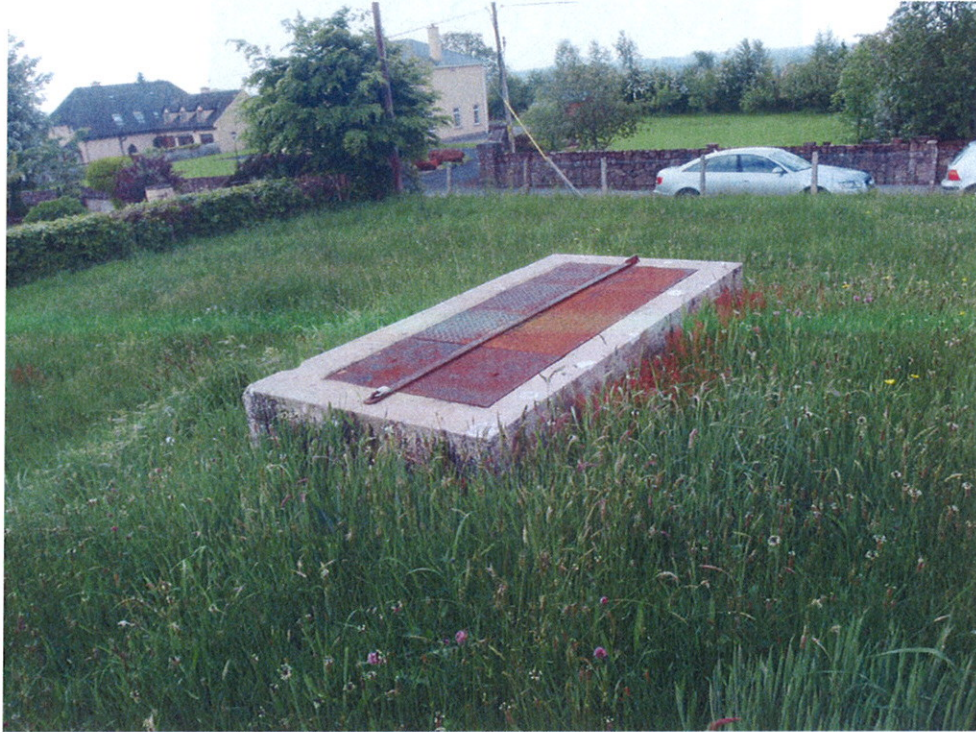
Photograph 6: The covers on the reservoir were observed not to be of the type that was sufficient to prevent surface water ingress. The reservoir was also observed to be covered in vegetation.

9. The Water Services Authority should carry out an integrity assessment of the clear water tank/service reservoir to ensure that there is no ingress into the reservoir. All vegetation from the sides and cover of the reservoir should be removed to ensure that the reservoir can be visually inspected on all sides and also prevent damage to the integrity of the reservoir.
