Drinking Water Audit Report

County:	Clare	Date of Audit:	16/10/2015
Plant(s) visited:	Shannon / Sixmilebridge Supply	Date of issue of Audit Report:	20/11/2015
		File Reference:	DW2014/375
		Auditors:	Mr Niall Dunne
Audit Criteria:	<ul style="list-style-type: none"> • The <i>European Union (Drinking Water) Regulations 2014 (S.I. 122 of 2014)</i>. • The <i>EPA Handbook on the Implementation of the Regulations for Water Services Authorities for Public Water Supplies (ISBN: 978-1-84095-349-7)</i> • The recommendations specified in the <i>EPA Drinking Water Report</i>. • The recommendations in any previous audit reports.

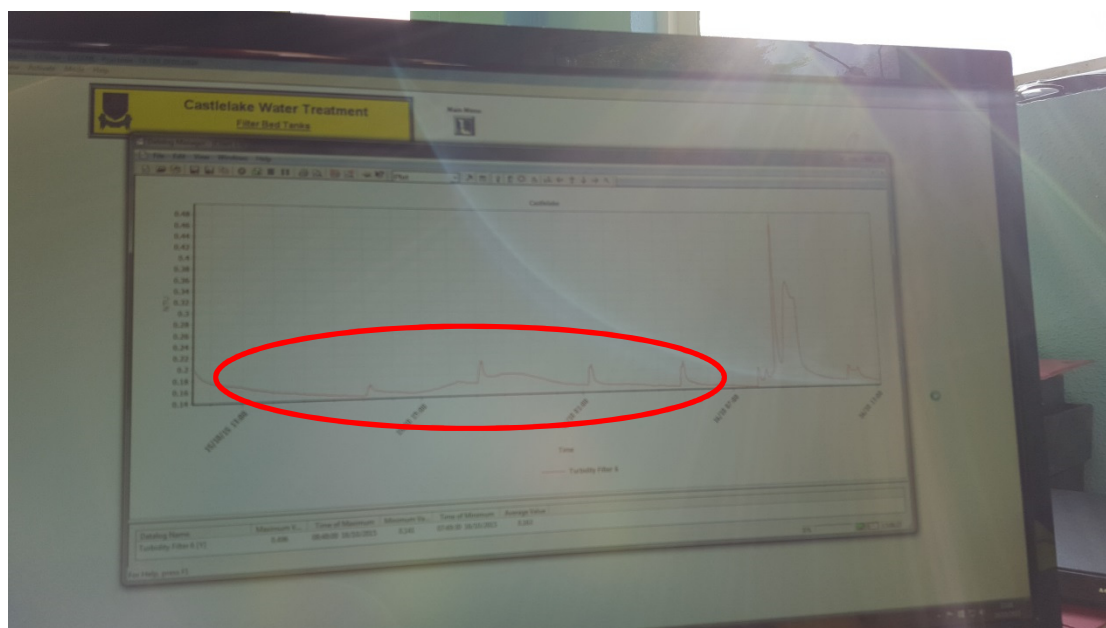
<p>3.</p>	<p>Filtration</p> <ul style="list-style-type: none"> a. The sand within the filter was last changed in 2010, at the time of the audit it was scheduled to be changed in November 2015. There were no sand level indicators located within the rapid gravity filters. b. PAC is dosed, at 3 mg/l, prior to the rapid gravity filter (RGF). a. The backwash sequence is set at 6 minutes air followed by 6 minutes water. The filters are allowed to settle for 15 minutes prior to being brought back into service. The filters are washed every 24 hours. Backwash water is sent to an onsite lagoon. b. It was noted on SCADA that there are slight elevations in turbidity levels once the filters are brought back into service after backwashing, (see photograph 1).

Photograph 1: Slight spikes in the turbidity readings noted after backwash.

1. Irish Water should review the alarm settings of 0.4 NTU on the turbidity monitors after the filters to ensure that the caretaker is given adequate time to respond to elevated turbidity readings.
2. Irish Water should undertake a review of the elevated turbidity readings detected when the rapid gravity filters are brought back into service following backwash. Irish Water should put measures in place to rectify this.
3. Irish Water should ensure that the sand within the filters is replaced as scheduled.

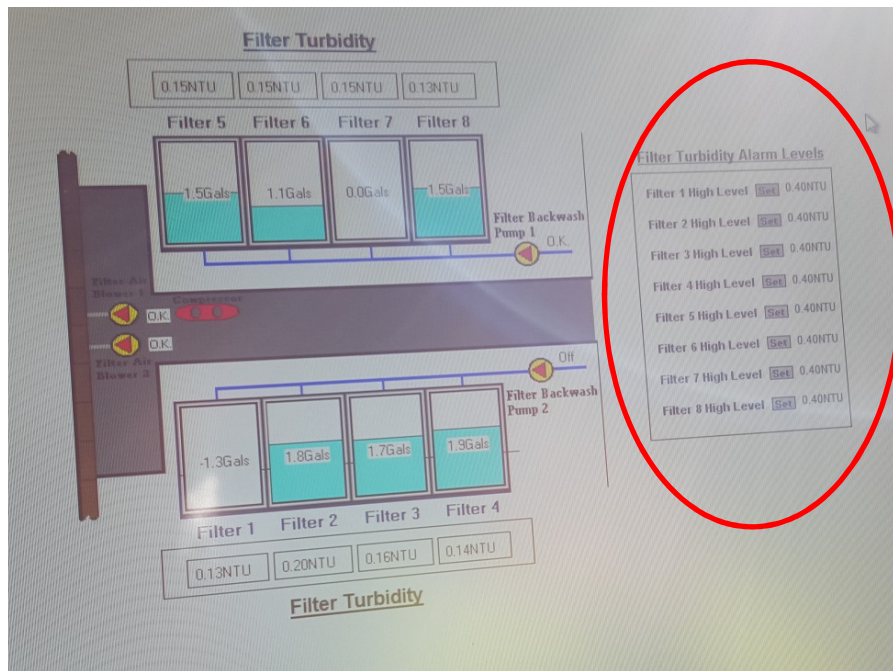
6.	Monitoring and Sampling Programme for treated water <ol style="list-style-type: none"> CCC confirmed that <i>Cryptosporidium</i> samples are taken at the plant every second month. It was noted on SCADA that the turbidity alarms are set at 0.4 NTU, (see photograph 2), however documentation noted on site stated that turbidity alarms are set at 0.6 NTU, (see photograph 3). Turbidity readings on the day of the audit were observed to range from 0.14 NTU – 0.2 NTU.

Photograph 2: Turbidity alarms set at 0.4NTU

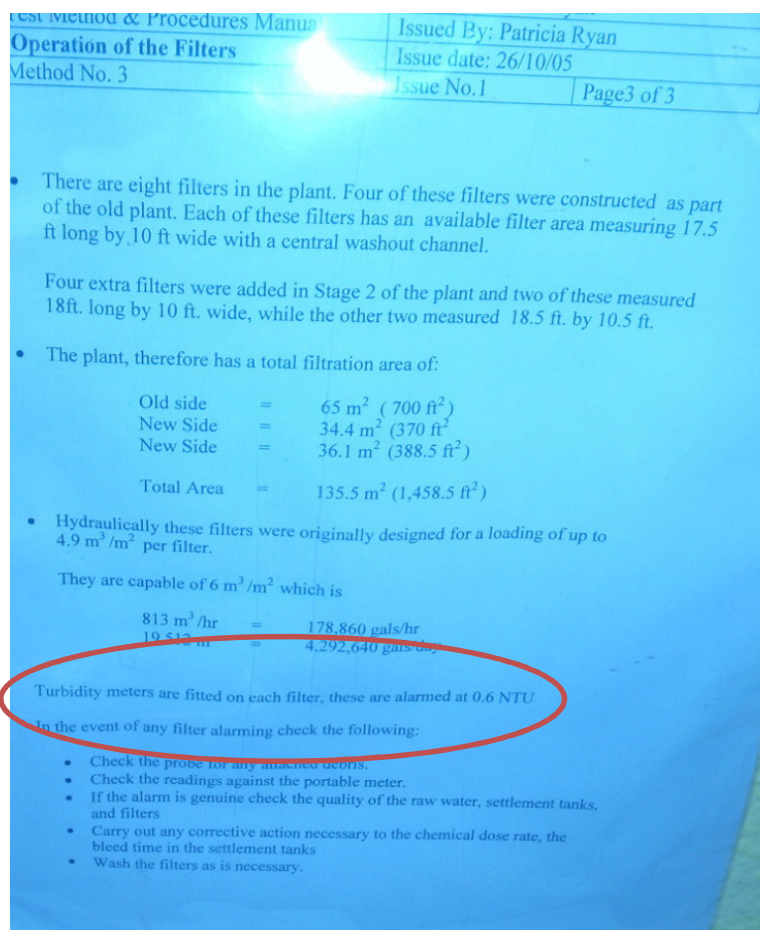
Photograph 3: On site documentation showing alarms set at 0.6 NTU.

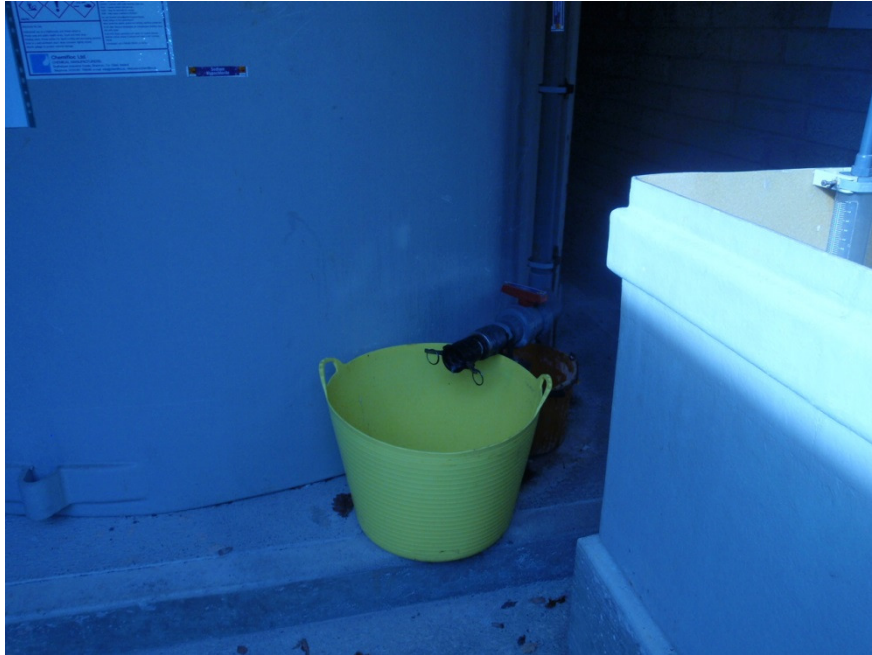
8.	Chemical storage and bunds <ol style="list-style-type: none"> At the fill point on the bulk chlorine storage tank, it was observed that there was not a proper spill tray in place, (see photograph 4).

Photograph 4: Inappropriate spill tray on bulk storage tank.

9. Irish Water should install automatic switch over between the chemical dosing pumps, and ensure that the pumps are alarmed in the event of pump failure.
10. Irish Water should ensure that proper spill trays are located on all bulk storage fill points.

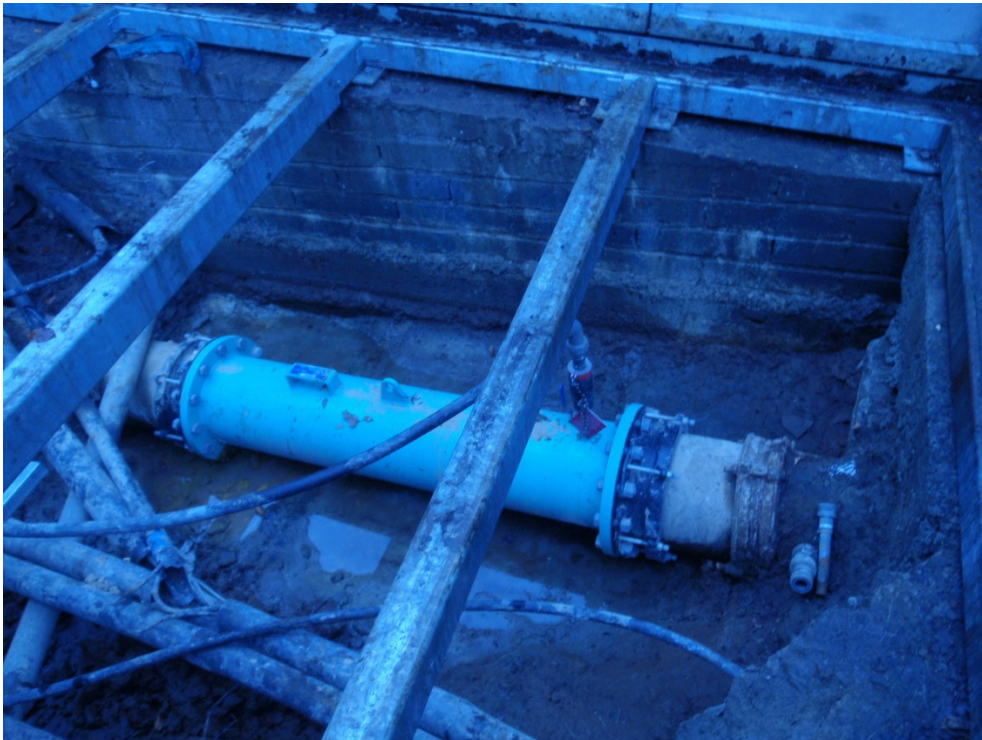
9.	Hygiene and Housekeeping <ol style="list-style-type: none"> The standard of housekeeping at the plant was good, certain areas need attention. In the alum dosing chamber there was no floor or sump and standing water was observed in the base of the chamber, (see photograph 5), algae was observed in the alum spill trays (see photograph 6).

Photograph 5: No finished floor or sump within chamber, standing water observed.

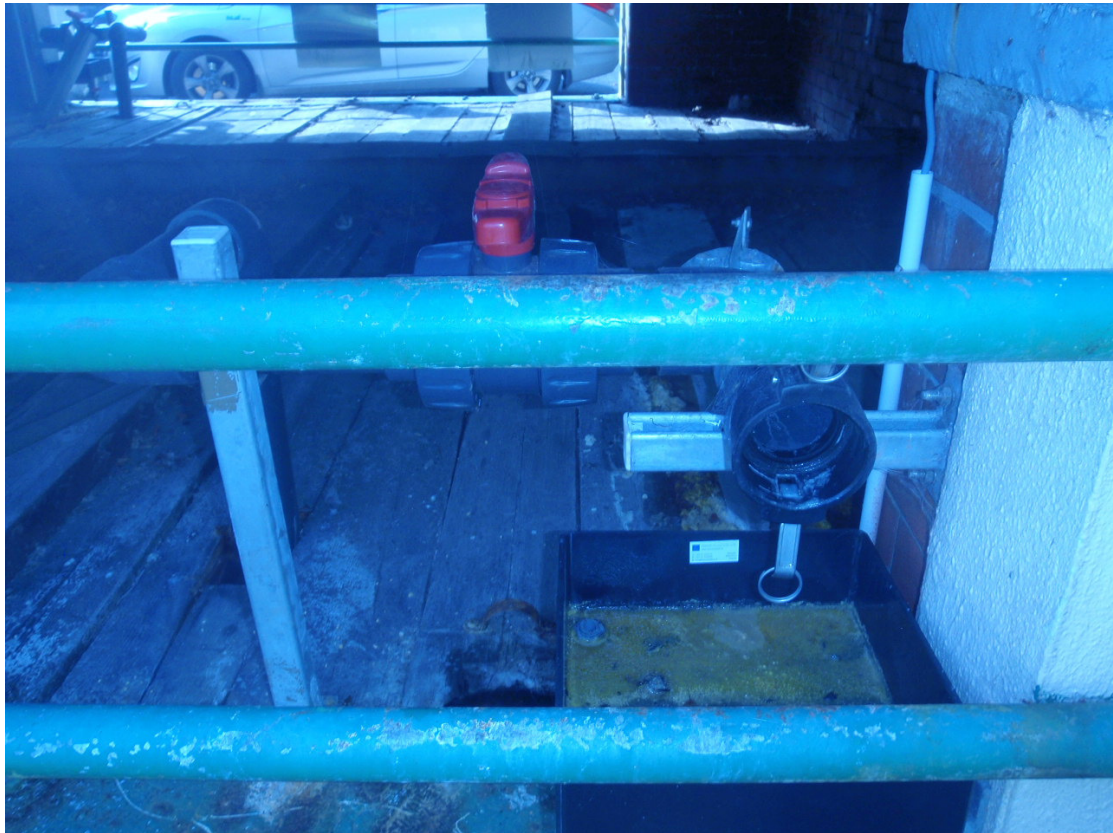
Photograph 6: Algae within spill chamber.
