# Drinking Water Audit Report

<b>County:</b>	Clare	<b>Date of Audit:</b>	11/02/2016
<b>Plant(s) visited:</b>	Turlough Public Water Supply (0300PUB1068)	<b>Date of issue of Audit Report:</b>	02/03/2016
		<b>File Reference:</b>	DW2016/30
		<b>Auditors:</b>	Mr Niall Dunne
<b>Audit Criteria:</b>	<ul style="list-style-type: none"> <li>• The <i>European Union (Drinking Water) Regulations 2014 (S.I. 122 of 2014)</i>.</li> <li>• The <i>EPA Handbook on the Implementation of the Regulations for Water Services Authorities for Public Water Supplies (ISBN: 978-1-84095-349-7)</i></li> <li>• The recommendations specified in the <i>EPA Drinking Water Report</i>.</li> <li>• EPA Drinking Water Advice Notes No.s 1 to 15.</li> <li>• The recommendations in any previous audit reports.</li> </ul>

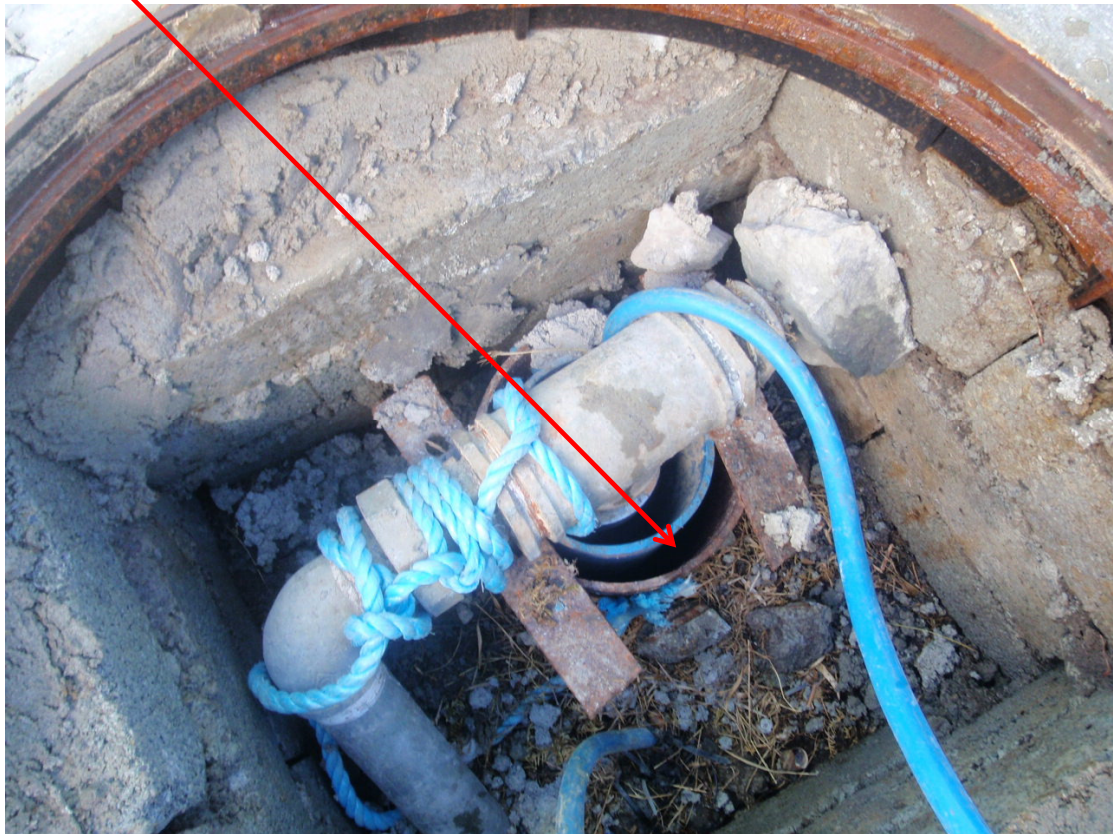
1.	<p><b>Source Protection</b></p> <p>a. The Turlough supply is fed from a borehole. CCC (Clare County Council) stated that the borehole is approximately 75 m deep and lined with a PVC ducting to a depth of approximately 66 m. It was observed that there was no grouting between the inner and outer borehole casings, (see photograph 1).</p> <p>b. The well head was observed to be below ground level and there was no well head capping in place, (see photograph 1). The borehole is not constructed as per EPA guidelines, (see photograph 1&amp;2).</p> <p>c. CCC stated that seven farms were identified within the vicinity of the well and that the farmers were written to as per the GAP regulations.</p>

**Photograph 1: No grouting observed between inner and outer casing and no well head capping in place:**

1. Irish Water should ensure that a duty standby chlorine dosing system, with auto switchover, is installed as part of the disinfection program. Irish Water must ensure that disinfection program updates are submitted to the EPA on a quarterly basis, the next update is due 31/03/2016.
2. Irish Water, separate to the disinfection program, should put in place an alarm cascade system to ensure, in the event that the first contact is not available that a second appropriate person is alerted within a specific time frame.
3. Irish Water should review the low level chlorine alarm setting to ensure that adequate response times for activated alarms are allowed for.
4. Irish Water should ensure that the borehole is properly grouted and that the well head is covered, constructed and protected as per *EPA Drinking Water Advice Note No 14: Borehole Construction and Wellhead Protection*.

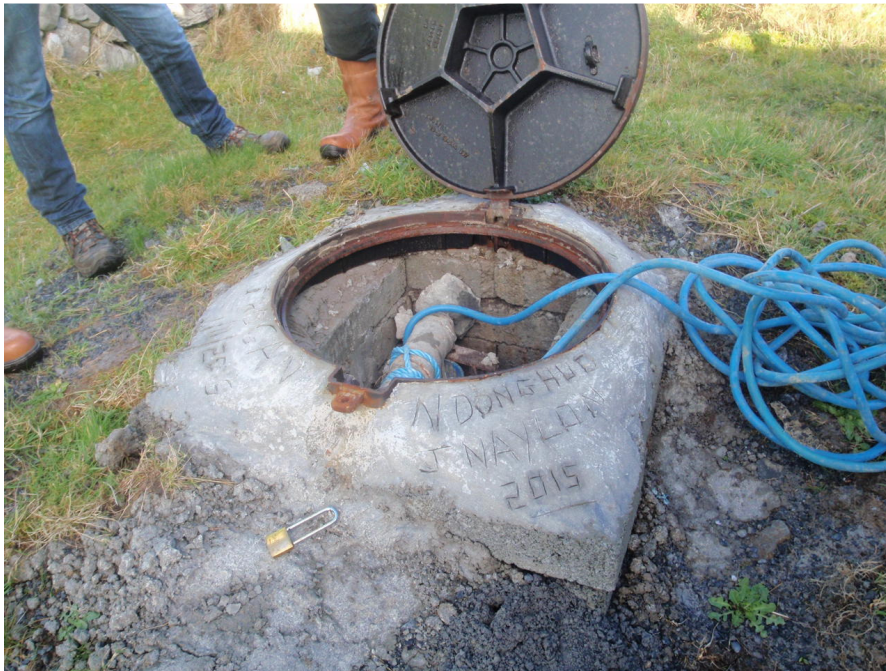
**Photograph 2: Borehole construction not constructed as per EPA guidelines.**

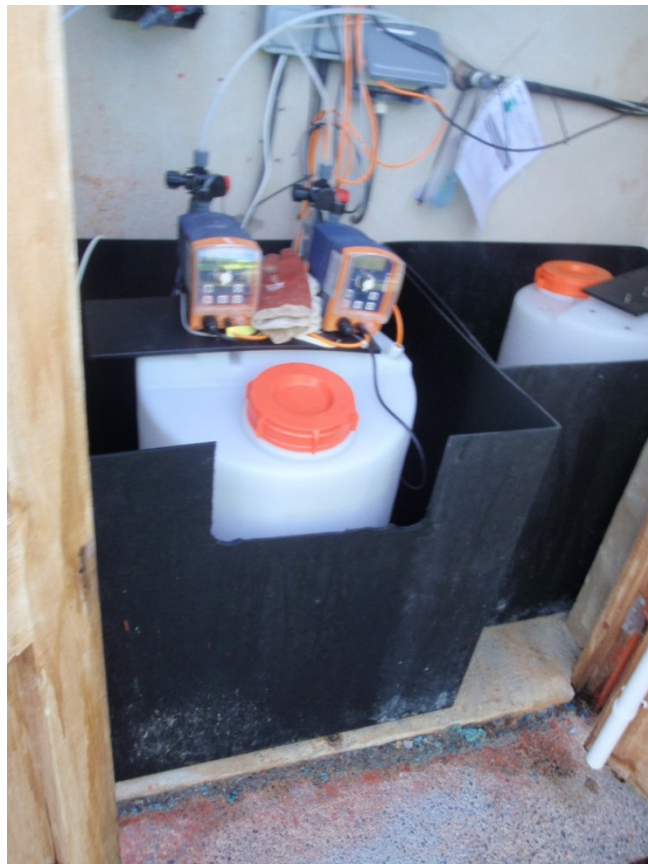
<ul style="list-style-type: none"> <li>e. CCC confirmed that chlorine is dosed at a fixed rate. The observed residual chlorine reading was 0.54 mg/l.</li> <li>f. Residual chlorine readings of 0.2 mg/l taken at the end of the network were observed in the caretaker's diary.</li> <li>g. CCC stated that chlorine samples are taken within the network on a daily basis.</li> </ul>
<b>3.</b>	<b>Monitoring and Sampling Programme for treated water</b> <ul style="list-style-type: none"> <li>a. CCC stated that one audit and three check monitoring samples are taken annually.</li> </ul>
<b>4.</b>	<b>Chemical storage and bunds</b> <ul style="list-style-type: none"> <li>a. The chlorine day tanks were adequately bunded, (see photograph 3).</li> </ul>

**Photograph 3: Chlorine day tank adequately bundled.**
