Drinking Water Audit Report

County:	Clare	Date of Audit:	23/03/2017
Plant visited:	Turlough Public Water Supply (0300PUB1068)	Date of issue of Audit Report:	12/04/2016
		File Reference:	DW2016/30
		Auditors:	Mr Niall Dunne Ms Criona Doyle
Audit Criteria:	<ul style="list-style-type: none"> • The <i>European Union (Drinking Water) Regulations 2014 (S.I. 122 of 2014)</i>. • The <i>EPA Handbook on the Implementation of the Regulations for Water Services Authorities for Public Water Supplies (ISBN: 978-1-84095-349-7)</i> • The recommendations specified in the <i>EPA Drinking Water Report</i>. • EPA Drinking Water Advice Notes No.s 1 to 15. • The recommendations in any previous audit reports.

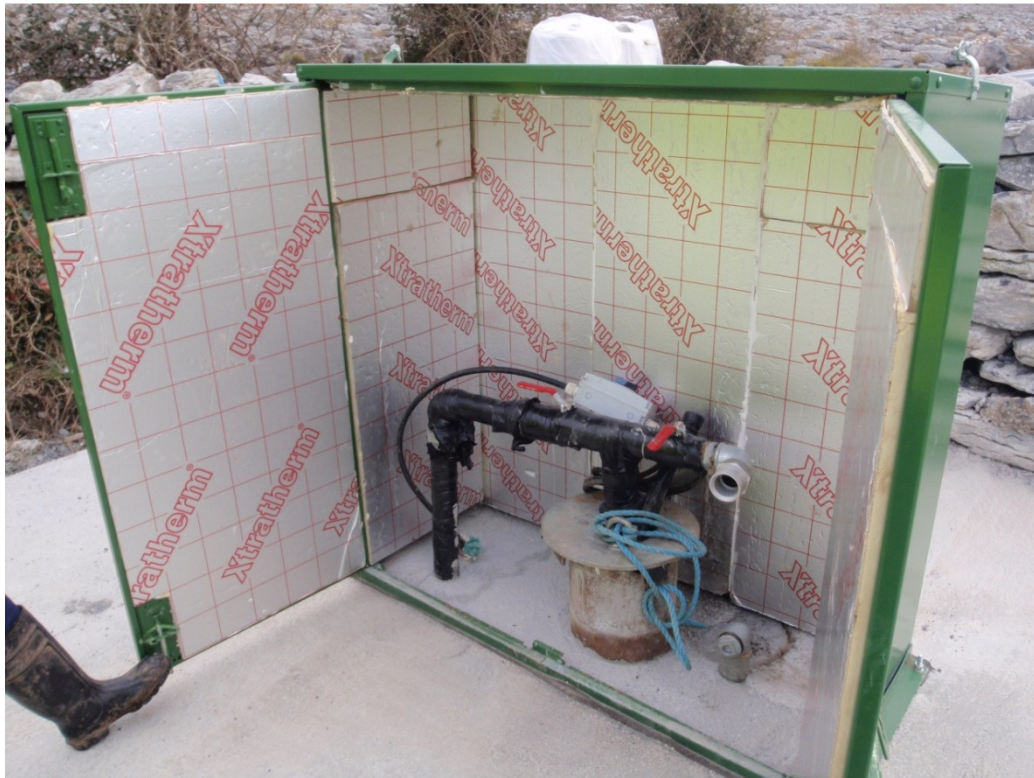
1.	<p>Source Protection</p> <ul style="list-style-type: none"> a. A recommendation of a previous audit, undertaken on 11/02/2016, was that the borehole should be properly grouted. Since then a new borehole has been drilled and the old borehole decommissioned. The housing and the well head of the new borehole are constructed to a very good standard, (see photograph 1). b. Irish Water (IW) stated that there are eight farmers within the catchment and that these farmers have been written to outlining their obligations under the European Union (Good Agricultural Practice for Protection of Waters) Regulations 2014.

A recommendation of a previous audit was that the borehole be properly grouted. Irish Water replaced the old borehole and constructed a new borehole to high standard. This standard of borehole construction should be replicated in other ground water sources under the remit of Irish Water.

Photograph 1: New borehole constructed to a high standard.
