Drinking Water Audit Report

County:	Co. Cork	Date of Audit:	14/04/2015
Plant visited:	Crookstown PWS (Cloughduv source) (0500PUB3102)	Date of issue of Audit Report:	25/05/2015
		File Reference:	DW2010/68
		Auditors:	Cliona Ní Eidhin Michelle Roche
Audit Criteria:	<ul style="list-style-type: none"> • The <i>European Union (Drinking Water) Regulations 2014 (S.I. 122 of 2014)</i>. • The <i>EPA Handbook on the Implementation of the Regulations for Water Services Authorities for Public Water Supplies (ISBN: 978-1-84095-349-7)</i> • The recommendations specified in the <i>EPA Drinking Water Report</i>. • The recommendations in any previous audit reports.

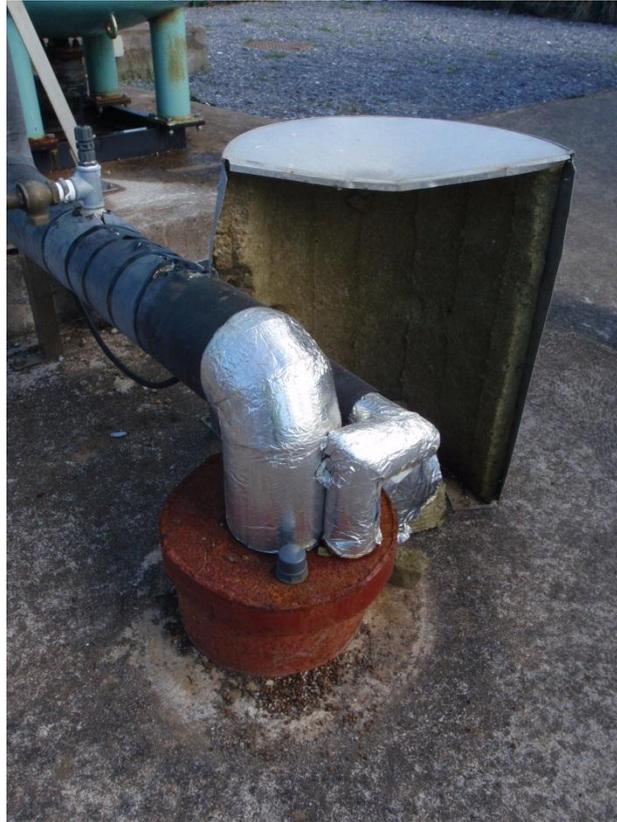
<p>located within the same groundwater body / aquifer as Cloughduv. The WSA advised that decommissioning was to be undertaken but that this work was not yet scheduled.</p> <ul style="list-style-type: none"> e. Drilling logs and details of borehole construction had not been collated and were not on record at the plant. (This information was obtained and submitted to the EPA in the days immediately following the audit.) f. The in-use borehole was capped but it could not be determined whether the cap was fully sealed. The cap material was noted by the auditor to be rusting. (see Photograph 1) g. A second borehole is situated <10 m from the operational borehole within the Cloughduv treatment plant compound. This borehole is not currently in use, nor has it been decommissioned. No details on the construction of this borehole had been obtained by the WSA from the drilling company, nor was its status, as a back-up borehole or otherwise, known to the WSA. The well head of this second borehole was incompletely capped and was not sealed. (See Photograph 2)

Photograph 1: Rusting cap on borehole.

5. Irish Water should ensure that the well head currently in use is capped with a suitable material and sealed. See EPA Advice Note No. 14 on Borehole Construction and Wellhead Protection. (http://www.epa.ie/pubs/advice/drinkingwater/EPA_DrinkingWater_AdviceNoteNo14b_web.pdf)

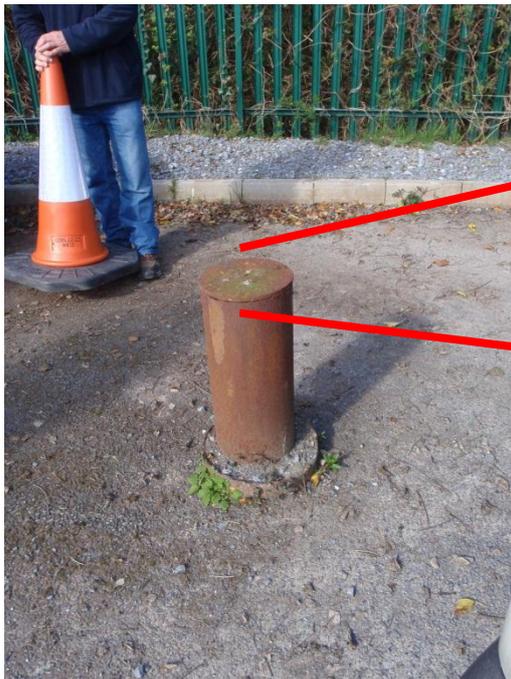
Photograph 2: Second borehole <10 m from operational borehole – unsealed and not decommissioned.

4. Irish Water should establish the status of the second borehole at the Cloughduv treatment plant site and decommission it in accordance with best practice guidelines (see recommendation 3) if it is redundant. If it is to be maintained as a contingency borehole, the borehole should be capped and sealed.
