Drinking Water Audit Report

County:	Co. Cork	Date of Audit:	03/04/2014
Plant(s) visited:	Glenduff Public Water Supply (0500PUB1502)	Date of issue of Audit Report:	15/04/2014
		File Reference:	DW2014/157
		Auditors:	Ms. Cliona Ní Eidhin Ms. Yvonne Doris
Audit Criteria:	<ul style="list-style-type: none"> • The <i>European Union (Drinking Water) Regulations 2014 (S.I. 122 of 2014)</i>. • The <i>EPA Handbook on the Implementation of the Regulations for Water Services Authorities for Public Water Supplies (ISBN: 978-1-84095-349-7)</i> • The recommendations specified in the EPA Report on <i>The Provision and Quality of Drinking Water in Ireland</i>. • The recommendations in any previous audit reports.

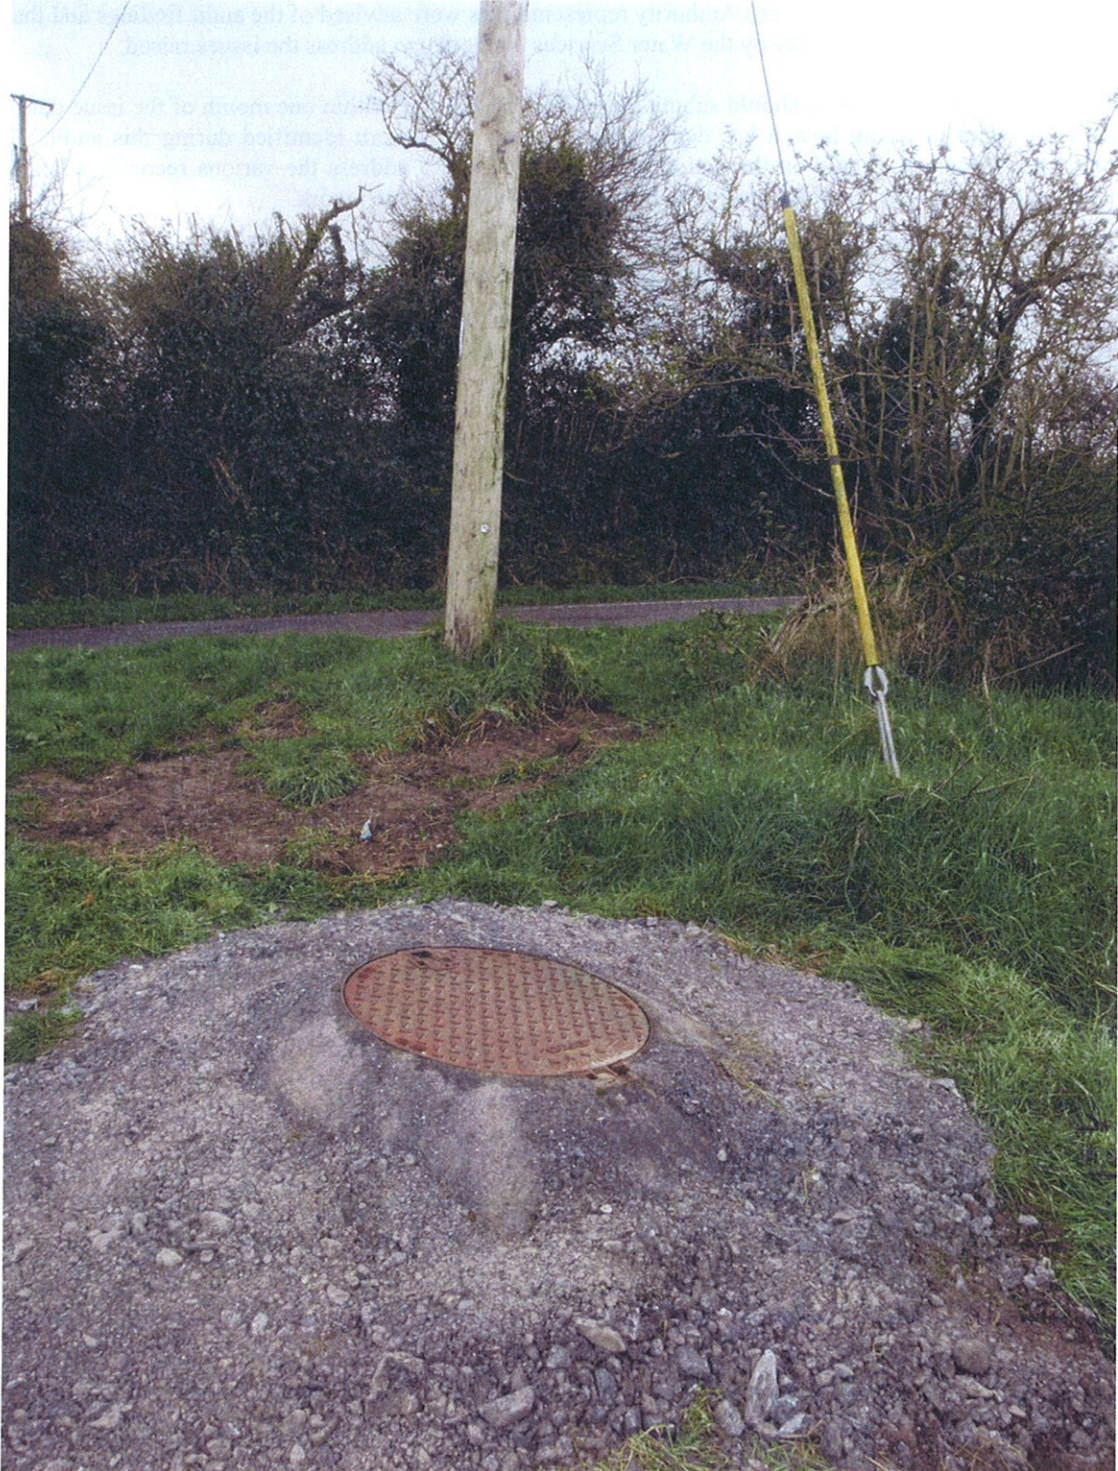
Photograph 1 – Borehole locality. Note no formal drain at road verge and potential for surface water drainage in the direction of the well head.

1. **Source protection:** The Water Services Authority should take action should to ensure that the borehole source for the Glenduff Public Water Supply is made secure against surface water ingress, risks from the adjacent roadway or malicious damage.
2. **Source protection:** The Water Services Authority should inspect septic tanks and premises in the locality of the borehole in order to assess any potential risks to drinking water quality.

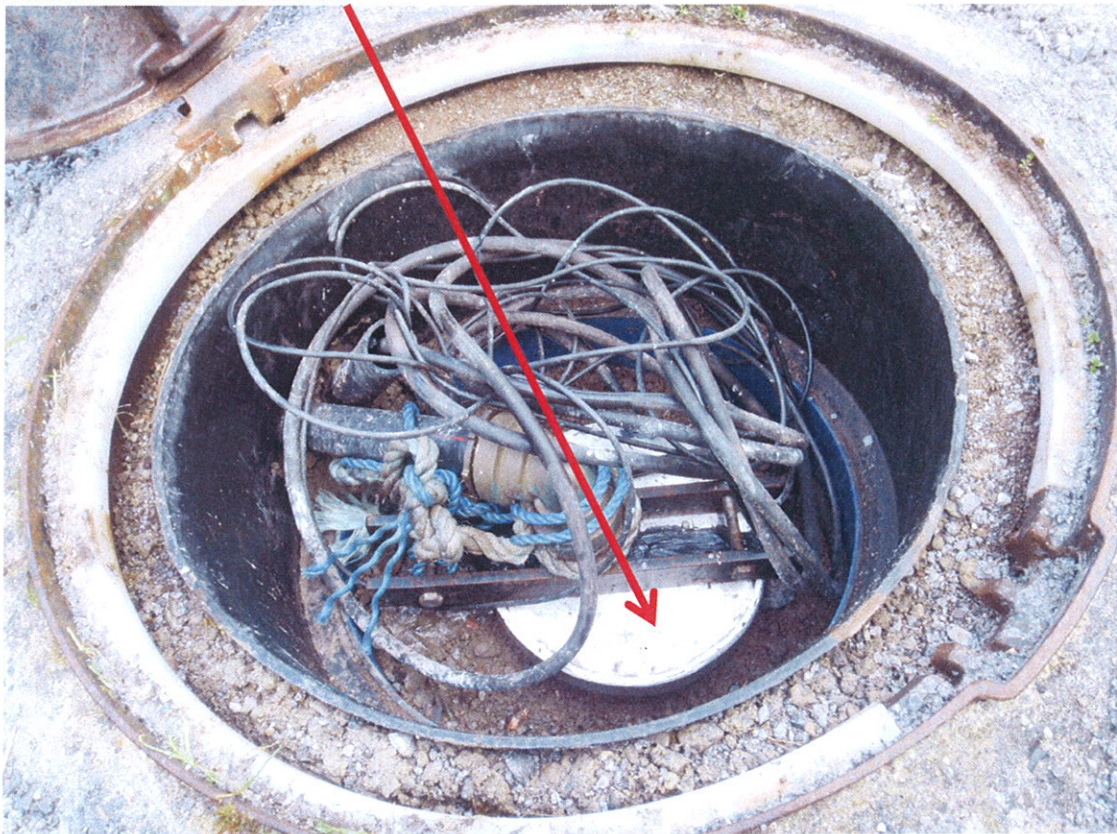
1.	<p>Source Protection</p> <ol style="list-style-type: none"> a. The zone of contribution to the borehole has not been delineated and farms in the locality have not been surveyed or contacted in terms of landspreading activities that could potentially impact on the water quality from the borehole. b. The <i>Cryptosporidium</i> Risk Assessment has been completed for the Glenduff PWS yielding a result of 16, indicating low risk. c. The nearest residence is located approximately 150m up slope from the borehole and is served by a septic tank. The septic tank has not been inspected by the WSA, nor has the private premises been visited to assess potential risks from stored materials such as home heating oil. d. The borehole itself was located within a small chamber beneath an unlocked inspection hatch which was raised some 6 inches above ground level. The inspection hatch cover was not sealed. e. The area immediately surrounding the borehole, including the adjacent road verge, was observed to be without formal drainage channels. It was noted that in heavy rain events, surface water flow could potentially run downslope towards the borehole. (see Photograph 1) f. Borehole drilling logs had not been located by the WSA and details of its construction were not known. From an examination of the well head the borehole shaft was confirmed to be cased. A cap had recently been installed to the well head but it appeared to be laid on top of the shaft rather than adequately sealed. (See photograph 2) The entry point for a pipe/cable to the well shaft was not adequately sealed.

Photograph 2 – Well head. Cap laid in place but not sealed allowing potential for ingress to the borehole shaft from the surface.

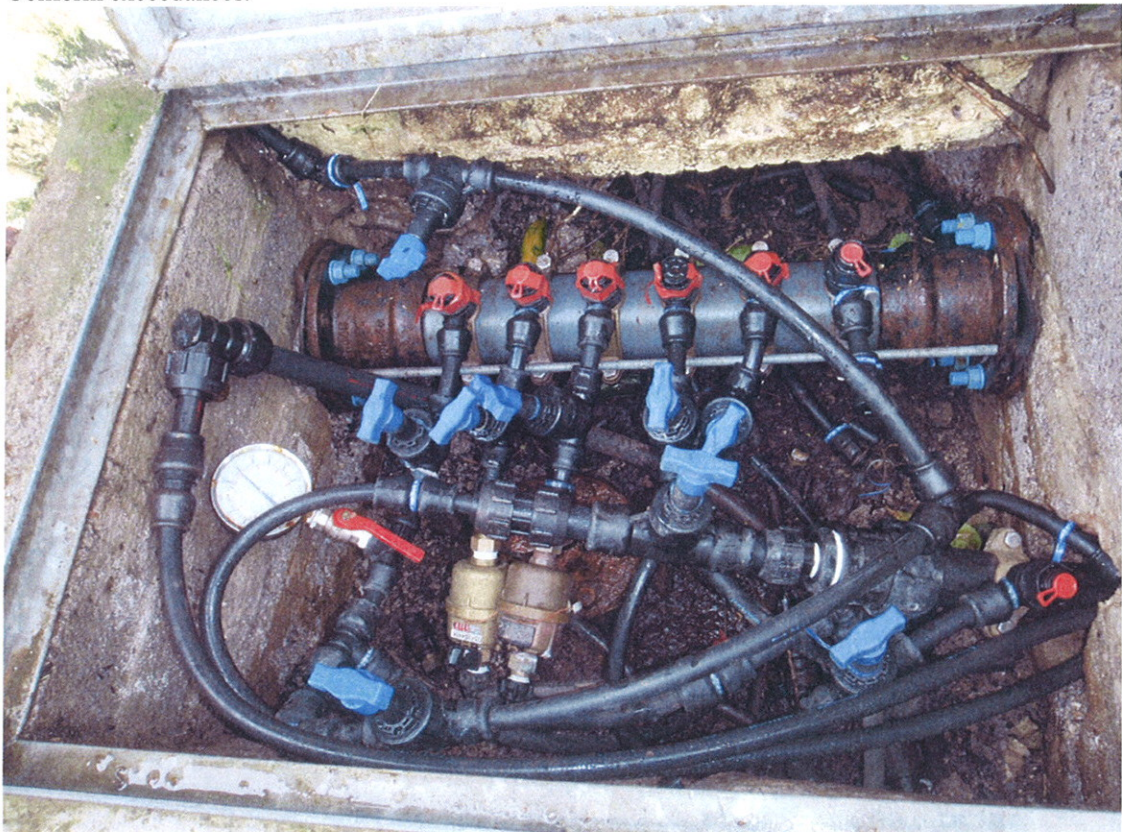
6.	<p>Management and Control</p> <ul style="list-style-type: none"> a. The Glenduff PWS is visited daily by the curator. b. A plant manual has been prepared by the WSA for the Glenduff PWS and is held in the treatment house for reference by the curator. This was reviewed by the auditors and found to include disinfectant delivery records and a number of documented procedures on the management of the plant. c. In the distribution network, the manifold system catering for the domestic connections was inspected by the auditors. The manifold and connections were housed under a single inspection hatch. The auditors noted that the pipework arrangement at the location of the manifold was not labelled. (See Photograph 3) This was noted as a point of concern on this supply as the switching on of an unlabelled pipe was identified as the origin of the March 2014 <i>E.coli</i> & Coliform exceedances.

Photograph 3 – Manifold and individual connections in the distribution network – note the unlabelled pipes. The switching on of an unlabelled pipe was identified as the origin of the March 2014 *E.coli* & Coliform exceedances.

5. **Management and Control:** The Water Services Authority should ensure that the following procedures are documented and available in the plant manual for reference by the plant curator (or relief curator) at all times:
 - a. a procedure with regard to checking the use-by date of sodium hypochlorite disinfectant.
 - b. a procedure for the curator response to the detection of low chlorine in the distribution network.
6. **Management and Control:** The Water Services Authority should label the series of pipes at the location of the manifold in the distribution network such that the purpose of each is clearly discernible to the curator, relief curator and any contractors who may be involved in the maintenance of the supply.
