Drinking Water Audit Report

| Plant(s) visited: | Midleton (0500PUB2406) | Date of issue of Audit Report: | 30/03/2015 |
| | | File Reference: | DW2014/404 |

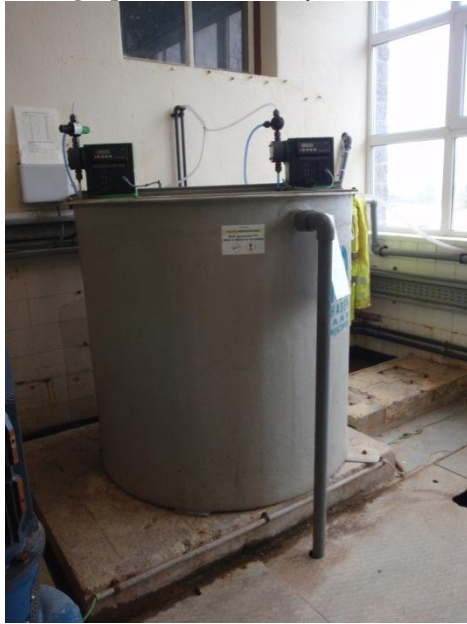
| <p>10.</p> | <p>Chemical storage and bunds</p> <p>a. The Poly Aluminium Chloride day tank was not banded. (See Photograph No. 1)</p> |

Photograph No. 1: PAC day-tank not banded.

6. **Chemical Storage and Bunds:** Irish Water should ensure that the poly aluminium chloride day-tank is adequately banded.

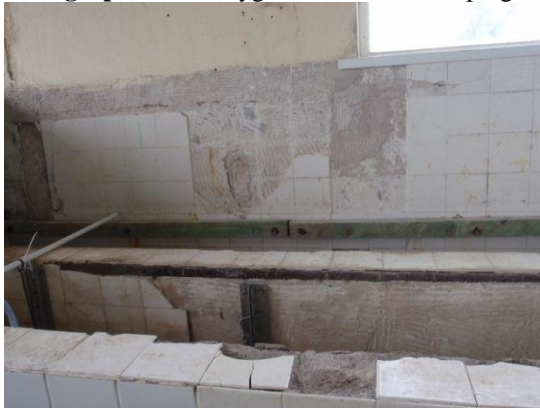
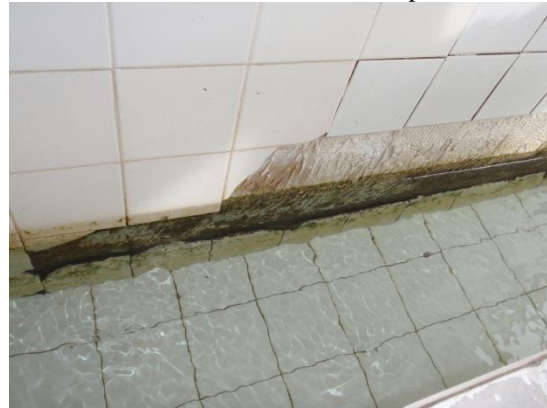
| <p>11.</p> | <p>Hygiene and Housekeeping</p> <p>a. The treatment plant was noted to be maintained in moderate condition, in terms of hygiene and housekeeping. Whilst tiled channels were clean, the tilework on these water channels was aged and damaged in a number of areas. Peeling paintwork on ceilings and light dust/debris on window sills were noted and require attention. (See Photograph No. 2) The WSA was aware of these issues and expressed an intention to address them.</p> |

Photograph No. 2: Hygiene and Housekeeping: tilework on water channels in need of repair.

9. **Hygiene and Housekeeping:** Irish Water should attend to general hygiene and housekeeping at the plant and ensure that this is maintained to standard through routine tidying and cleaning of surfaces.
