# Drinking Water Audit Report

<b>County:</b>	Cork	<b>Date of Audit:</b>	10/10/16
<b>Plant(s) visited:</b>	Millstreet PWS (Scheme Code 0500PUB1408)	<b>Date of issue of Audit Report:</b>	26/10/16
		<b>File Reference:</b>	DW2016/171
		<b>Auditors:</b>	Ms. Criona Doyle Ms. Cliona Ni Eidhin
<b>Audit Criteria:</b>	<ul style="list-style-type: none"> <li>• The <i>European Union (Drinking Water) Regulations 2014 (S.I. 122 of 2014)</i>.</li> <li>• <i>The EPA Handbook on the Implementation of the Regulations for Water Services Authorities for Public Water Supplies (ISBN: 978-1-84095-349-7)</i></li> <li>• The recommendations specified in the <i>EPA Drinking Water Report</i>.</li> <li>• EPA Drinking Water Advice Notes No.s 1 to 15.</li> <li>• The recommendations in any previous audit reports.</li> </ul>

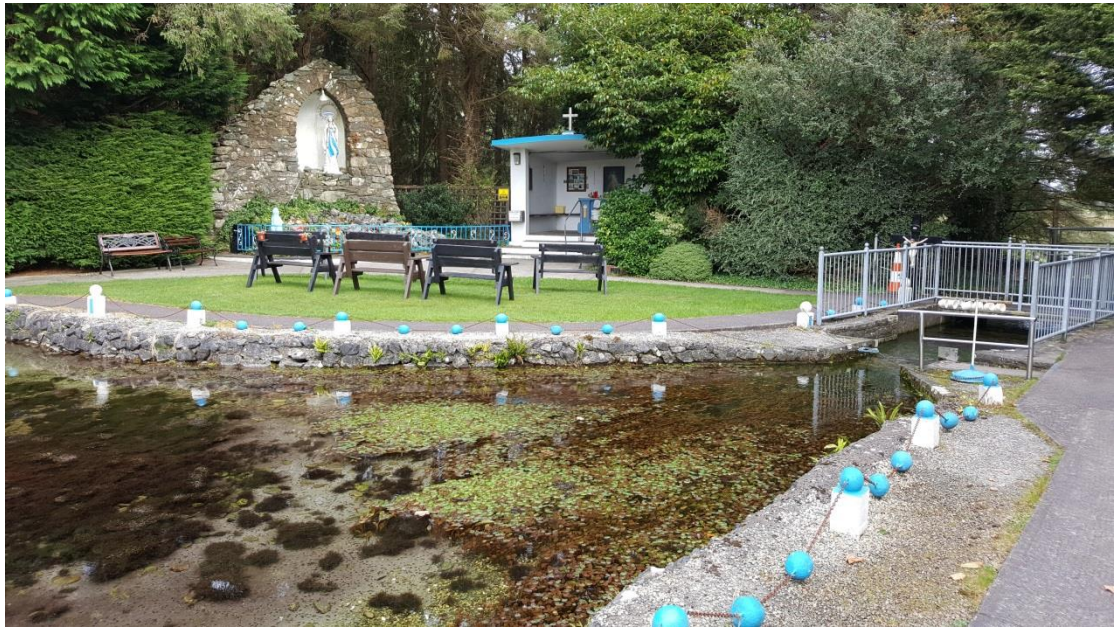
**Photograph No.1:** Tubrid Spring Emergence

<p><b>3.</b></p>	<p><b>Source Protection</b></p> <ul style="list-style-type: none"> <li>a. The main source for the Millstreet Supply is the Tubrid Spring which is an open spring located in an area accessible to the public and potentially birds and animals (Photo No. 1).</li> <li>b. The spring supply is augmented by a borehole located within the Water Treatment Plant Compound (supply volume 200 – 250m<sup>3</sup>/d). The borehole was drilled in 2007 and was commissioned in 2012. A protective chamber has been installed and a sealed wellhead is provided. No borehole log or construction details were available to confirm that an adequate seal is present beneath the wellhead and in the annulus surrounding the borehole.</li> <li>c. A Zone of Contribution (ZOC) (1.95km<sup>2</sup>) was delineated for the spring in 2007. Buffer zones have been delineated for the spring source and a map of the 200m and 250m buffer zones is displayed on site.</li> <li>d. Cork County Council confirmed that all landowners within the buffer zones were written to in 2008 to advise them of appropriate set-back distances for the prevention of water pollution from fertilisers and certain activities.</li> <li>e. The most recent <i>Cryptosporidium</i> Risk Assessment was completed in 2015 with a risk score of 135 (very high risk). This represented a significant increase from the previous risk score of 58 (moderate risk).</li> <li>f. Public toilet facilities are provided on site as it is a popular local amenity. Wastewater treatment is provided via a Biocycle unit. The treated wastewater is piped along the western site boundary and is discharged via a pipe to the Finnow River approximately 200m down gradient of the spring.</li> <li>g. Visitors to the holy well site would not be aware that the spring is the main source for the Millstreet PWS.</li> <li>h. The spring is located on private land. Cork County Council purchased some additional lands to the east of the WTP in 2010 – 2011.</li> <li>i. Landuse in the immediate vicinity of the spring includes coniferous forestry to the west and south west. There is a more recent broadleaf plantation to the south. There are a number of houses along the R582 south of the spring within the ZOC likely to be served private wastewater treatment systems (septic tanks). It is not known if any of these have been inspected as part of the National Inspection Plan.</li> <li>j. No unusual activities are reported in the surrounding catchment prior to the detection of <i>Cryptosporidium</i>. Irish Water indicated that investigative work in the catchment is to continue.</li> <li>k. The caretaker reports that there are no issues with elevated turbidity in response to rainfall in the catchment. The catchment is not flashy and demonstrates a very consistent water quality. There is no history of an increase in chlorine demand in response to rainfall events.</li> <li>l. The results of raw water monitoring data from Cork County Council and EPA Groundwater Monitoring Programme were provided and reviewed. A copy of the results was subsequently forwarded by Cork County Council on the 11/10/16 indicating a consistent water quality.</li> <li>m. The spring overflow discharges to the River Finnow approximately 200m north east of the spring. A gate has been installed to prevent the ingress of flood waters to the drinking water abstraction point during periods of flooding on the River Finnow.</li> </ul>

- 4. Irish Water should take action to ensure that the source is made secure and fenced off to prevent animal access and ensure that the gates are kept closed at all times.
- 5. Irish Water should ensure the small hole over the clear water sump is sufficiently sealed/protected to prevent ingress to the treated water.

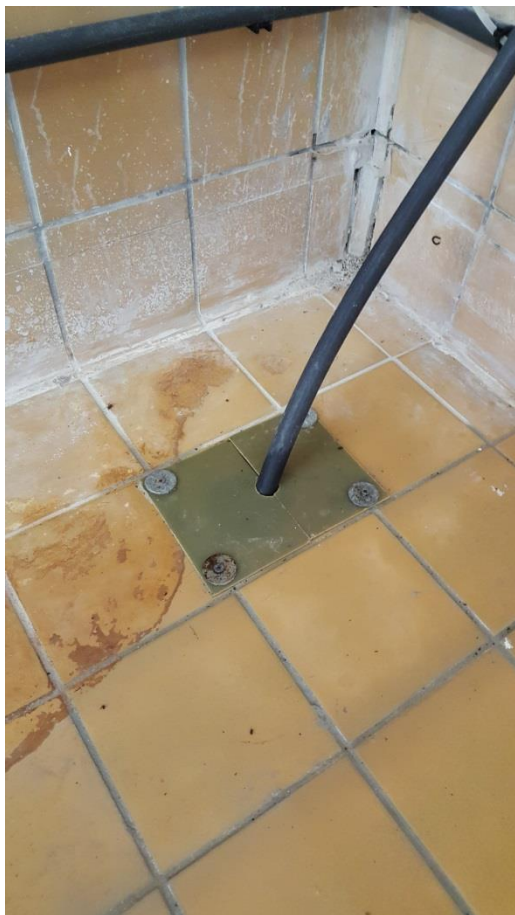
**Photograph No. 2:** Hole Above Clear Water Sump

<b>7.</b>	<p><b>Hygiene and Housekeeping</b></p> <p>a. Both the caretaker and relief caretaker only work on the water treatment plant and water network and are not involved in the operation of any waste water treatment plants.</p> <p>b. A small hole in the floor over the clear water sump was noted under the UVT monitor presenting the potential for accidental ingress. (Photograph No. 2).</p> <p>c. A notice is in place on the entrance gate to the site indicating “Dogs Not Allowed”. On the date of the audit the gate was open.</p>
<b>8.</b>	<p><b>Management and Control</b></p> <p>a. There is a turbidity alarm present with automatic shut down at the inlet to the plant when a level of 1 NTU is exceeded for 30 minutes. The caretaker gets a text alarm and the system restart requires a physical restart by the caretaker at the plant.</p> <p>b. There is a response cascade system in place with both the caretaker and relief caretaker getting text message alarms.</p>
