Drinking Water Audit Report

County:	Co. Cork	Date of Audit:	14/04/2015
Plant visited:	Templemartin PWS (0500PUB3104)	Date of issue of Audit Report:	21/04/2015
		File Reference:	DW2015/45
		Auditors:	M. Cliona Ní Eidhin Ms. Michelle Roche
Audit Criteria:	<ul style="list-style-type: none"> • The <i>European Union (Drinking Water) Regulations 2014 (S.I. 122 of 2014)</i>. • The <i>EPA Handbook on the Implementation of the Regulations for Water Services Authorities for Public Water Supplies (ISBN: 978-1-84095-349-7)</i> • The recommendations specified in the <i>EPA Drinking Water Report</i>. • The recommendations in any previous audit reports.

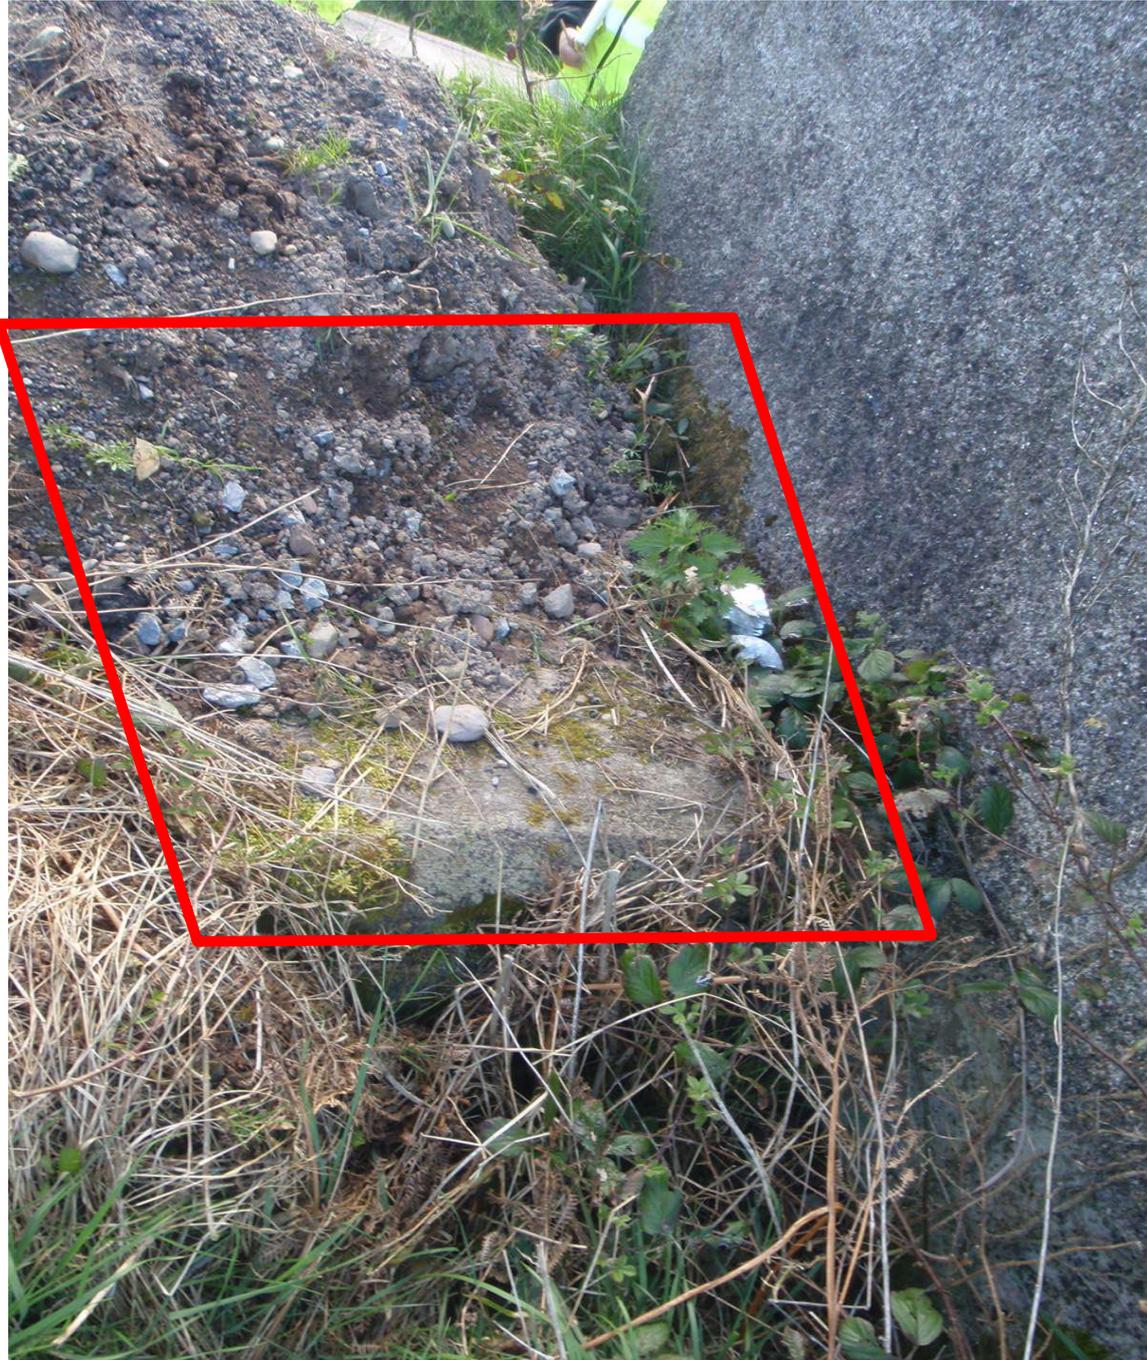
- i. *The concrete chamber enclosing the uncapped well head is part covered by a roadside earthen embankment establishing the potential for ingress into the well.*
- ii. *The disinfection alarm currently alerts only one individual when triggered. There is no dial-out cascade in place.*
- iii. *The sodium hypochlorite in use as a disinfectant in this supply was reported during the audit to be of a suspected different strength to that indicated on the canisters.*

Photograph No. 1: Concrete chamber containing uncapped well head – part-covered by earthen embankment.

1. Irish Water should submit the source protection, catchment risk, and overall score for the *Cryptosporidium* risk assessment of the Templemartin PWS.
2. Irish Water should undertake works to remove the accumulated earthen embankment and vegetation from immediately around the borehole chamber to prevent ingress of surface water or drainage water and to facilitate access to the borehole for maintenance and inspection.
3. Irish Water should ensure that the borehole is capped and sealed in order to prevent ingress.
