Drinking Water Audit Report

County:	County Cork	Date of Audit:	12/08/2014			
Plant(s) visited:	Tibbotstown (0500PUB2408)	Date of issue of Audit Report:	20/08/2014			
		File Reference:	DW2014/284			
		Auditors:	Ms. Cliona Ní Eidhin			
Audit Criteria:	The EPA Handbook Services Authoriti	The EPA Handbook on the Implementation of the Regulations for Water Services Authorities for Public Water Supplies (ISBN: 978-1-84095-349-7)				
	 The recommendations specified in the EPA Report on <i>The Provision and Quality of Drinking Water in Ireland</i>. The recommendations in any previous audit reports.

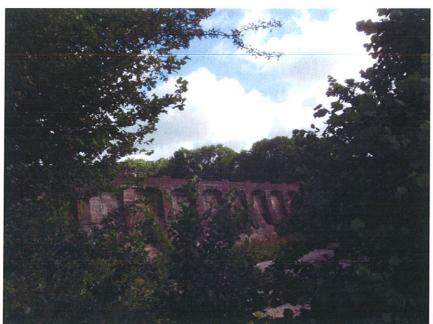
Appendix 1 Photograph No. 1: The primary raw water source – an impounded lake located adjacent to the plant.

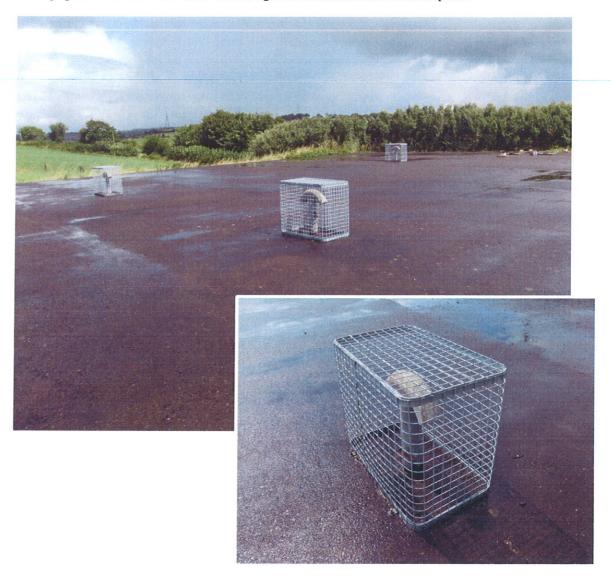
- a. Two reservoirs are in use located in the distribution network of the Tibbotstown public water supply at Springhill Upper and Killahora. The Springhill Upper reservoir was inspected as part of the audit.
- b. The reservoir was constructed in 1970 and comprises two cells. Inspection hatches were confirmed to be locked and sealed. Immediately after the audit, the WSA informed the auditor that the reservoir was last drained down, washed and integrity assessed in Aril 2004 with no concerns identified.
- c. It was noted that, whilst the reservoir vents were secure against vandalism (see Photograph No. 3), there was no mesh in place on the vent openings.

Photograph No. 3: Reservoir vents – secure against vandalism but no mesh in place.

20. **Treated Water Storage:** The Water Services Authority should ensure that all vents on the Springhill Upper and Killahora reservoirs are secured against ingress of animals or insects. A photograph should be submitted as an example of the mesh put in place at either reservoir.
