Drinking Water Audit Report

County:	Cork	Date of Audit:	26/09/2016
Plant(s) visited:	Whitegate Regional 0500PUB2407	Date of issue of Audit Report:	30/09/2016
		File Reference:	DW2016/37
		Auditors:	Mr Niall Dunne Ms Pauline Gillard
Audit Criteria:	<ul style="list-style-type: none"> • The <i>European Union (Drinking Water) Regulations 2014 (S.I. 122 of 2014)</i>. • <i>The EPA Handbook on the Implementation of the Regulations for Water Services Authorities for Public Water Supplies (ISBN: 978-1-84095-349-7)</i> • The recommendations specified in the <i>EPA Drinking Water Report</i>. • The recommendations in any previous audit reports.

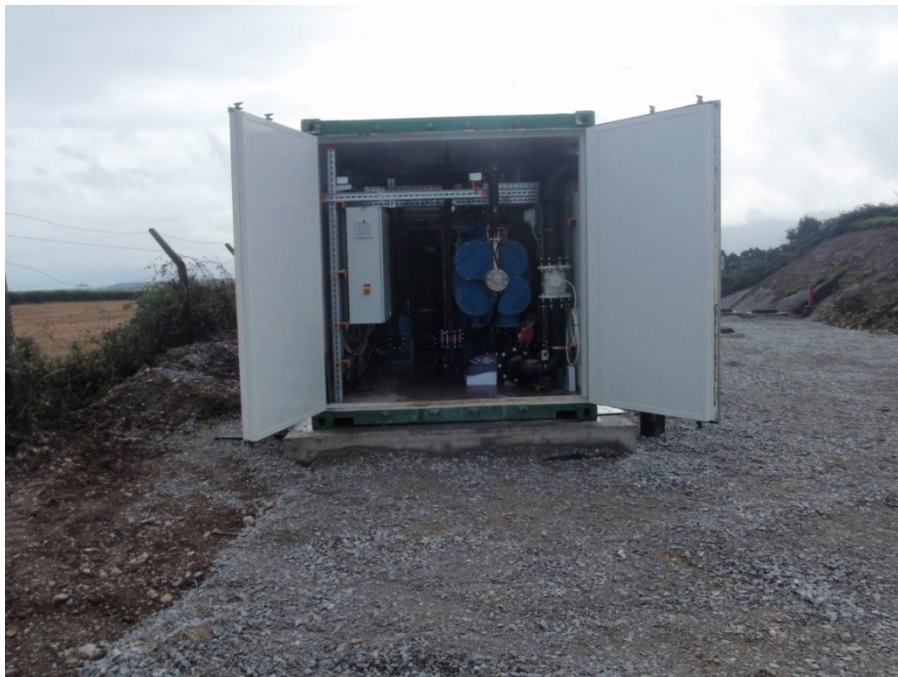
3.	<p>Filtration</p> <p>a. One of the recommendations of the 02/02/2016 EPA audit report was that additional treatment, organics removal prior to disinfection, should be considered.</p> <p>b. IW has installed two self-cleaning Amiad microfilters, which can filter to 2 microns, (see photograph 1). According to IW the filters were commissioned on the 16/09/16. At the time of the audit additional works on the filters were ongoing; these were scheduled to be completed by the 30/09/2016.</p> <p>c. Each filter is designed to treat up to 150 m³/hr.</p> <p>d. It is proposed that automatic filter backwashes will be initiated on time, turbidity and on a 0.25 bar pressure differential (ΔP) across the filter. A second backwash will be initiated if the 0.25 ΔP does is not reduced. A dial out alarm will be initiated if 0.25 bar ΔP is recorded after the second backwash. Dial out alarms are also initiated on 0.7 NTU being exceeded for 15 minutes pre or post the filters.</p> <p>e. The plant is set to auto shutdown if post-filter turbidity > 1 NTU, for 15 minutes, and if ΔP > 0.45 bar across the filter.</p> <p>f. During the audit the observed turbidity readings were 0.066 NTU pre-filter, 0.05NTU post filter no. 1 and 0.061 NTU post filter no. 2.</p>

At the time of the audit some works were still outstanding on the micro filtration units. Irish Water should ensure that these works are complete without delay and that operational data is submitted to provide evidence of their effectiveness.

Photograph 1: One of the micro filtration unit, still under commission.

1. Irish Water should confirm when the microfiltration systems are fully commissioned and operational. Once operational Irish Water should submit at least one weeks plant performance data in graph form of the following parameters;
