Drinking Water Audit Report

County:	Donegal	Date of Audit:	19 August 2014
Plant(s) visited:	Bundoran Urban (L. Melvin) Water Treatment Plant	Date of issue of Audit Report:	02 September 2014
		File Reference:	DW2014/303
		Auditors:	Ms Derval Devaney
Audit Criteria:	<ul style="list-style-type: none"> • The <i>European Union (Drinking Water) Regulations 2014 (S.I. 122 of 2014)</i>. • The <i>EPA Handbook on the Implementation of the Regulations for Water Services Authorities for Public Water Supplies (ISBN: 978-1-84095-349-7)</i> • The recommendations specified in the EPA Report on <i>The Provision and Quality of Drinking Water in Ireland</i>. • The recommendations in any previous audit reports.

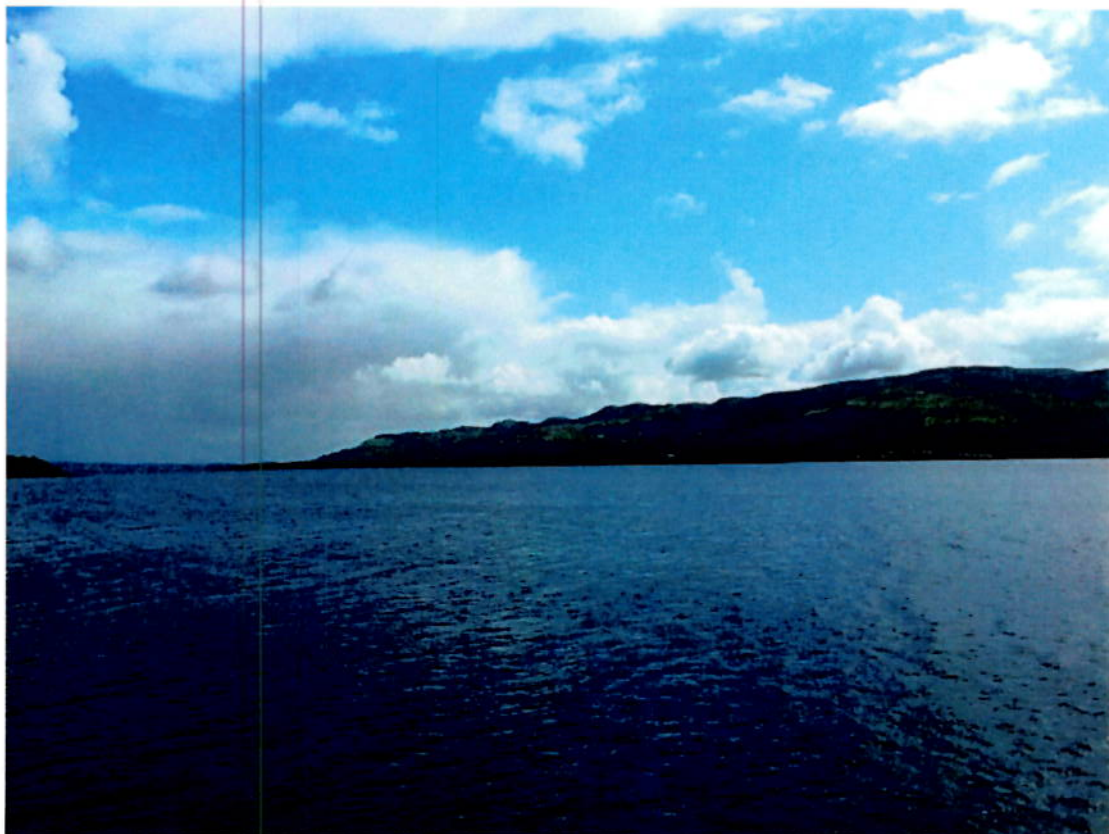
1.	<p>Source Protection</p> <ol style="list-style-type: none"> The Bundoran PWS supply is sourced from Lough Melvin, with the abstraction point situated in the north-west of Co. Leitrim, about 4 km south of Bundoran (see Photo 1). The lake is approximately 13 km long by 3 km wide and lies on the border of Co Leitrim and Co Fermanagh (N. Ireland). Lough Melvin is a Special Area of Conservation and is listed on Annex I of the E.U. Habitats Directive. The site is also important for otter, for the presence of a unique fish community, including Atlantic Salmon, a species that is listed on Annex II of the E.U. Habitats Directive, and for a diverse flora which includes a number of rare plants, most notably, the protected Globeflower. The lake is used for boating, fishing and water abstraction, while much of the terrestrial part of the site is used for grazing (low intensity agricultural activity). Consequently, the main threats to the site are from agricultural pollution and recreational use. The lake is susceptible to algal blooms and the caretaker observes the lake for signs of accumulation of algae. Abstracted water (at a rate of 170 m³/hr) is filtered through 20mm screens prior to being gravity fed to the raw water sump at the nearby water treatment plant. The raw water turbidity monitor read 0.59 NTU during the audit and colour was 50 Hazen. The <i>Cryptosporidium</i> risk score is 74 (moderate) for this supply.

Photo 1 Lough Melvin source

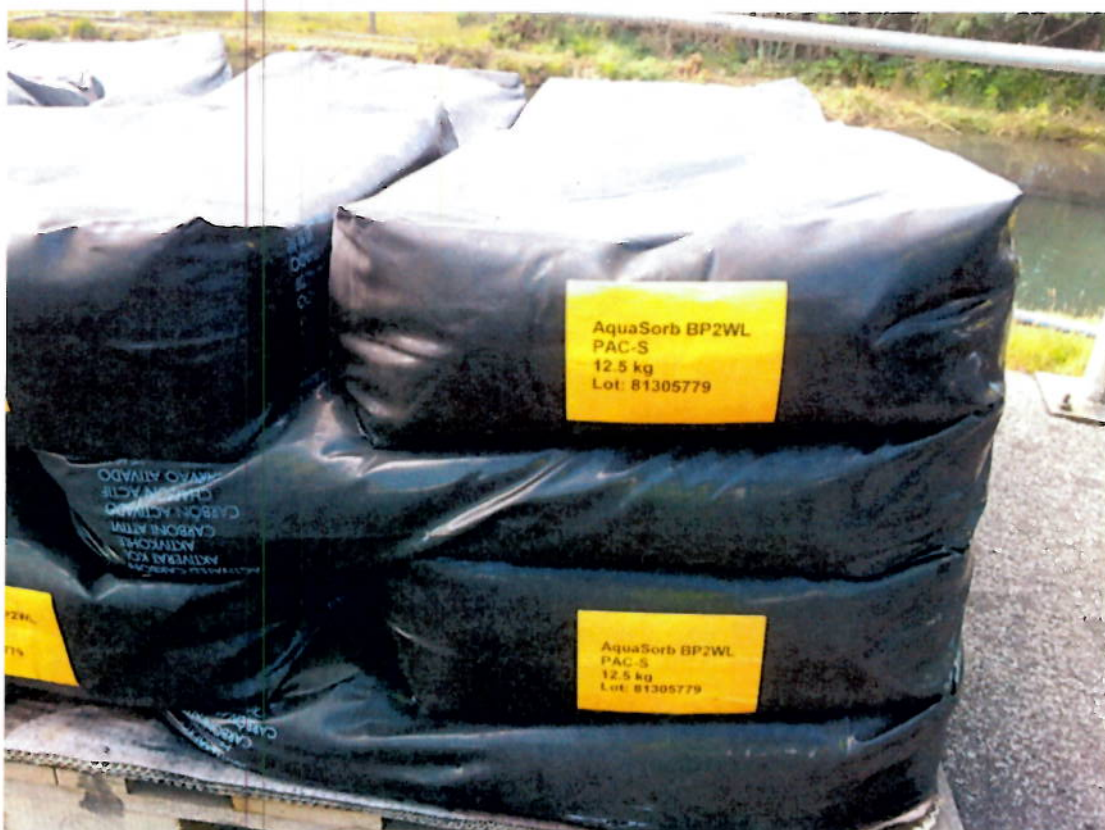
8.	<p>Chemical storage and bunds</p> <p>a. Bags of Powered Activated Carbon were being stored uncontained on a pallet on top of contact tank which posed a risk of PAC unintentionally entering the water system if a bag was severed or unintentionally torn (see Photo 2).</p> <p>b. There is a bulk liquid alum and hydrofluorosilicic acid tank stored indoors in a bunded area at the plant. The bulk alum tank had a crack near its roof.</p> <p>c. Sodium hypochlorite drums are stored in a bunded area on-site and used to fill the day tank.</p>

Photo 2 Powdered Activated Carbon stored on a pallet on top of the contact tank

6. The Water Services Authority should ensure that crack evident on the liquid alum bulk storage tank is repaired so that the tank is fit for purpose.
7. The Water Services Authority should ensure that bags of Powered Activated Carbon are stored in a bund to ensure any spillage of material that might occur will not pose a risk to the water treatment process or environment.

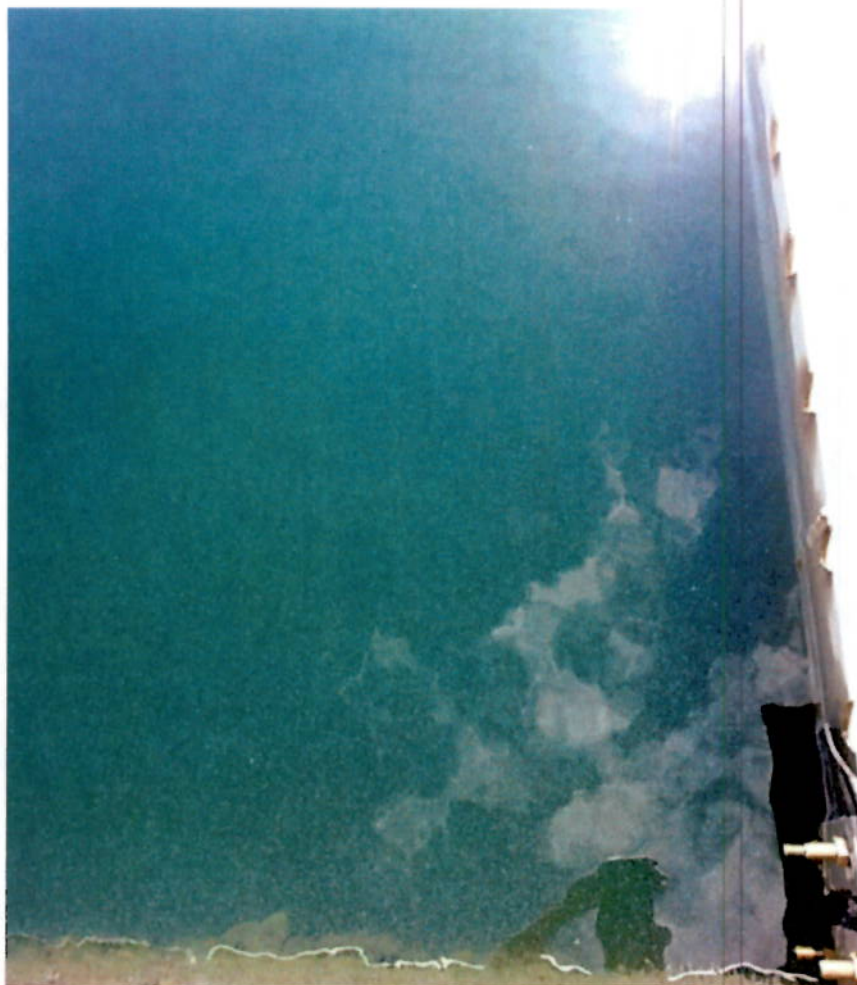
<p>improved and a sludge thickener and holding tank was installed. Sludge from the clarifier is diverted to the picket fence thickener and the thickened sludge is diverted to a sludge holding tank for tankering off-site for treatment while the supernatant from the process is sent to the on-site lagoon. The supernatant from the lagoon is diverted to the intake chamber along with the filter backwash water for recycling through the water treatment plant.</p> <ul style="list-style-type: none"> c. The upflow rate in the clarifier is 3 m rise / hour with a surface area of 72.9 m². d. The turbidity meter on the clarified water read 0.14 NTU on the day of the audit. e. Pin-floc was observed in the settled water as it spilled into the decanting troughs within the clarifier (see Photo 3).

Photo 3 Pin-floc evident in clarifer

1. The Water Services Authority should carry out an investigation to identify the cause of floc carryover from the clarifier into the filters. In this regard the Water Services Authority shall consult Table 2 on Page 41 of the EPA publication "*Water Treatment Manual: Coagulation,*

Flocculation and Clarification” and investigate the use of polyelectrolyte and pH correction in line with the designed plant’s operating procedures.

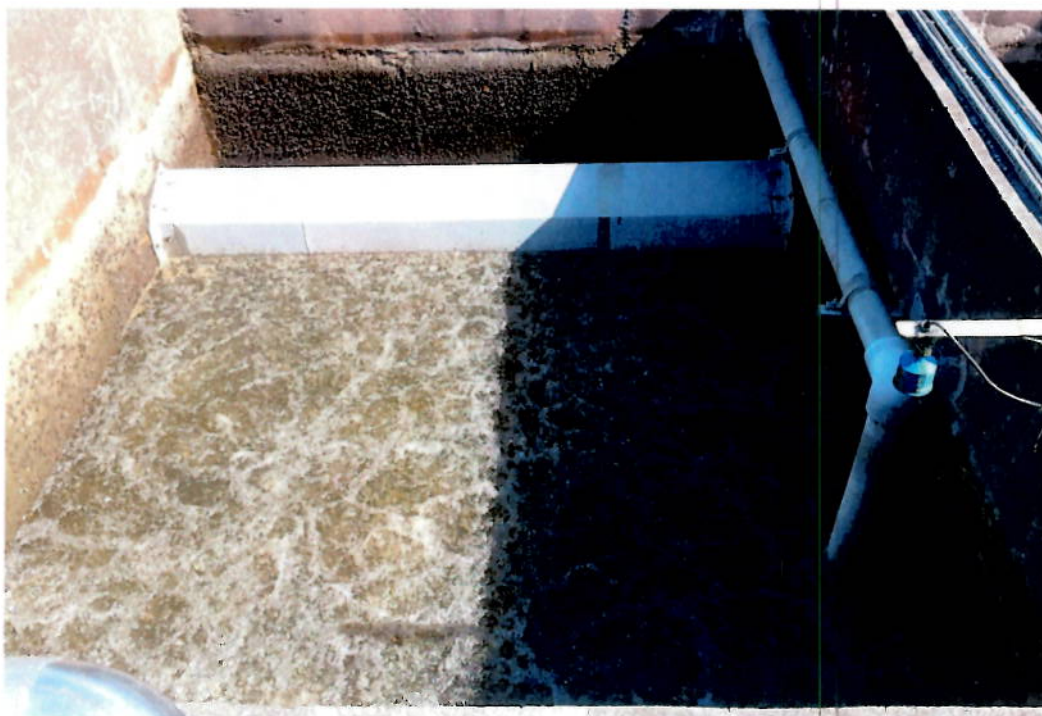
Photo 4 Even distribution of backwash water on Filter No. 3

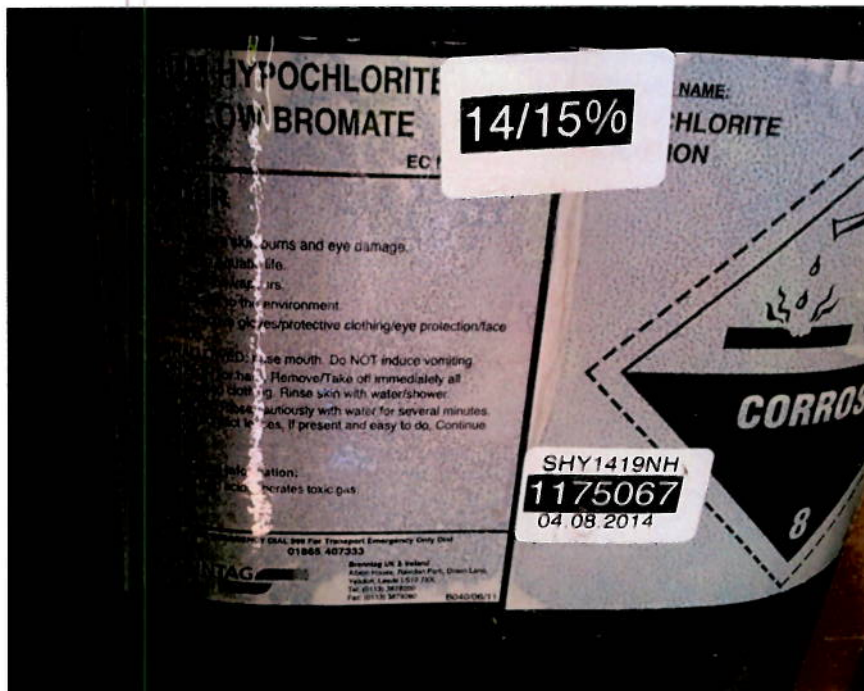
9.	<p>Management and Control</p> <p>a. Brenntag supply sodium hypochlorite drums to the plant for use as a disinfectant (see Photo 5). The label of biocidal detergents is to contain all the relevant elements specified in Article 69 of the Biocidal Products Regulation (EU) No 528/2012 (e.g. the notification or approval number PCS 9xxxx or IE/BPA 7xxxx). The label did not appear to have such number displayed nor did it have an expiry date (The date 04.08.14 on Photo 5 refers to the manufacture date). Irish legislation requires that all biocides on the market in Ireland must as a first step be notified with DAFM. It is the responsibility of any company wishing to place a biocidal product on the market in Ireland to ensure that the product is notified in accordance with Statutory Instrument S.I. No. 625 of 2001. Further information can be found at http://www.pcs.agriculture.gov.ie/biocides.htm and by contacting the Pesticide Registration and Control Division at biocides@agriculture.gov.ie</p> <p>b. There were complaints in the past regarding taste and odour which were linked to the presence of algae in the source water. No complaints have been received in recent times and PAC was introduced to alleviate the issue.</p> <p>c. There is a standby generator in place in the event of a power failure which is tested on an ongoing basis.</p>

Photo 5 Sodium Hypochlorite supplied by BRENNTAG

3. As filter backwash water is returned to the head of the works, the Water Services Authority should investigate the feasibility of installing a UV unit to increase the safety and security of the supply and reduce the risk of *Cryptosporidium* entering the supply.
4. The Water Services Authority should ensure that the disinfectant product used for the treatment of this water supply is notified to the Pesticide Registration and Control Division of DAFM in accordance with Statutory Instrument S.I. No. 625 of 2001. The label of biocidal detergents is to contain all the relevant elements specified in Article 69 of the Biocidal Products Regulation (EU) No 528/2012 which is to include the expiry date.
