Drinking Water Audit Report

County:	Donegal	Date of Audit:	21 st September 2016
Plant(s) visited:	Cresslough Water Treatment Plant	Date of issue of Audit Report:	14 th October 2016
		File Reference:	DW2011/48
		Auditors:	Ms Derval Devaney
Audit Criteria:	<ul style="list-style-type: none"> • The <i>European Union (Drinking Water) Regulations 2014 (S.I. 122 of 2014)</i>. • <i>The EPA Handbook on the Implementation of the Regulations for Water Services Authorities for Public Water Supplies (ISBN: 978-1-84095-349-7)</i> • The recommendations specified in the <i>EPA Drinking Water Report</i>. • EPA Drinking Water Advice Notes No's 1 to 15.

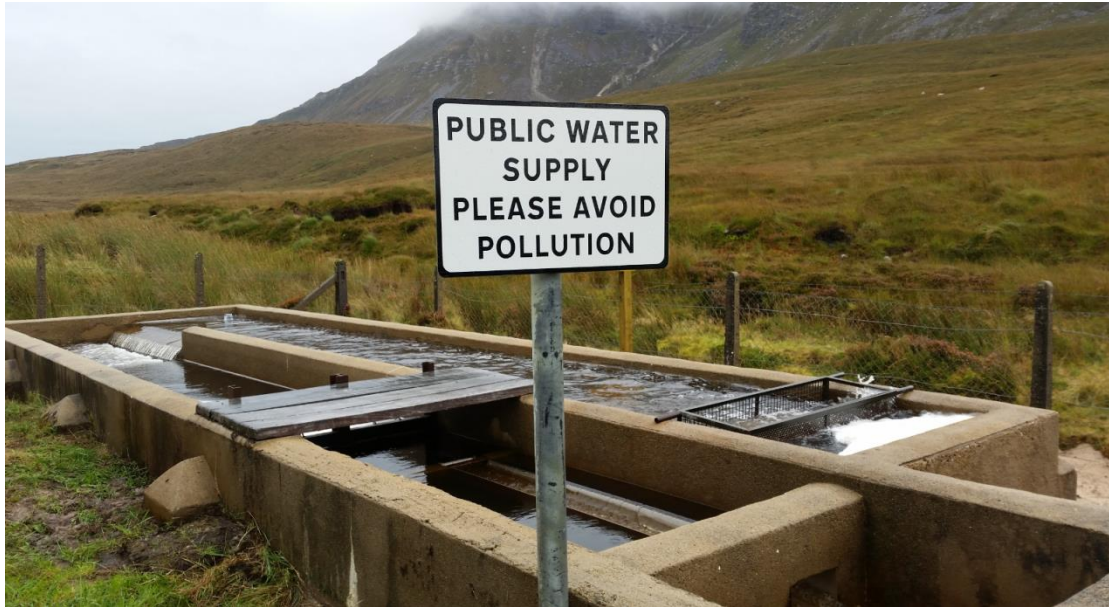
Photo 1 Silt and Sand trap on Lough Muckish stream
