# Drinking Water Audit Report

<b>County:</b>	Donegal	<b>Date of Audit:</b>	20 <sup>th</sup> September 2016
<b>Plant(s) visited:</b>	Frosses-Inver Water Treatment Plant	<b>Date of issue of Audit Report:</b>	14 <sup>th</sup> October 2016
		<b>File Reference:</b>	DW2016/144
		<b>Auditors:</b>	Ms Derval Devaney
<b>Audit Criteria:</b>	<ul style="list-style-type: none"> <li>• The <i>European Union (Drinking Water) Regulations 2014 (S.I. 122 of 2014)</i>.</li> <li>• <i>The EPA Handbook on the Implementation of the Regulations for Water Services Authorities for Public Water Supplies (ISBN: 978-1-84095-349-7)</i></li> <li>• The recommendations specified in the <i>EPA Drinking Water Report</i>.</li> <li>• EPA Drinking Water Advice Notes No.s 1 to 15.</li> </ul>

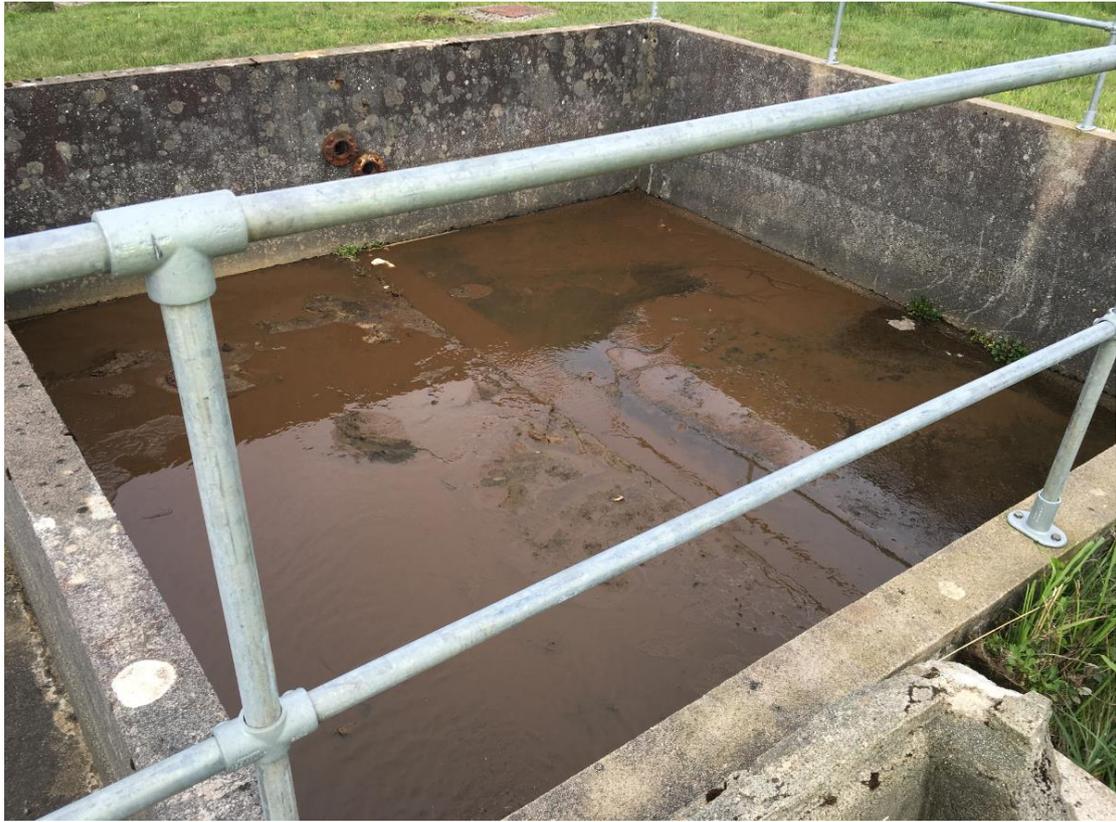
<b>8.</b>	<p><b>Management and Control</b></p> <p>a. This plant is due upgrades under 2 Minor Programmes; the disinfection programme and flocculation programme. An initial review of the flocculation process was carried out by a consultant engineer a few months ago which will feed into the flocculation programme. The disinfection programme is expected to be complete by end of 2016 and the flocculation programme by the end of Q3, 2017.</p>
<b>9.</b>	<p><b>Sludge Management</b></p> <p>a. There is no sludge handling facility on-site. Since 1972, backwash water and material from sludge bleeds enters an open concrete tank (see Photo 1) and its contents are piped to a stream which flows into the Inny River.</p>

**Photo 1 Holding tank for expended backwash water and sludge bleeds**

6. Irish Water should review current methods of handling and disposal of water treatment sludge to ensure that the practice is not in contravention of the *Waste Management Act, 1996-2003*. The discharge of water treatment sludge to receiving water, where practiced, should cease as soon as possible. Irish Water should submit a plan on how it is to handle sludge waste

generated at the plant. Irish Water should determine if sludge discharge to date has had any impact on the receiving waters. Leachate from stored drinking water sludge should not give rise to environmental pollution
