# Drinking Water Audit Report

<b>County:</b>	Donegal	<b>Date of Audit:</b>	20 August 2014
<b>Plant(s) visited:</b>	Killybegs Water Treatment Plant	<b>Date of issue of Audit Report:</b>	19 September 2014
		<b>File Reference:</b>	DW2014/305
		<b>Auditors:</b>	Ms Derval Devaney
<b>Audit Criteria:</b>	<ul style="list-style-type: none"> <li>• The <i>European Union (Drinking Water) Regulations 2014 (S.I. 122 of 2014)</i>.</li> <li>• The <i>EPA Handbook on the Implementation of the Regulations for Water Services Authorities for Public Water Supplies (ISBN: 978-1-84095-349-7)</i></li> <li>• The recommendations specified in the EPA Report on <i>The Provision and Quality of Drinking Water in Ireland</i>.</li> <li>• The recommendations in any previous audit reports.</li> </ul>

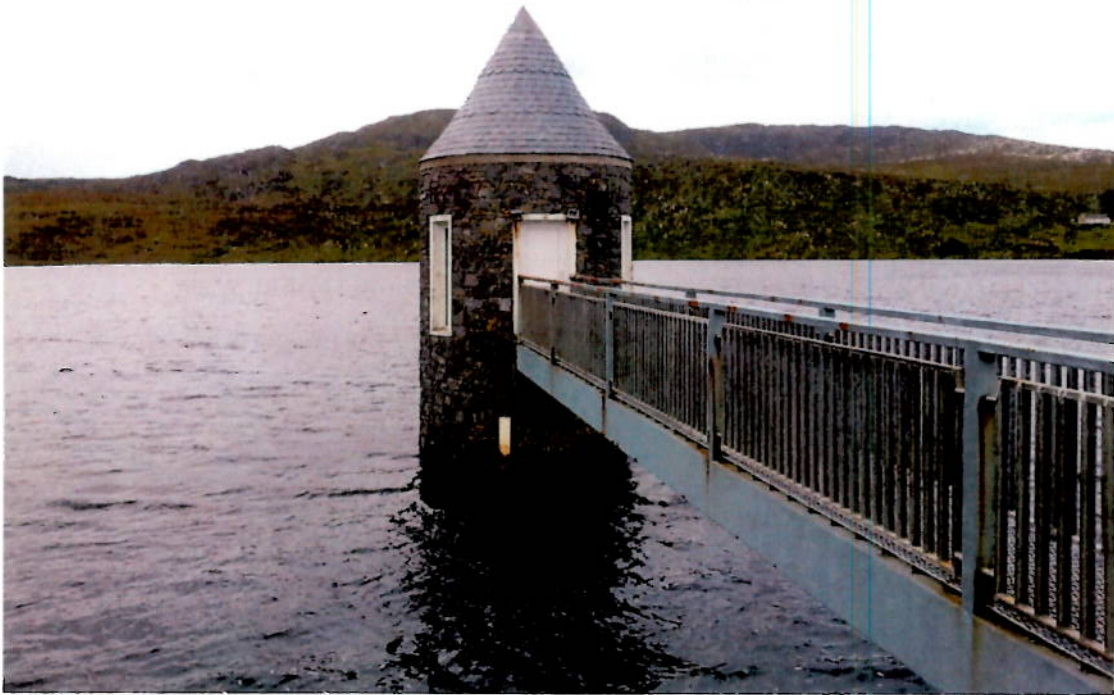
1.	<p><b>Source Protection</b></p> <ul style="list-style-type: none"> <li>a. Two impoundment dams were constructed to store water in the Lough Adeery source (see Photo 1) and a stream to the north of the lake was diverted to flow into the lake (see Photo 2). The lake's surface area is approx.7 hectares.</li> <li>b. There are 2 abstraction points in the lake – one at 2m high water level and one at 4m low water level. It is the upper level that is used by the Water Supplier.</li> <li>c. Currently 150 m<sup>3</sup>/hr is abstracted from Lough Adeery (a set abstraction rate that is controlled at the inlet) and there is capacity to abstract to 450 m<sup>3</sup>/hr. There is also the capacity to deliver 450 m<sup>3</sup>/hr to the distribution network however currently the plant can only treat a maximum of 225 m<sup>3</sup>/hr.</li> <li>d. Land use in the catchment of about 800 hectares comprises of low intensity agriculture (mainly sheep grazing). There are 4 houses on the catchment.</li> <li>e. MCPA was an issue in this catchment in the past and recently (2013 and 2014) elevated levels of manganese are evident (400 ug/l<sup>+</sup>) in the source water.</li> <li>f. There is a Johnston Screen of 6mm at the inlet point which is manually cleaned via air purging.</li> <li>g. Raw water colour varies seasonally ranging from 40-170 Hazen. The raw water turbidity monitor was reading 0.5 NTU on the day of the audit.</li> </ul>

**Photo 1 Abstraction location in Lough Adeery**

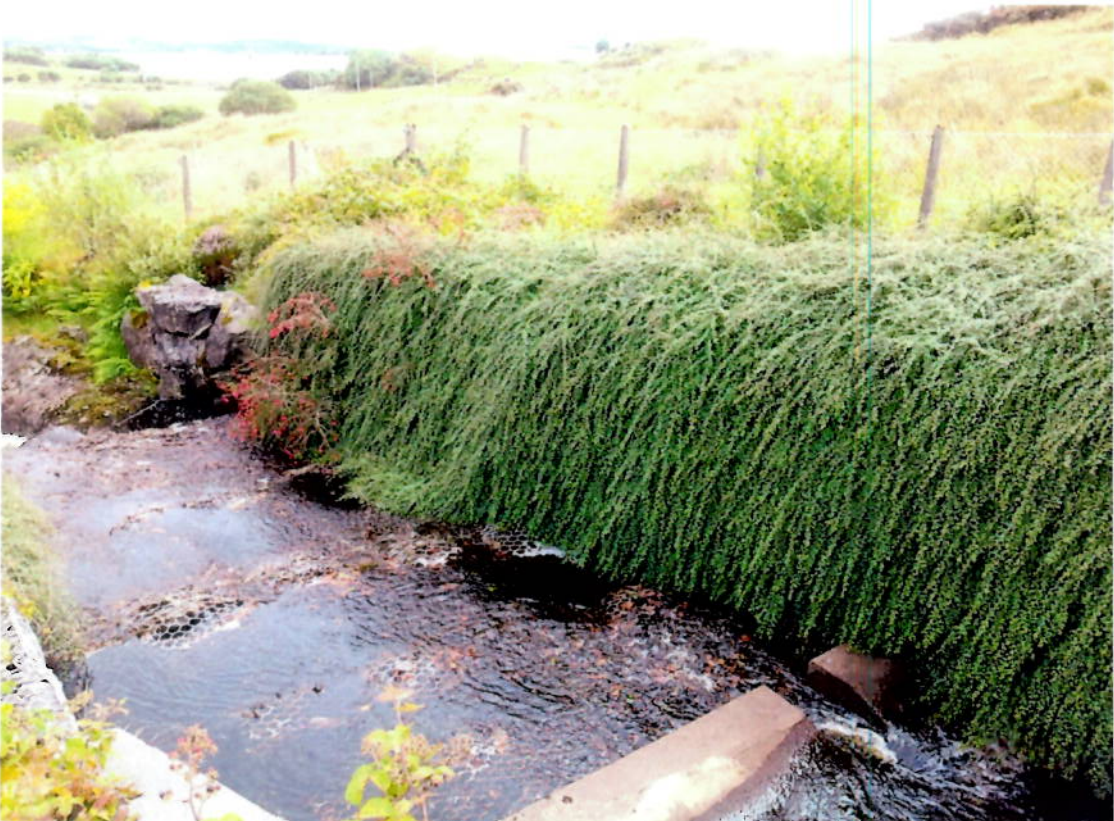
**Photo 2 Stream diverted to feed Lough Adeery**

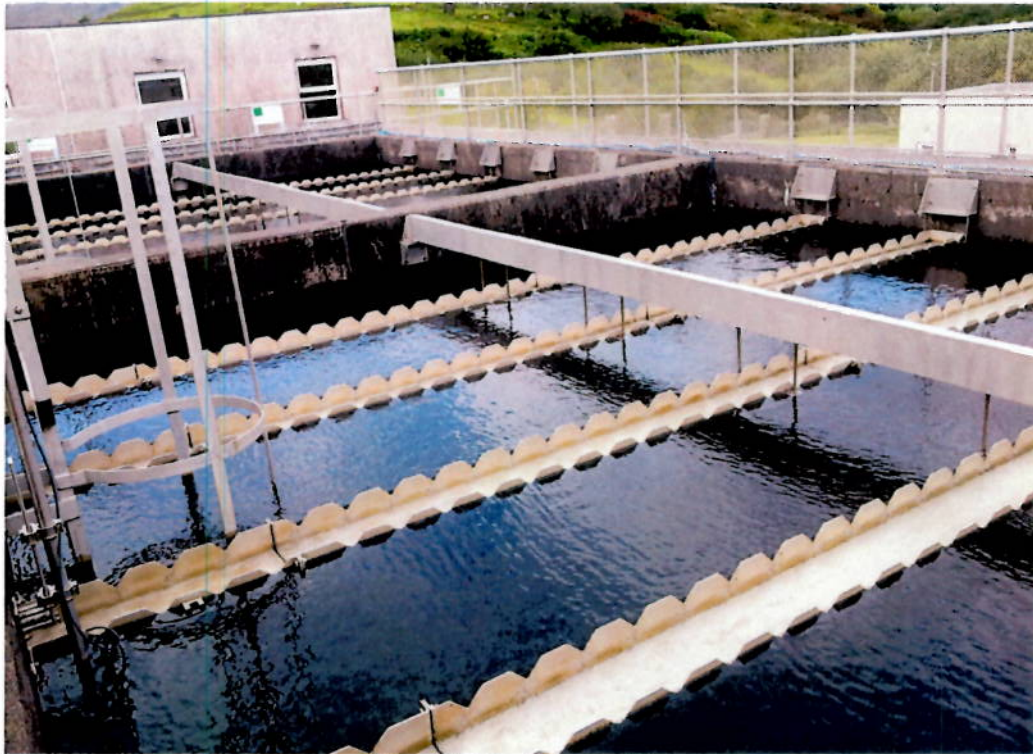
**Photo 3 Clarifiers (2 No.)**

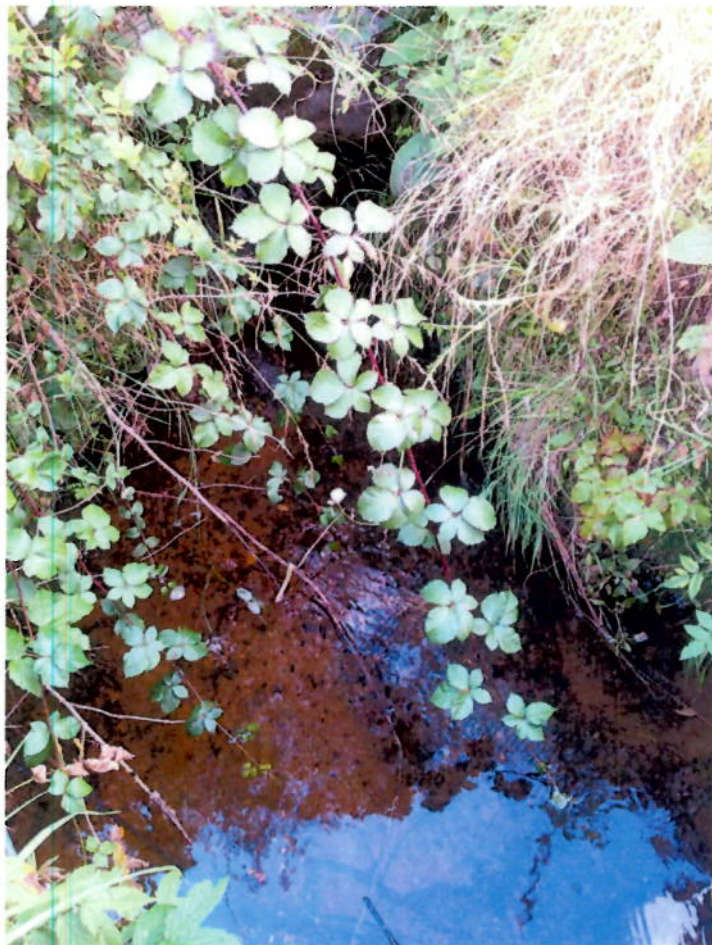
- i. **Sludge and washwater waste produced from the water treatment process is discharged to the nearby stream. Irish Water is requested to cease this practice and submit a timeframe for cessation of the discharge.**

<b>9.</b>	<b>Sludge Management</b> <p>a. The sludge facility built on-site does not work and therefore the sludge bleeds from the clarifiers are discharged to the nearby stream ( see Photo 4) and onto the estuary. A number of options (e.g. pipe sludge to a WWTP facility, treat sludge on-site for which there is planning for) are to be assessed to arrive at the best solution for treatment and disposal of this waste.</p>

**Photo 4 Stream receiving sludge and wash water wastes from plant**

2. The Water Services Authority should review current methods of handling and disposal of water treatment sludge to ensure that the practice is not in contravention of the *Waste Management Act, 1996-2003*. The discharge of water treatment sludge to receiving water, where practiced, should cease without delay. The Water Services Authority is requested to submit a timeframe for the cessation of the discharge of water treatment sludge to receiving waters and submit any Q-values / water quality of the stream to indicate if the discharge over time has had any negative impact on the receiving waters.
