Drinking Water Audit Report

County:	Donegal	Date of Audit:	21 August 2014
Plant(s) visited:	Rosses Regional PWS (Crolly WTP)	Date of issue of Audit Report:	19 September 2014
		File Reference:	DW2013/88
		Auditors:	Ms Derval Devaney
Audit Criteria:	<ul style="list-style-type: none"> • The <i>European Union (Drinking Water) Regulations 2014 (S.I. 122 of 2014)</i>. • The <i>EPA Handbook on the Implementation of the Regulations for Water Services Authorities for Public Water Supplies (ISBN: 978-1-84095-349-7)</i> • The recommendations specified in the EPA Report on <i>The Provision and Quality of Drinking Water in Ireland</i>. • The recommendations in any previous audit reports.

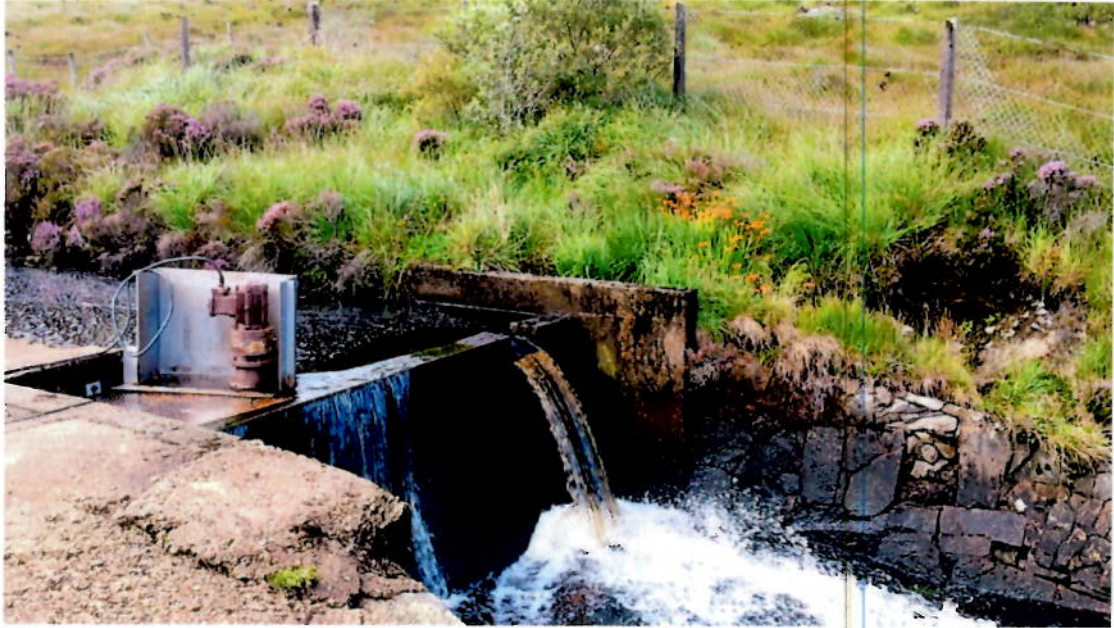
1.	<p>Source Protection</p> <ul style="list-style-type: none"> a. The Lough Keel stream is main source of the supply which is abstracted close to the plant (at 165 m³/hr – max capacity 180 m³/hr). There are rotating mechanical screens at the streams intake point (see Photo 1) and the direct abstraction area was fenced to prohibit animal (e.g. sheep) access. b. The original source for the supply from Lough Keel is still in use with abstraction rate of 35 m³/hr (max. capacity is 45 m³/hr) which has a catchment that appears to have limited habitation and agricultural use (see Photo 2). Water is also piped from the lake to the Lough Keel stream and any overflow from the weir (see Photo 3a and 3b) from the lake also flows into this stream which is abstracted further downstream as outlined in Point 1 above. c. The stream is a flashy source and temperature fluctuates. The piped stream water flows by gravity to the raw water tank near the abstraction point and the lake source is piped directly to the plant. The combined flow to the plant, rises to the contact tank at 200 m³/hr. The plant's capacity is 225 m³/hr. d. The source in general has a low alkalinity, low turbidity, a pH of 5.9 and can have elevated colour. There is a turbidity meter on the raw water and it read 1.04 NTU on the day of the audit.

Photo 1 Water abstraction point from Lough Keel Stream

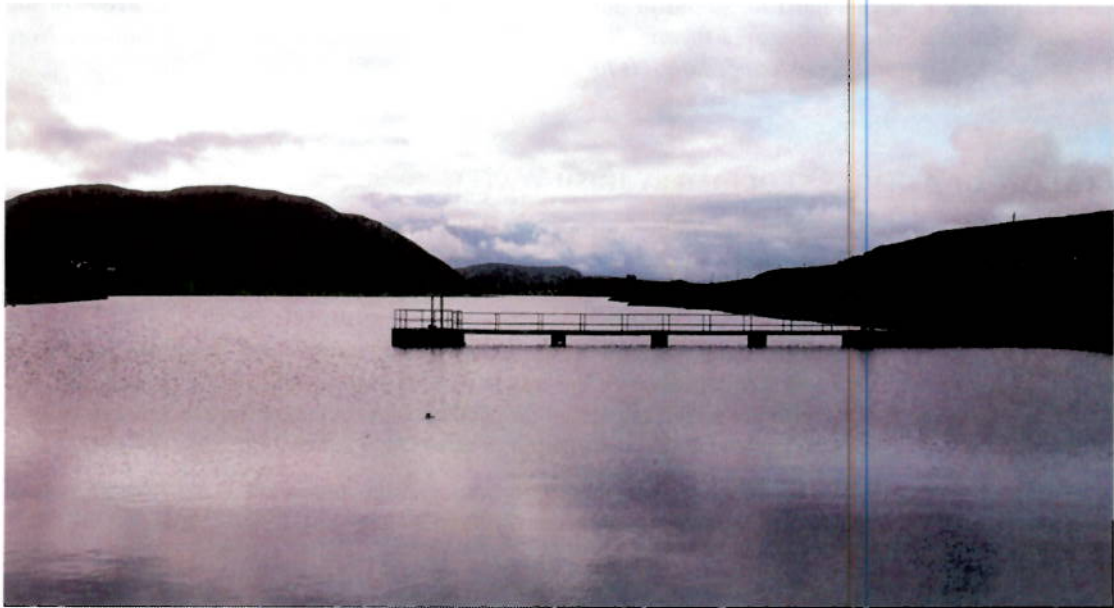
Photo 2 Water abstraction point from Lough Keel

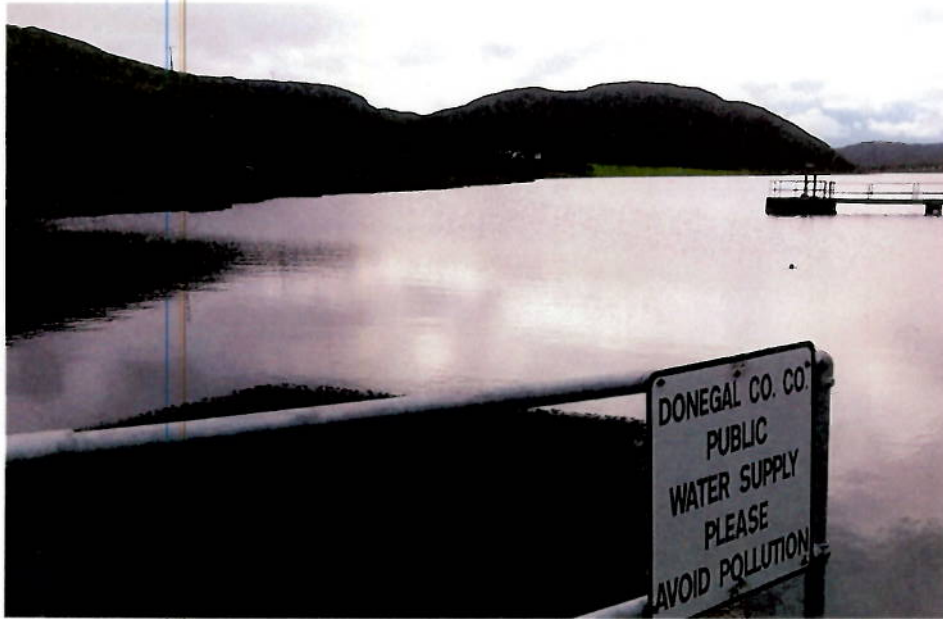
Photo 3a Weir at Lough Keel, where overflow feeds Lough Keel stream

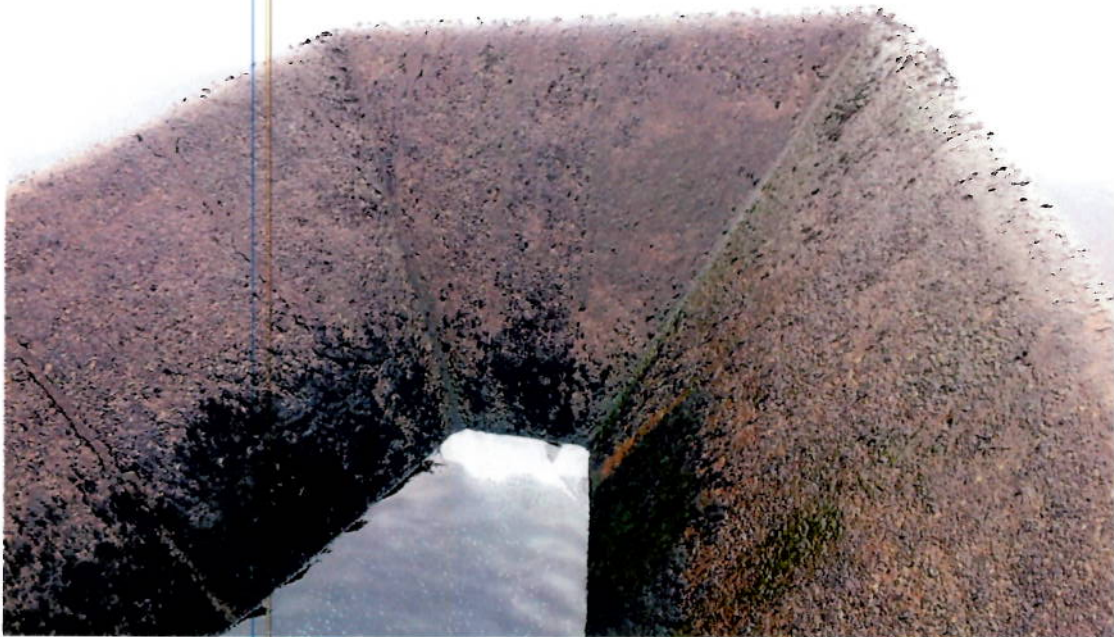
Photo 3b Overflow weir at Lough Keel

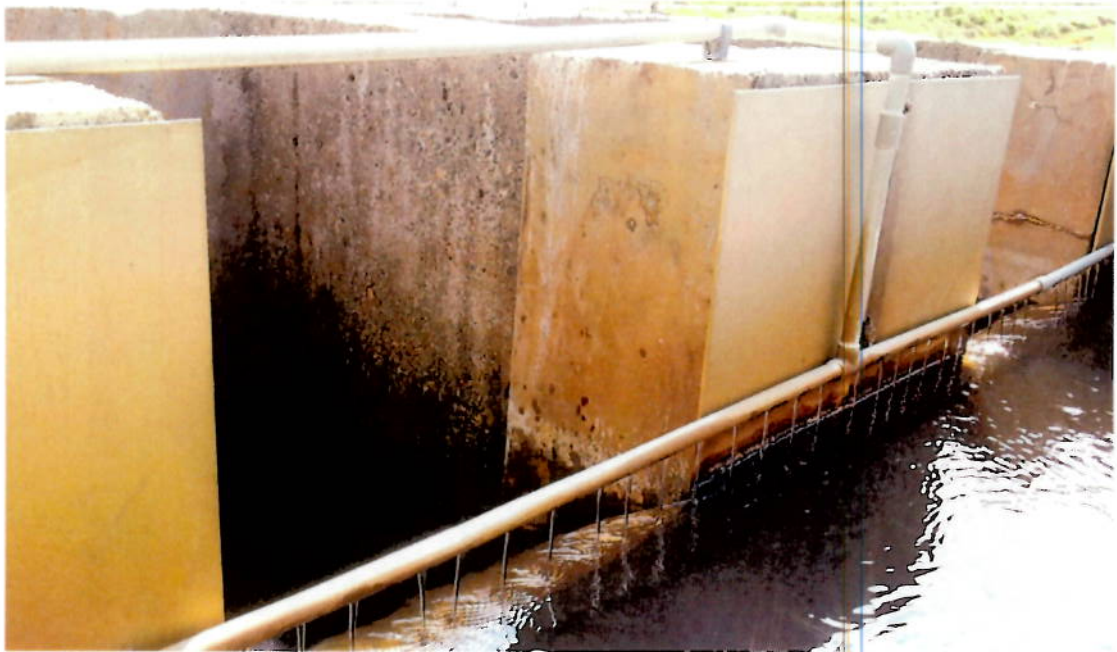
Photo 4 Poly being dosed in contact tank prior to clarifiers

1. The Water Services Authority should carry out an investigation to identify the cause of floc carryover from the clarifier into the filters. In this regard the Water Services Authority shall consult Table 2 on Page 41 of the EPA publication "*Water Treatment Manual: Coagulation, Flocculation and Clarification*" and investigate the use and management of polyelectrolyte and pH correction in line with the designed plant's operating procedures. The cascade system in place post addition of poly should be investigated to ensure it does not result in the break-up of flow post clarification.

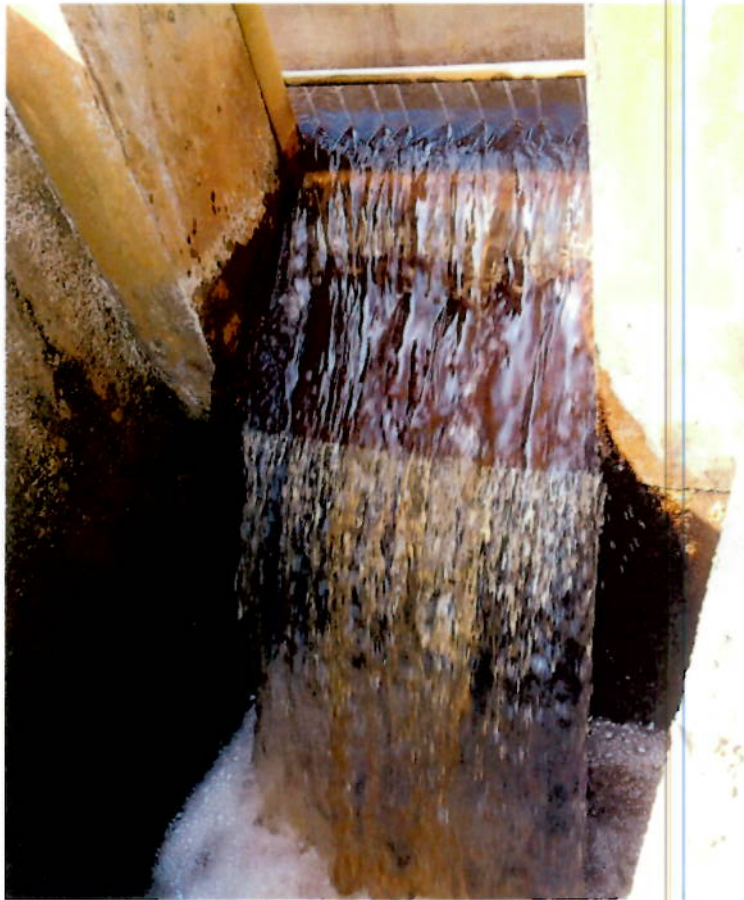
Photo 5 Cascade post contact tank prior to entry to clarifiers
