Drinking Water Audit Report

County:	Dublin	Date of Audit:	19 th July 2018
Plant visited:	Ballyboden Water Treatment Plant and Reservoir Scheme Code 0700PUB1002	Date of issue of Audit Report:	8 th August 2018
		File Reference:	DW2010/127
		Auditors:	Aoife Loughnane Michelle Minihan
Audit Criteria:	<ul style="list-style-type: none"> • The <i>European Union (Drinking Water) Regulations 2014 (S.I. 122 of 2014), as amended.</i> • <i>The EPA Handbook on the Implementation of the Regulations for Water Services Authorities for Public Water Supplies (ISBN: 978-1-84095-349-7)</i> • The recommendations specified in the <i>EPA Drinking Water Report.</i> • EPA Drinking Water Advice Notes No.s 1 to 15. • The recommendations in any previous audit reports.

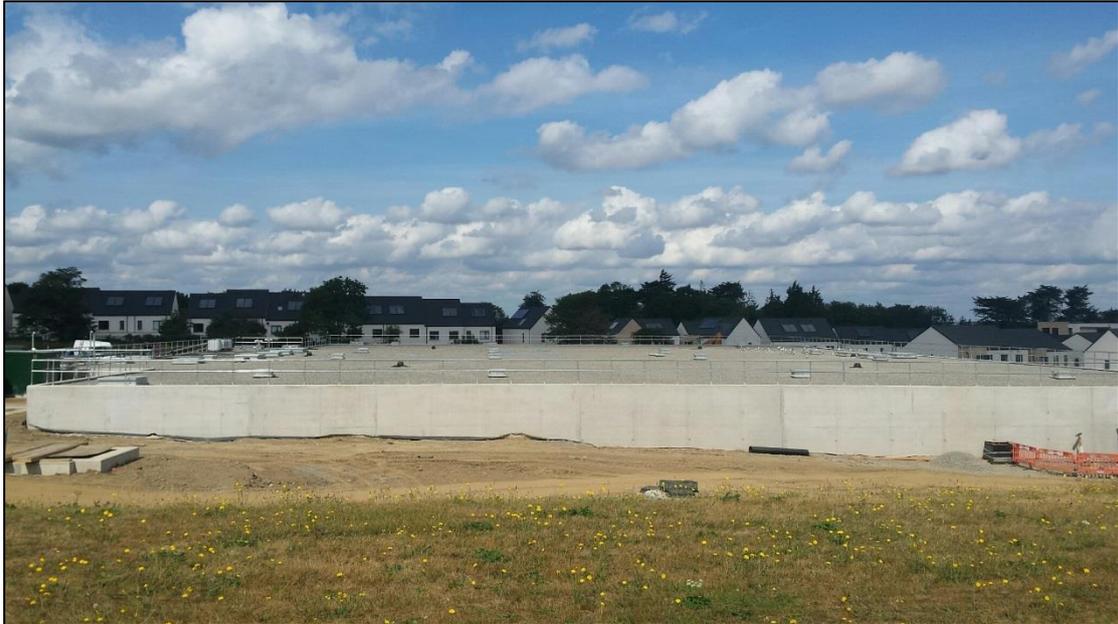
from Ballymore Eustace water treatment plant in the open storage reservoir at Ballyboden, after which it is re-chlorinated before entering distribution. A new covered reservoir has been built at Ballyboden, as required by EPA Direction. The reservoir is fully commissioned and a proportion of the drinking water supply to the Greater Dublin Area has been delivered through covered storage since early July 2018.

Photo 1: New covered storage reservoir at Ballyboden water treatment plant

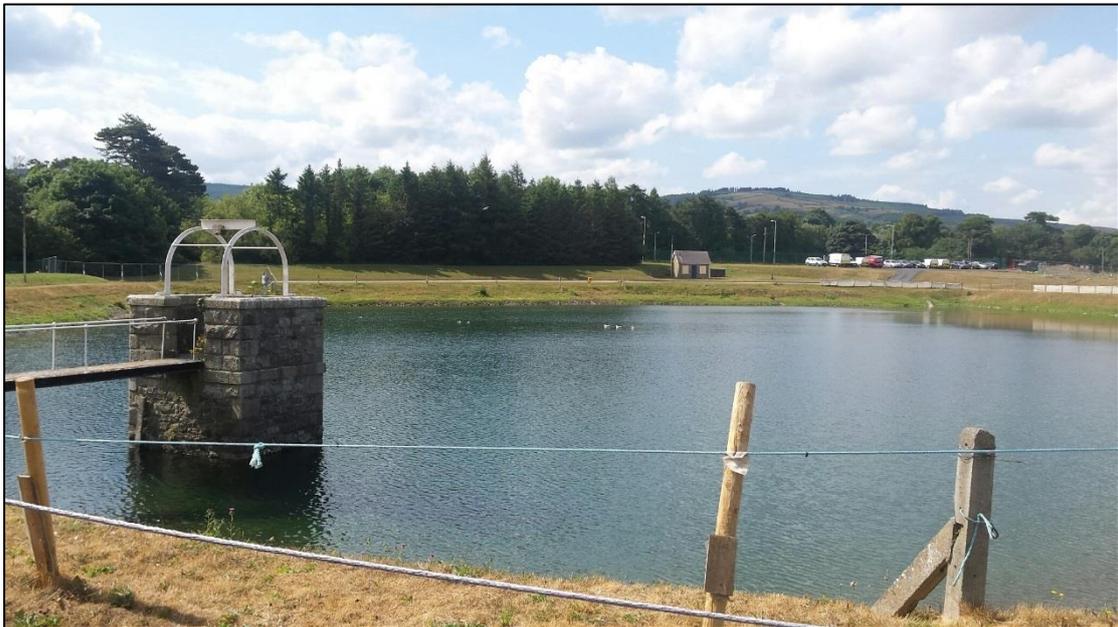
However, on the day of the audit the open storage pond was still in use for treated water storage, and Irish Water confirmed it has not yet been possible to completely cease this arrangement due to operational issues with pumping arrangements in the downstream network. To mitigate the risk of loss of supply to consumers, Irish Water is not yet able to fully cease the use of open storage of treated water, but expects to do so in the coming days. Ballyboden public water supply will remain on the EPA's Remedial Action List until the open storage of treated drinking water has ceased.

Photo 2: Open storage of treated water still in use on the day of the audit (note birds present on water surface)

1. Irish Water should ensure the remaining works to enable the cessation of open storage of treated water at Ballyboden water treatment plant are completed as soon as possible. Irish Water should notify the EPA as soon as the open storage arrangement has ceased.

2. Irish Water should continue the monitoring programme for *Cryptosporidium* and *Giardia* in the final blended water for at least two months following the cessation of open storage, to verify the microbiological quality of water entering the distribution network.

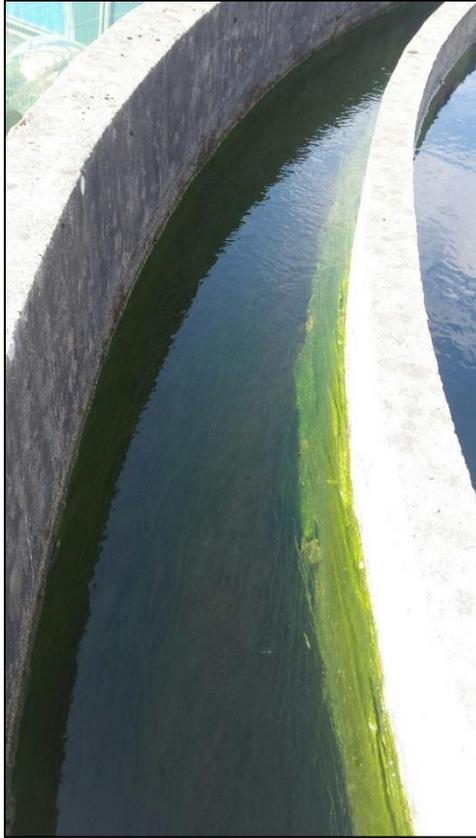
Photo 3: Algal growth on outlet channel in clarifier

3. Irish Water should ensure that the settled water outlet channels and the clarifier are cleaned on a regular basis to prevent build-up of algae on the weirs and on the walls of the clarifier.

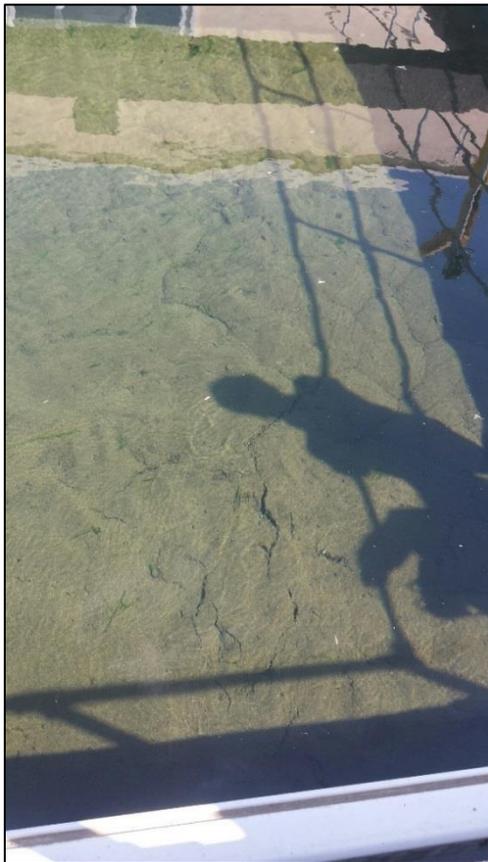
Photo 4: Cracks in filter media (Filter No. 5)

4. Irish Water should investigate the cause of the cracks in the filter media and should take appropriate action to optimise the operation of the filters. A sand depth level indicator should be installed in the filters.
