# Drinking Water Audit Report

<b>County:</b>	Dublin City	<b>Date of Audit:</b>	24 <sup>th</sup> February 2017
<b>Plant(s) visited:</b>	Vartry Water Treatment Plant	<b>Date of issue of Audit Report:</b>	6 <sup>th</sup> March 2017
		<b>File Reference:</b>	DW2009/397
		<b>Auditors:</b>	Ms. Michelle Roche
<b>Audit Criteria:</b>	<ul style="list-style-type: none"> <li>• The <i>European Union (Drinking Water) Regulations 2014 (S.I. 122 of 2014)</i>.</li> <li>• The <i>EPA Handbook on the Implementation of the Regulations for Water Services Authorities for Public Water Supplies (ISBN: 978-1-84095-349-7)</i></li> <li>• The recommendations specified in the <i>EPA Drinking Water Report</i>.</li> <li>• EPA Drinking Water Advice Notes No.s 1 to 15.</li> <li>• The recommendations in any previous audit reports.</li> </ul>

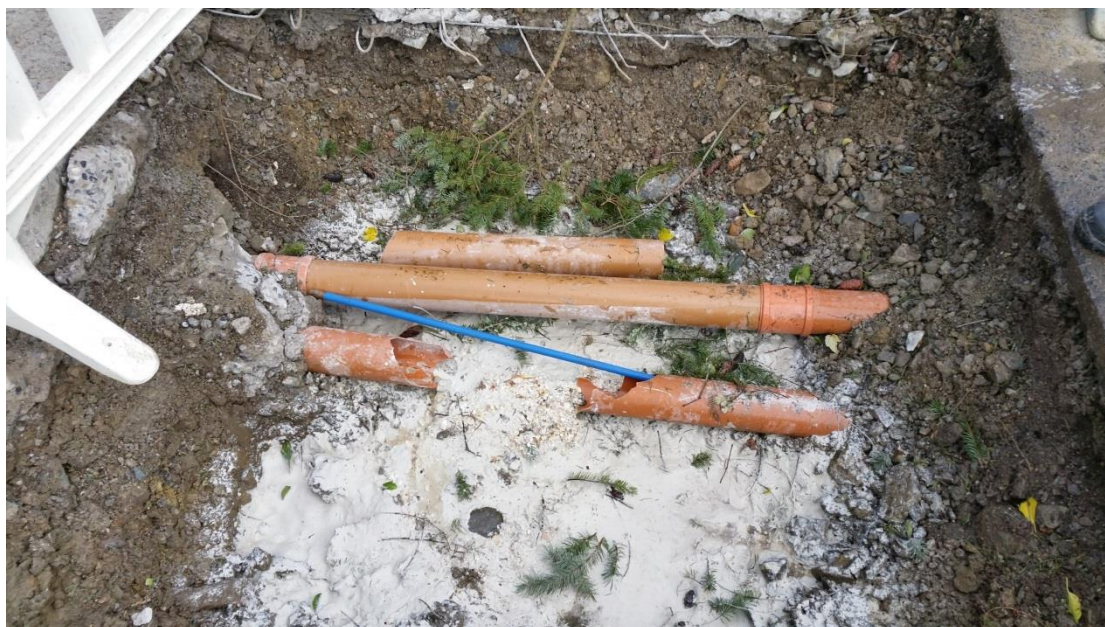
- i. Irish Water's investigation into the incident concluded that the lime discharge to the Vartry River occurred due to an historic connection between a lime slurry drainage pipe and a surface water drainage pipe.
- ii. Irish Water should verify that the connection between the two pipes is the only pathway for lime slurry discharge to the Vartry River.
- iii. Irish Water should verify that the remedial works to permanently disconnect the two pipes are successfully completed.

The audit found that management of the pH dosing system at the Vartry water treatment plant is satisfactory. The discharge of lime to the Vartry River was due to an historic issue with the drainage infrastructure at the plant. This drainage infrastructure was in the process of being upgraded at the time of the audit and the works will be validated using dye tracer before the drainage pipes are brought back into use. Vartry water treatment plant staff reacted quickly to the incident to minimise the impact of lime discharge to the Vartry River.

**Photograph 1: Remedial works to lime slurry drainage and surface water drainage pipes.**

1. Irish Water should confirm that;
  - i. The connection between the lime slurry drainage pipe and the surface water drainage pipe was the only pathway for the lime slurry discharge to the site overflow channel and subsequently to the Vartry River.

- ii. The works to upgrade the drainage pipes and permanently disconnect the two pipes are complete and the quality of the works is validated.
