# Drinking Water Audit Report

<b>County:</b>	Dublin City	<b>Date of Audit:</b>	12 <sup>th</sup> May 2016
<b>Plant(s) visited:</b>	Vartry Reservoir	<b>Date of issue of Audit Report:</b>	16 <sup>th</sup> May 2016
		<b>File Reference:</b>	DW2009/397
		<b>Auditors:</b>	Mr. Darragh Page Ms Michelle Roche Mr Conor Waters
<b>Audit Criteria:</b>	<ul style="list-style-type: none"> <li>• The <i>European Union (Drinking Water) Regulations 2014 (S.I. 122 of 2014)</i>.</li> <li>• The <i>EPA Handbook on the Implementation of the Regulations for Water Services Authorities for Public Water Supplies (ISBN: 978-1-84095-349-7)</i></li> <li>• The recommendations specified in the <i>EPA Drinking Water Report</i>.</li> <li>• EPA Drinking Water Advice Notes No.s 1 to 15.</li> <li>• The recommendations in any previous audit reports.</li> </ul>

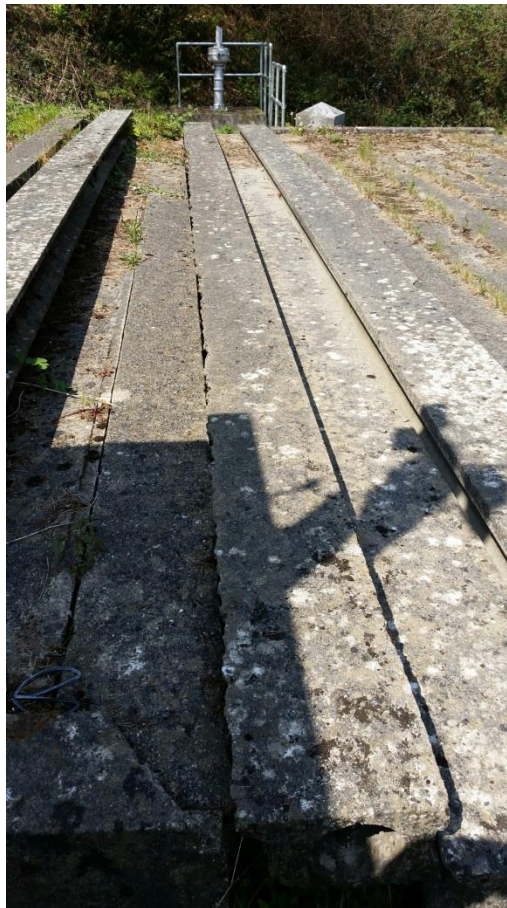
was possible through the gaps in the concrete slats (see Photo 1).
<b>3.</b>	<p><b>Filtration</b></p> <ol style="list-style-type: none"> <li>a. The filters are operated for a period of approximately 6 weeks (depending on raw water quality) before being skimmed and brought back into service.</li> <li>b. Once the filters have been skimmed and cleaned they are refilled and run to waste for a period of time. The turbidity levels are examined from the turbidity monitors and once the levels are &lt;0.5 NTU the filters are brought back into service. Mr. Fleming reported that different filters taken different lengths of time to come back into service depending on how quickly the levels return below 0.5 NTU. The results were observed on the SCADA and confirmed that this is the practice in place. The turbidity monitors are also alarmed if the turbidity goes above 1.0 NTU for more than 15 mins.</li> <li>c. Spot samples are collected from different filters each day to check that the levels reported on the monitors are accurate.</li> <li>d. At the time of the audit the calibration of the turbidity monitors was overdue and should have been carried out by 4<sup>th</sup> March 2016.</li> <li>e. During the previous audit the collection chamber on the older filters were leaking and ingress into the chambers was observed on the three filters examined. Remedial works have since been carried out on these and leaks are no longer occurring.</li> </ol>

Photo 1. Cover of the Callow Hill Break Pressure Tank

4. Irish Water should ensure that ingress into the Callow Hill break pressure tank is prevented and that the necessary remedial works are carried out to the cover to prevent such ingress.
