Drinking Water Audit Report

County:	Dun Laoghaire	Date of Audit:	16/11/2018
Plant visited:	DLR Zone 4 PWS - Glencullen water treatment plant and reservoir	Date of issue of Audit Report:	07/12/2018
		File Reference:	DW2018/188
		Auditor:	Aoife Loughnane
Audit Criteria:	<ul style="list-style-type: none"> • The <i>European Union (Drinking Water) Regulations 2014 (S.I. 122 of 2014)</i>, as amended. • The <i>EPA Handbook on the Implementation of the Regulations for Water Services Authorities for Public Water Supplies (ISBN: 978-1-84095-349-7)</i> • The recommendations specified in the <i>EPA Drinking Water Report</i>. • EPA Drinking Water Advice Notes No.s 1 to 15.

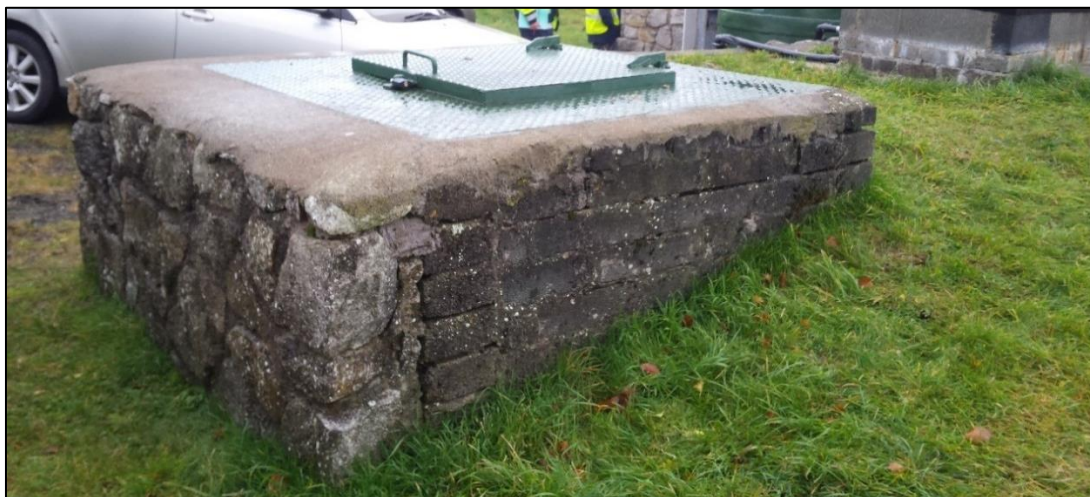
Photo 1: Borehole chamber at Glencullen water treatment plant
