Drinking Water Audit Report

County:	Fingal	Date of Audit:	8 th November 2019
Plant visited:	Leixlip Water Treatment Plant	Date of issue of Audit Report:	13 th November 2019
		File Reference:	DW2019/188
		Auditors:	Aoife Loughnane Michelle Minihan Darragh Page
Audit Criteria:	<ul style="list-style-type: none"> • The <i>European Union (Drinking Water) Regulations 2014 (S.I. 122 of 2014)</i>, as amended. • The <i>EPA Handbook on the Implementation of the Regulations for Water Services Authorities for Public Water Supplies (ISBN: 978-1-84095-349-7)</i> • The recommendations of the EPA's previous audits at Leixlip water treatment plant on 24th October 2019 and 22nd March 2019.

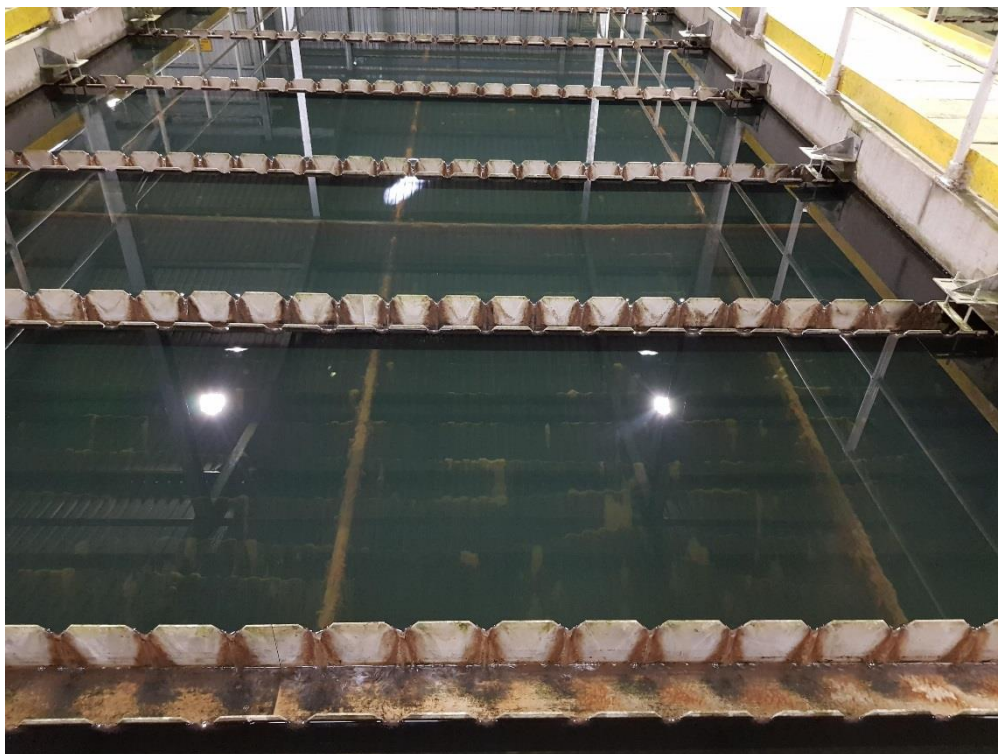
3.	<p>Coagulation, Flocculation & Clarification</p> <ul style="list-style-type: none"> a. The need for pH correction (sulphuric acid dosing) to ensure optimum coagulation was identified in the EPA's audit in March 2019. During this audit, Irish water could not identify the timeframe for this improvement, but stated that it was being re-prioritised. b. The clarifiers at the MMcP plant appeared to be in poor condition, with visibly damaged/collapsed lamella plates (see photo 1) which means the clarification process is not performing optimally. Pin floc was visible rising to the surface of the clarifiers, leading to floc carryover from the clarifiers to the filters.

The absence of pH correction prior to coagulation and the current condition of the clarifiers means the clarification process is not operating optimally and will reduce the effectiveness of the filter upgrades.

Photo 1: Clarifier in poor condition with visibly damaged/collapsed lamella plates at MMcP plant

5. Irish Water should review the operation of the clarifiers and replace the damaged lamella plates, to ensure the clarification process is optimised.
