<h1>Drinking Water Audit Report</h1>
---	--------------------------------------

County:	Fingal	Date of Audit:	24 th October 2019
Plant visited:	Leixlip Water Treatment Plant	Date of issue of Audit Report:	30 th October 2019
		File Reference:	DW2019/188
		Auditors:	Aoife Loughnane Michelle Minihan
Audit Criteria:	<ul style="list-style-type: none"> • The <i>European Union (Drinking Water) Regulations 2014 (S.I. 122 of 2014)</i>, as amended. • The <i>EPA Handbook on the Implementation of the Regulations for Water Services Authorities for Public Water Supplies (ISBN: 978-1-84095-349-7)</i> • The recommendations of the EPA's previous audit at Leixlip water treatment plant on 22nd March 2019.

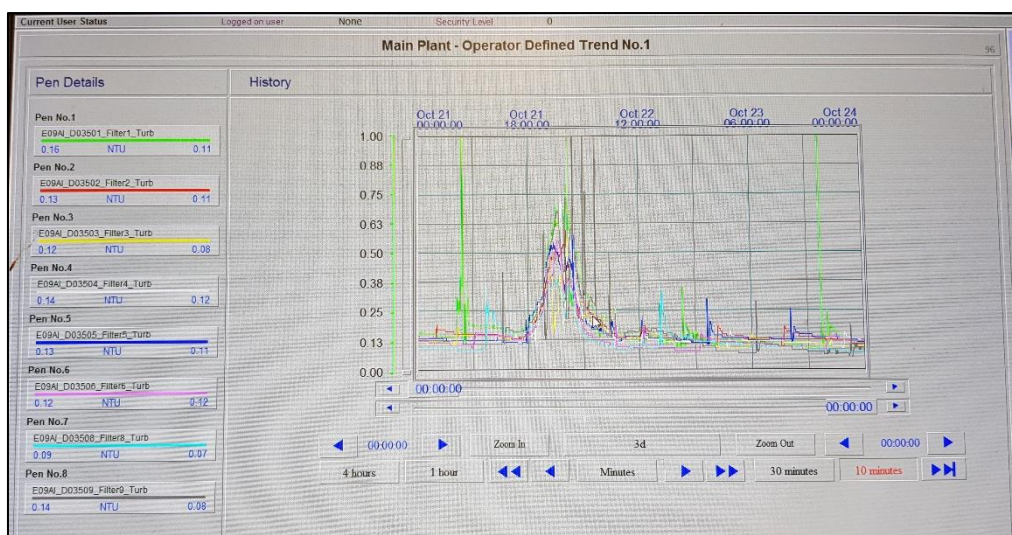
- ii. A blockage in the alum (coagulant) dosing line which occurred at Leixlip water treatment plant on 21/10/19 resulted in operational difficulties with the clarification and filtration processes, and gave rise to elevated turbidity levels in treated water. This indicated a significant risk to the safety of the water supply because the treatment barriers for the removal of *Cryptosporidium*/*Giardia* were compromised, and there was a risk of breakthrough of microscopic parasites into the water supply.

Photo 1: SCADA graph showing the impact on filtered water turbidity levels at the PCI plant following the blockage of the alum dosing line on 21/10/19. The treatment barriers to remove *Cryptosporidium*/*Giardia* are compromised when the turbidity increases above 0.2 NTU.

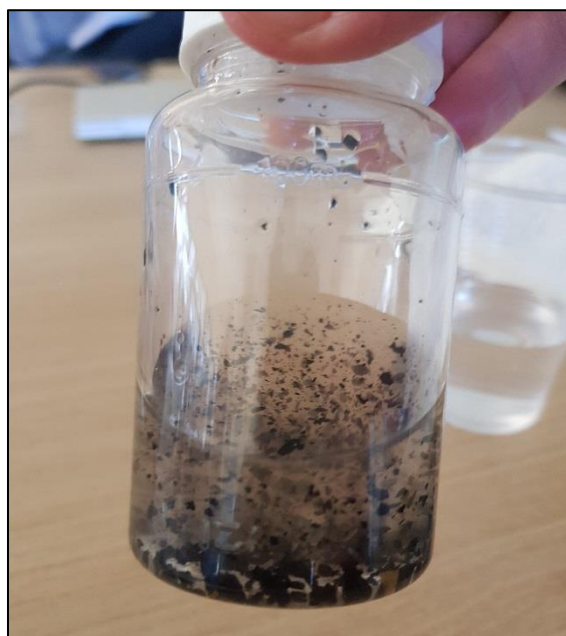
<ul style="list-style-type: none"> Identifying the need for cleaning and repair of alum storage tanks to prevent flakes of lining material causing further blockages. Arrangements are being made to drain down each alum tank to allow for inspection, cleaning & repair. This means that only one alum tank is in use for the PCI & MMcP plants, i.e. two weeks alum storage instead of one month. <p>k. Irish Water confirmed that the main reservoirs supplied by Leixlip water treatment plant, Ballycoolin, Peamount and Ballygoran reservoirs, have not been cleaned recently but will now be added to the Reservoir Cleaning Programme.</p>

Photo 2: Sample of black particles which caused blockage of alum dosing line, which are thought to originate from the disintegrating lining of the alum storage tanks

5. Irish Water and Fingal County Council should clean and repair, or completely replace, the alum storage tanks serving the PCI and MMcP plants, in order to prevent a further blockage of the coagulant dosing lines by the disintegrating lining material. Until the tanks are repaired or replaced, Irish Water and Fingal County Council must ensure increased vigilance, to prevent a reoccurrence of the alum dosing incident on 21/10/19.
