Drinking Water Audit Report

County:	Galway	Date of Audit:	5 th April 2016
Plant visited:	Ahascragh PWS Scheme code 1200PUB1001	Date of issue of Audit Report:	11 th April 2016
		File Reference:	DW2016/55
		Auditors:	Aoife Loughnane Conor Waters (intern)
Audit Criteria:	<ul style="list-style-type: none"> • The <i>European Union (Drinking Water) Regulations 2014 (S.I. 122 of 2014)</i>. • The <i>EPA Handbook on the Implementation of the Regulations for Water Services Authorities for Public Water Supplies (ISBN: 978-1-84095-349-7)</i> • The recommendations specified in the <i>EPA Drinking Water Report 2014</i>. • EPA Drinking Water Advice Notes No.s 1 to 15.

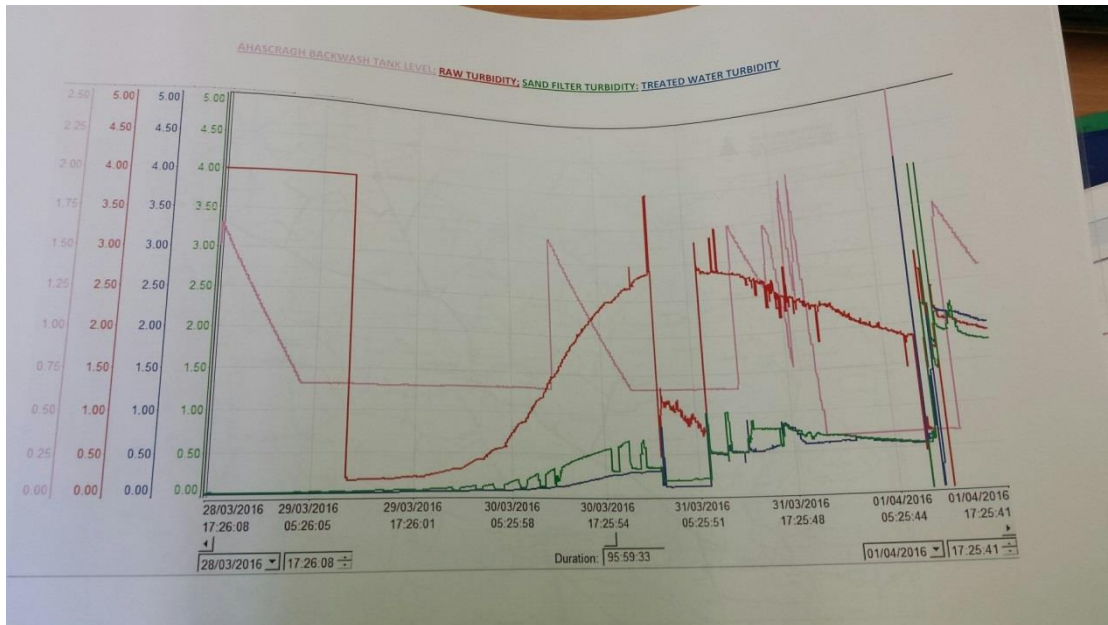
1.	<p>Turbidity exceedance – Investigations and actions</p> <p>a. Raw water in the spring source is monitored continuously for turbidity, colour and pH. The plant caretaker stated that the normal levels are 0.1 NTU, 4 - 6 Hazen and 6.7 - 6.8 pH. SCADA data from December 2015 to March 2016 was provided by Irish Water following the audit. The raw water quality remained relatively stable during that period despite a number of heavy storms (average turbidity 0.22 NTU, average colour 7.98 Hazen and average pH 6.6).</p> <p>b. There was a sudden change in raw water quality at the end of March 2016 (see SCADA data in photo 1) which led to a treated water turbidity of 2.8 NTU at the plant, which is an exceedance of the parametric value (1 NTU). The following timeline of events was identified by Irish Water and Galway County Council (GCC):</p> <ul style="list-style-type: none"> • Tuesday 29th March: At 8:30 am the raw water turbidity was 3.9 NTU. The caretaker cleaned the turbidity monitor and the reading dropped to 0.1 NTU. Later that evening it was reading 0.3 NTU. • Wednesday 30th March: At 8:30 am the raw water turbidity was 1.4 NTU, colour was 18 Hazen and treated water was 0.3 NTU. At 11:00 pm the treated water turbidity alarm (1 NTU) was triggered and the plant automatically shut down. The caretaker visited the plant and confirmed that the UV system had stayed in validation. The turbidity monitor was cleaned and turbidity fell to 0.2 NTU. • Thursday 31st March: At 1:00 am the plant was switched back on and stayed operating until 7:00 am when the plant shut-down again on high turbidity alarm in the treated water. The caretaker cleaned the turbidity monitor but there was no significant improvement in turbidity. <p>The incident was escalated within GCC and Irish Water. EPS were called to the site to check instruments and process operations.</p>

Photo 1: SCADA trend of raw turbidity (red line), filtered turbidity (green line) and treated water turbidity (blue line) from 28th March to 1st April 2016.

2. Irish Water should take action as necessary to ensure that water with turbidity > 1 NTU does not enter the contact tank at Ahascragh water treatment plant.

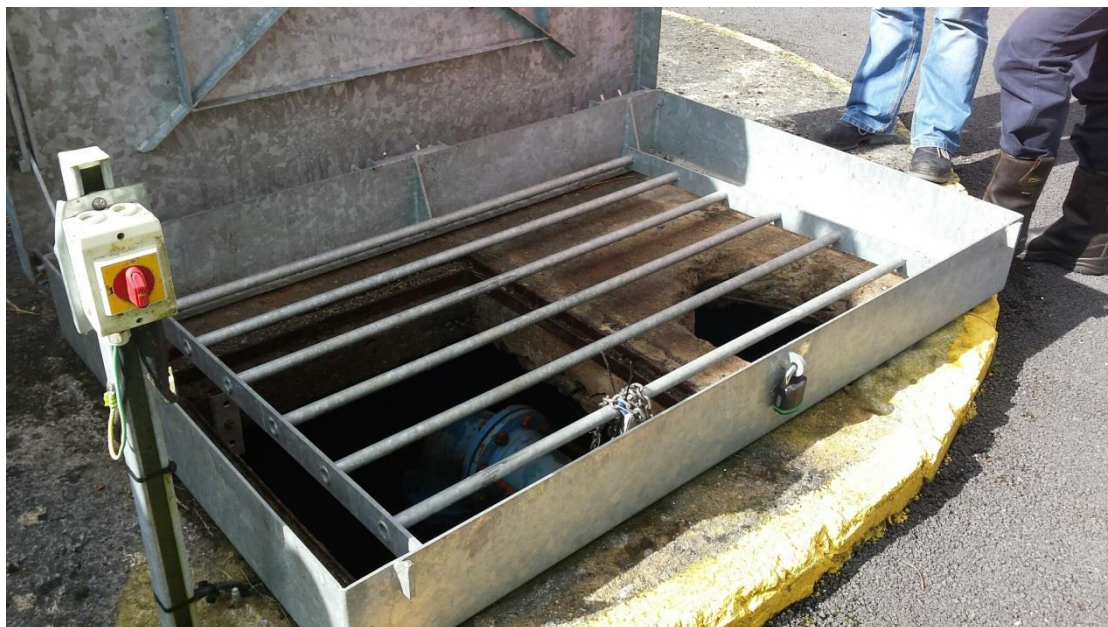
<p>3.</p>	<p>Source Protection</p> <ol style="list-style-type: none"> a. The spring source is located adjacent to the Ahascragh River. There was no evidence of surface water ingress into the spring chamber (see photo 2). GCC representatives stated that the spring is not directly connected to the river and that recent flooding in the area in Winter 2015/2016 did not affect the spring water quality. b. The report <i>Water Framework Directive Groundwater Monitoring Report – Site Information Ahascragh PWS, EPA August 2011</i> identifies that; <ul style="list-style-type: none"> • the spring chamber is less than 3 metres deep (depth to bedrock), • the spring may receive water from three potential sources; river (discounted by GCC), bedrock and shallow sediments, • the estimated zone of contribution is 1.14 km² covering Ahascragh village and agricultural lands, • the aquifer classification is Rkc – regionally important karstified bedrock dominated by conduit flow. c. GCC stated that the raw water quality is consistently good, with turbidity usually less than 0.1 NTU. d. The treatment plant’s pre-chlorination facility to remove iron and manganese from the raw water has not been used since the plant was upgraded in June 2011. GCC stated that there have been no issues with elevated iron or manganese concentrations in the supply.

Photo 2: Spring abstraction chamber

1. Irish Water should complete the investigation into the cause of the sudden change in raw water quality at Ahascragh water treatment plant and submit a report to the Agency, to include the hydrogeologist's findings and recommendations regarding the spring source.

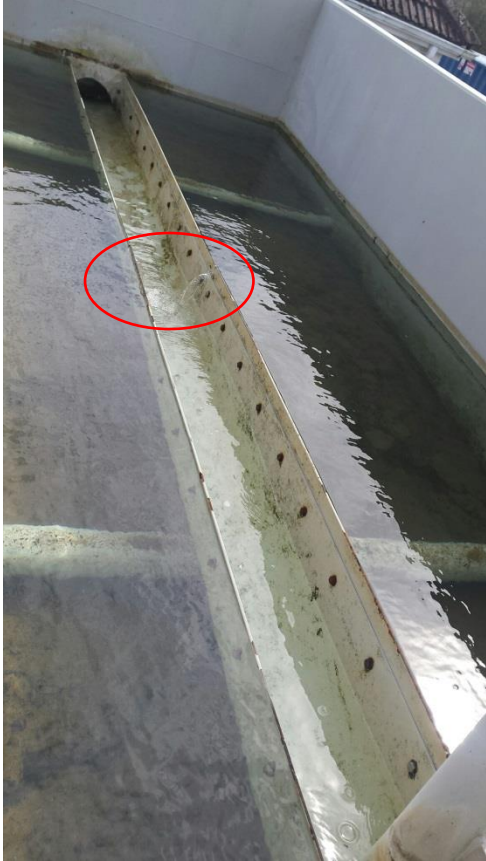
<p>4.</p>	<p>Filtration</p> <ol style="list-style-type: none"> a. A rapid gravity sand filter was installed in June 2011 to remove the solids generated from the oxidation of iron and manganese by pre-chlorination (no longer carried out at the plant). b. The filter contains 1 m of silica sand which includes a layer of manganese dioxide, according to the filter design specification document. c. The maximum filtration rate is 6 m/hr. d. Filter backwashing is triggered by time (normally every 24 hours but currently increased to 8 hour intervals). The backwash sequence consists of: <ul style="list-style-type: none"> • Air scour: 30 m/hr for 5 minutes • Water wash: 20 m/hr for 10 minutes • Settlement: 5 minutes <p>The raw water pumps are then turned back on and take 5 minutes to ramp up to full capacity as they are variable speed drive pumps.</p> e. A backwash was observed during the audit. The air scour was even across the filter bed. There was an uneven flow of backwash water through gaps in the weir wall (see photo 3). f. The post-filter turbidity monitor was reading 0.659 NTU during the audit.

Photo 3: Wash water flowing through gaps in the weir wall.

- (ii) The operation of the filter incorporates a slow start or run to waste before the filter is brought back into service following a backwash; and
 - (iii) There is an even flow of backwash water across the top of the weir.

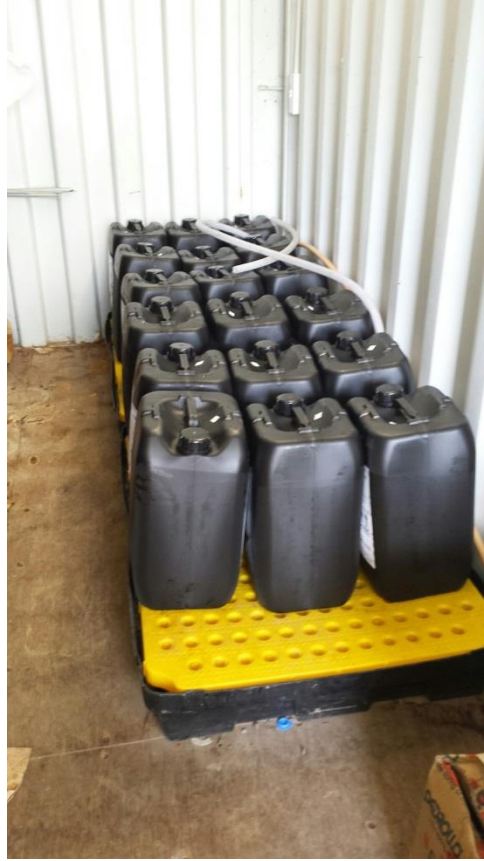
7.	<p>Chemical storage</p> <p>a. There were 18 x 25 litre drums of sodium hypochlorite with an expiry date of 11/04/16 on the labels (see photo 4) being stored at the plant. The caretaker confirmed that 4 drums per week are used in the chlorination system and the remaining 14 drums would not be used by their expiry date at this plant. GCC agreed to send the surplus drums to other chlorination systems in Galway for use before the expiry date.</p>

Photo 4: Sodium hypochlorite drums fast approaching expiry date (11/04/16)

6. Irish Water should inspect the contact tank and storage reservoirs in order to determine if they need to be cleaned out.
7. Irish Water should put a system in place so that stocks of chemicals kept on-site are regularly checked to see if they are in date.
