Drinking Water Audit Report

County:	Galway	Date of Audit:	14 March 2019
Plant(s) visited:	Ballinasloe Water Treatment Plant	Date of issue of Audit Report:	05 April 2019
		File Reference:	DW2009/175
		Auditors:	Ms Derval Devaney
Audit Criteria:	<ul style="list-style-type: none"> • The <i>European Union (Drinking Water) Regulations 2014 (S.I. 122 of 2014), as amended.</i> • <i>The EPA Handbook on the Implementation of the Regulations for Water Services Authorities for Public Water Supplies (ISBN: 978-1-84095-349-7).</i> • The recommendations specified in the <i>EPA Drinking Water Report.</i> • EPA Drinking Water Advice Notes No.s 1 to 15. • The recommendations in any previous audit reports.

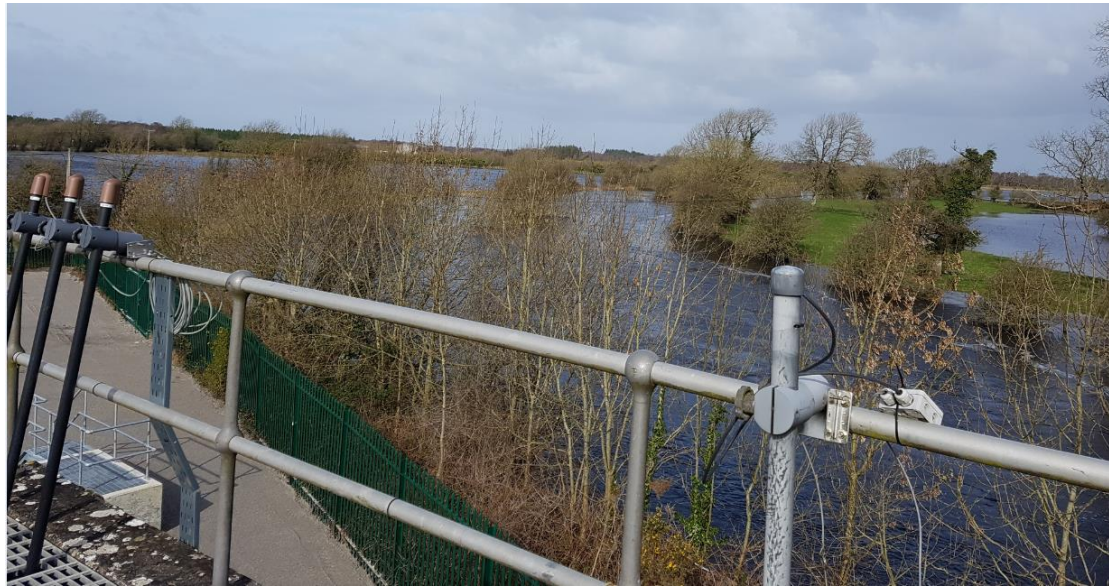
Photo 1 River Suck and Bunowen River burst its banks - water surrounds perimeter of water treatment plant due to flooding

9. Irish Water should ensure that there are adequate flood control measures in place to reduce or prevent detrimental effects of flood waters or high water levels on the water treatment plant.
10. Irish Water should confirm that the filter's turbidity monitors were calibrated during March 2019 as required.
11. Irish Water should update the Ballinasloe PWS & Associated Public GpWS map to reflect network connections from the PWS to these group water schemes and display the map at the water treatment works. Irish Water should ensure a communications procedure is in place setting out how the private supplies are informed in the event of an exceedance of a parametric value in the public water supply or water outage, which may have the potential to affect the group water schemes water quality or quantity.

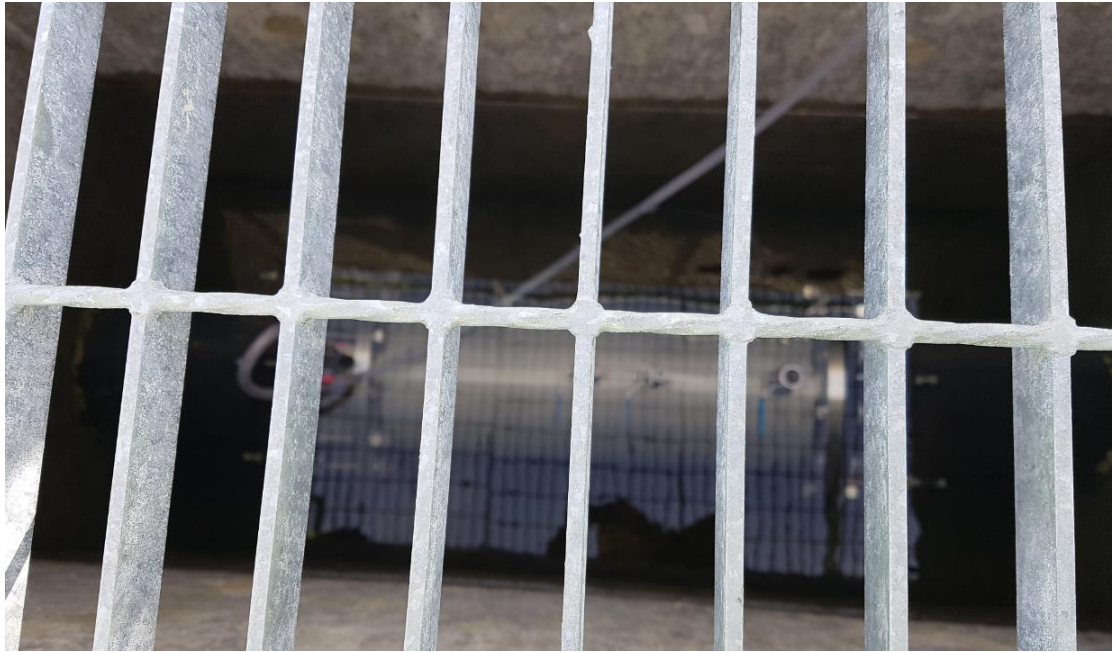
Photo 3 Rainwater has collected in the aluminium dosing point chamber and submerges the transfer pipe

8. Irish Water should ensure that water does not collect in the chamber housing the aluminium dose injection point.

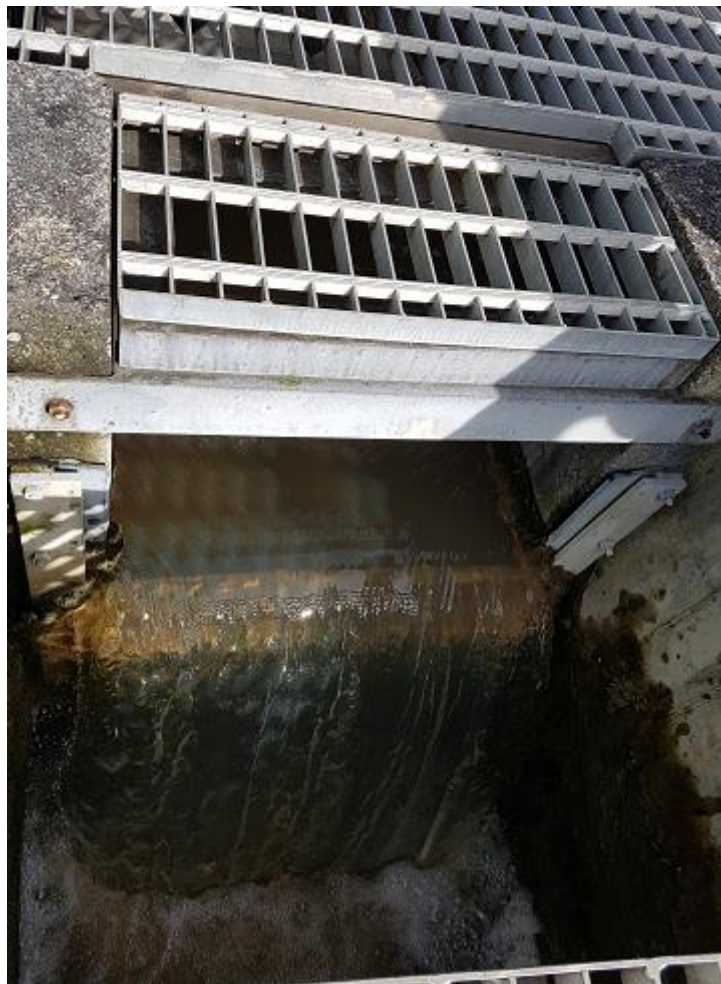
Photo 4 Weir post poly dose prior to entry to clarifiers

1. Irish Water should confirm that the weir post the addition of coagulant aid does not give rise to turbulent flows that interfere and break up floc already formed during the coagulation/flocculation process. In this respect, please refer to the EPA's Drinking Water Advice Note No. 15: Optimisation of Chemical Coagulant Dosing at Water Treatment Works which states weirs should not have a greater fall than 0.5 m, and water velocities should be less than 0.3 m/s, in order to ensure that floc are not broken.

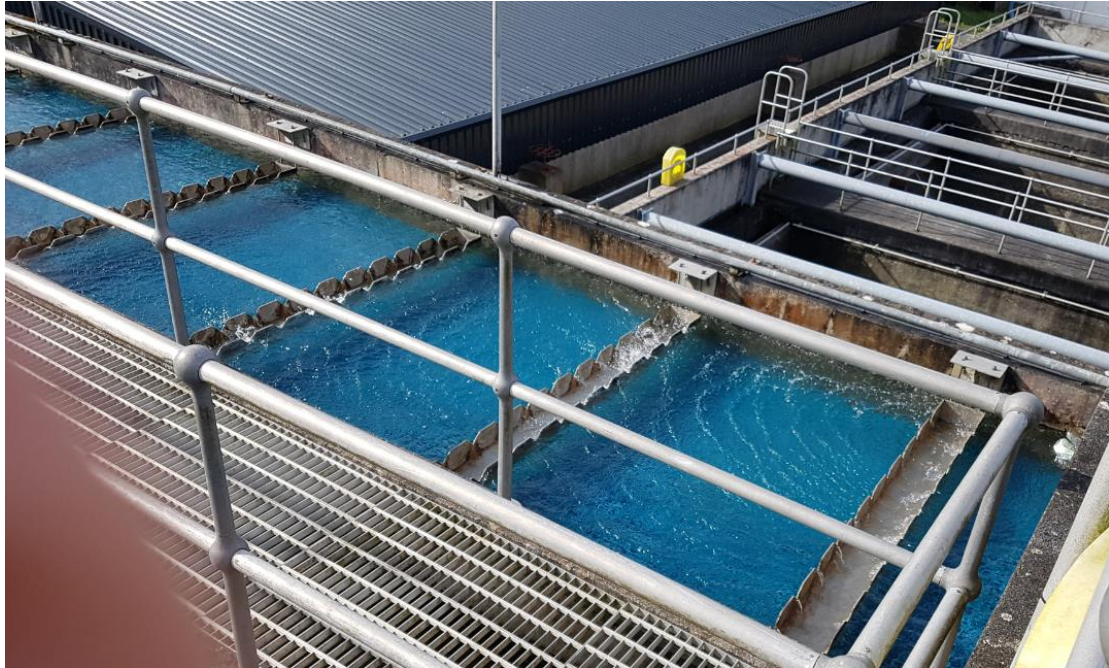
Photo 5 Strong winds producing surface water currents in the clarifier and affecting settled water entering decanting troughs

2. Irish Water should investigate, and if necessary take action, to ensure that strong winds do not lead to operational difficulties with the two open clarifiers (e.g. creating a circulating current leading to short circuiting, scouring of settled particles from the sludge zone, wind-induced turbulence, density currents, etc.) resulting in reduced settled water quality.
