Drinking Water Audit Report

County:	Galway	Date of Audit:	13 May 2014
Plant(s) visited:	Cineal Feicin PWS	Date of issue of Audit Report:	23 May 2014
		File Reference:	DW2014/6
		Auditors:	Mr. Darragh Page
Audit Criteria:	<ul style="list-style-type: none"> • The <i>European Union (Drinking Water) Regulations 2014 (S.I. 122 of 2014)</i>. • The <i>EPA Handbook on the Implementation of the Regulations for Water Services Authorities for Public Water Supplies (ISBN: 978-1-84095-349-7)</i> • The recommendations specified in the EPA Report on <i>The Provision and Quality of Drinking Water in Ireland</i>. • The recommendations in any previous audit reports.

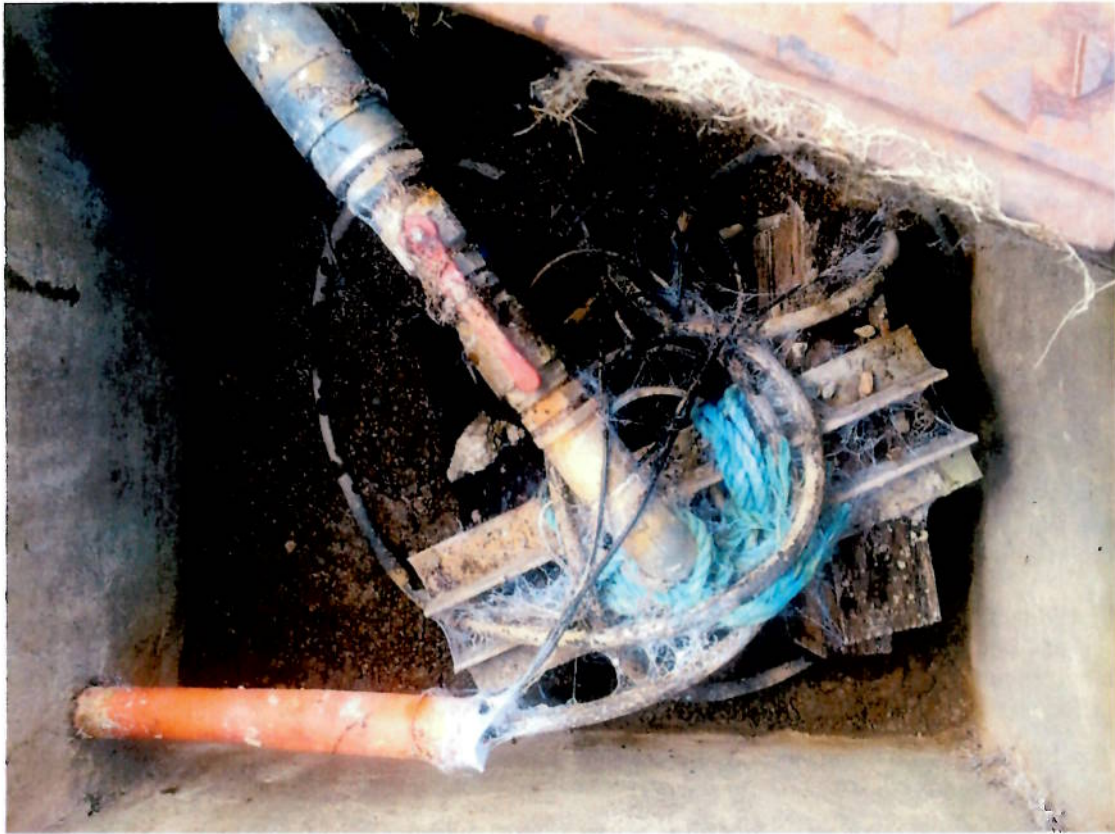
- i. The source of the Cineal Feicin PWS is in a poor location as it was constructed too close to a pre-existing farmyard and slatted slurry tank and therefore there is a risk of contamination. No assessment of the vulnerability of the source has been carried out. In the absence of this assessment and given the historical results (intermittent high turbidity and microbiological failures) it would appear that the treatment in place provides no barrier against *Cryptosporidium*, however further assessment of the borehole construction is necessary.

The source of the Cineal Feicin PWS is in a poor location as it was constructed too close to a pre-existing farmyard and slatted slurry tank and therefore there is a risk of contamination. Very little information was known about the well construction or the geology/hydrogeology by either Galway County Council or Irish Water. No assessment of the vulnerability of the source has been carried out. In the absence of this assessment and given the historical results (intermittent high turbidity and microbiological failures) it would appear that the treatment in place provides no barrier against *Cryptosporidium*, however further assessment of the borehole construction is necessary.

Photo 1. Borehole of the Cineal Feicin PWS (note no cover on borehole).

4. Irish Water should ensure that a cap is placed on the borehole to prevent ingress.
5. Irish Water should assess the borehole to determine if it is secure against surface water and shallow groundwater contamination.
