Drinking Water Audit Report

County:	Galway	Date of Audit:	31 st August 2016
Plant visited:	Glenamaddy Water Treatment Plant (scheme code 1200PUB1021)	Date of issue of Audit Report:	30 th September 2016
		File Reference:	DW2009/184
		Auditors:	Aoife Loughnane Emer Cooney
Audit Criteria:	<ul style="list-style-type: none"> • The <i>European Union (Drinking Water) Regulations 2014 (S.I. 122 of 2014)</i>. • The <i>EPA Handbook on the Implementation of the Regulations for Water Services Authorities for Public Water Supplies (ISBN: 978-1-84095-349-7)</i> • The recommendations specified in the <i>EPA Drinking Water Report</i>. • EPA Drinking Water Advice Notes No.s 1 to 15. • The recommendations in any previous audit reports.

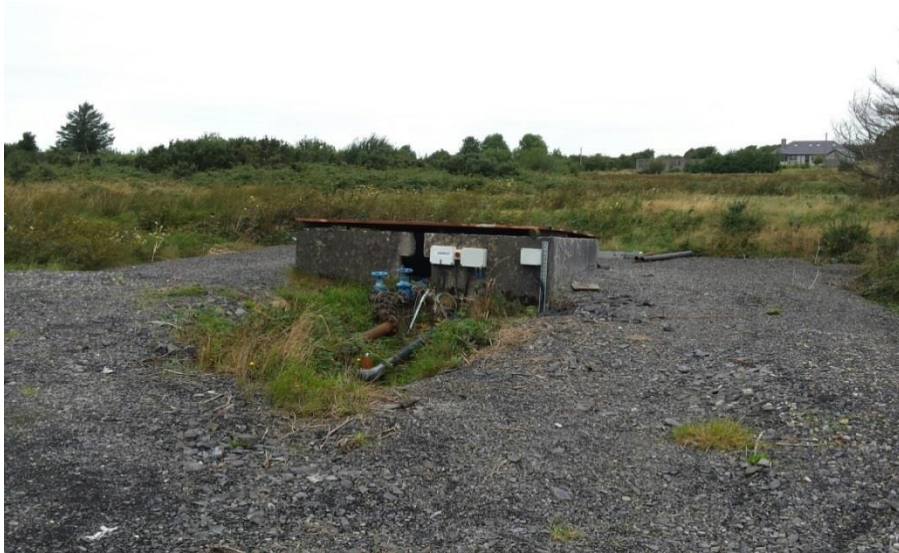
1.	<p>Source Protection</p> <ul style="list-style-type: none"> a. The spring source is covered with a concrete chamber and corrugated roof (see photo 1). The access hatch on top of the spring chamber was unlocked. b. Refurbishment works on the spring chamber to address health and safety concerns had commenced and are due to be completed soon, including a new lockable spring cover. c. Galway County Council representatives stated that the spring chamber was cleaned approximately 2 years ago. d. Raw water is monitored continuously for colour, turbidity and pH which were 27.4 Hazen, 0.06 NTU and 6.62 pH at the time of the audit.

Photo 1: Bushtown spring chamber - refurbishment works to be completed

- Irish Water should complete the refurbishment works on the spring chamber as soon as possible, to include ensuring the access hatch is locked.

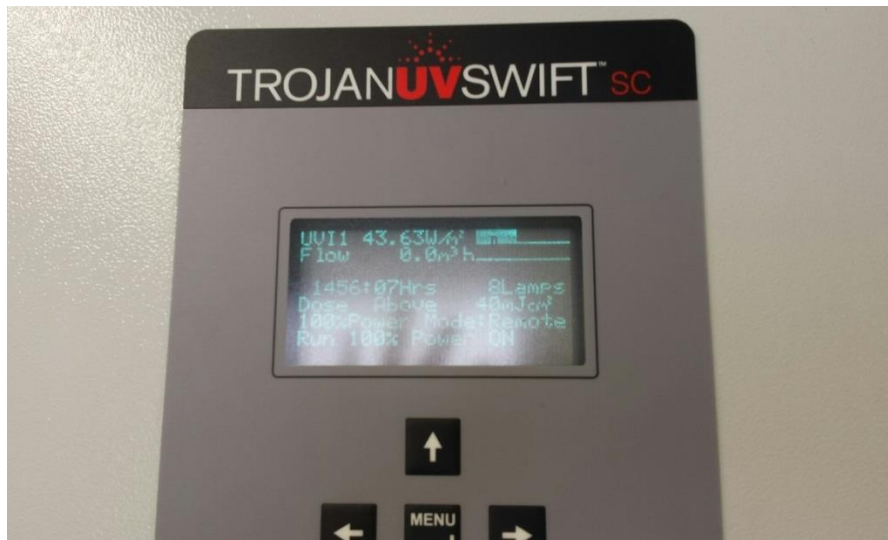
7.	<p>Management and Control</p> <ol style="list-style-type: none"> The final water is monitored continuously for colour, turbidity, pH and residual chlorine which were 6.15 Hazen, 0.04 NTU, 7.05 pH and 1.77 mg/l at the time of the audit. UV reactor control panel No. 1 was displaying a flow reading of 0.0 m³/hr during operation (see photo 2). However, the flow monitor in the plant control room displayed 20 m³/hr. The control set-points which activate an automatic plant shut-down are final water turbidity > 1 NTU, UVT < 83%, residual chlorine < 0.7 mg/l leaving the plant. The HMI screen shows an 'Alarm Debounce Time' of 49 minutes (see photo 3) which the caretaker believes to be the time delay before plant shutdown is activated. This significant delay before plant shutdown presents a risk to the final water quality. The current EDEN scheme data for Glenamaddy PWS identifies the population served as 1,206, volume supplied as 517 m³/d and level of treatment as "<i>ozonation, GAC filtration, UV, pH adjustment and chlorination</i>". During the audit, the operators identified that the population and volume figures are too high (they believe 370 m³/day is more accurate) and there is no pH adjustment carried out at the plant.

Photo 2: UV Reactor No. 1 control panel showing 0.0 m³/hr flow during operation

- (ii) there is minimum delay in automatic plant shutdown if the final water quality does not meet the required operating criteria.
4. Irish Water should investigate and rectify why the control panel on UV Reactor No. 1 was displaying no flow reading during operation.

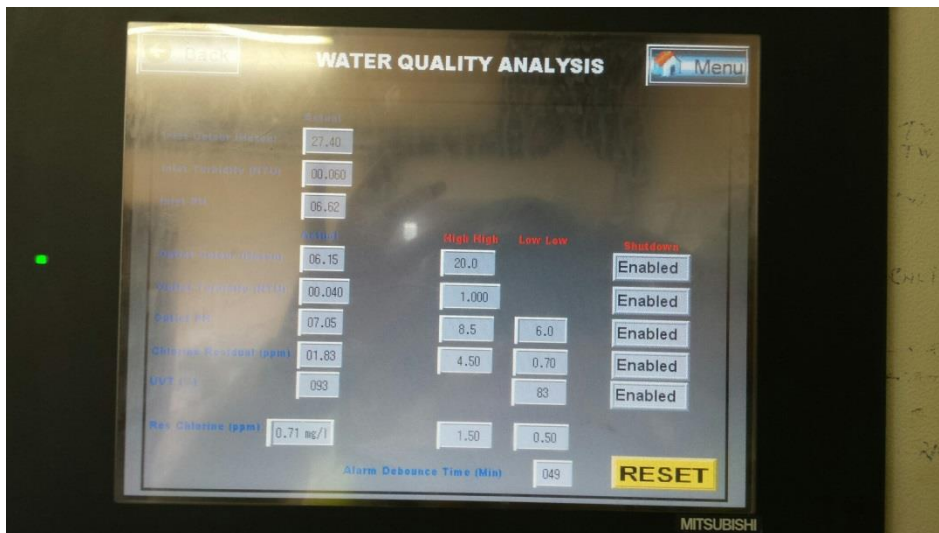
Photo 3: HMI plant control settings showing 'Alarm Debounce Time' of 49 minutes

3. Irish Water should review the plant control settings to ensure that:
 - (i) the alarm and automatic shutdown set-points on the UV disinfection system are appropriate to the validated operating criteria. The validated operating criteria should be clearly displayed and a copy of the UV certificate and validated operating characteristics should be kept at the plant.
