Drinking Water Audit Report

County:	Galway	Date of Audit:	20 th August 2015
Plant(s) visited:	Inis Mór public water supplies: Kilcarna/Oghill, scheme code 1200PUB1026 Cregacareen, scheme code 1200PUB1053	Date of issue of Audit Report:	1 st September 2015
		File Reference:	DW2013/99
		Auditors:	Ms Aoife Loughnane
Audit Criteria:	<ul style="list-style-type: none"> • The <i>European Union (Drinking Water) Regulations 2014 (S.I. 122 of 2014)</i>. • The <i>EPA Handbook on the Implementation of the Regulations for Water Services Authorities for Public Water Supplies (ISBN: 978-1-84095-349-7)</i> • The recommendations specified in the <i>EPA Drinking Water Report</i>. • The recommendations in any previous audit reports.

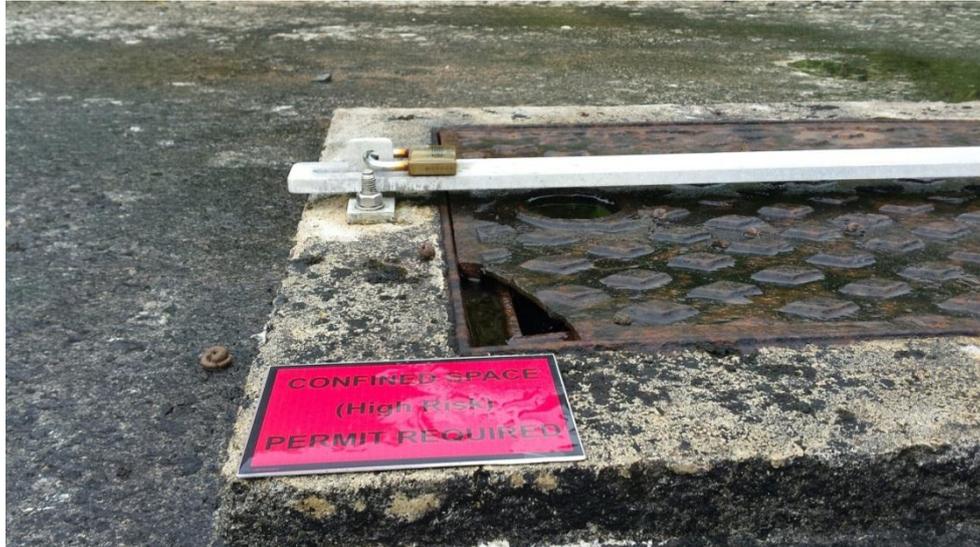
- b. One of the manhole covers on the Kilcarna source chamber was broken and faecal matter (bird droppings) were observed in the immediate vicinity (see photo 1).

Photo 1: Damaged manhole cover at Kilcarna rainwater spring source (note the bird droppings in the immediate vicinity present a risk of contamination of the raw water source)

2. Irish Water should take action should to ensure that the sources are made secure and fenced off to prevent livestock access.
3. Irish Water should ensure that the open boreholes are adequately sealed and capped in order to prevent surface water ingress.

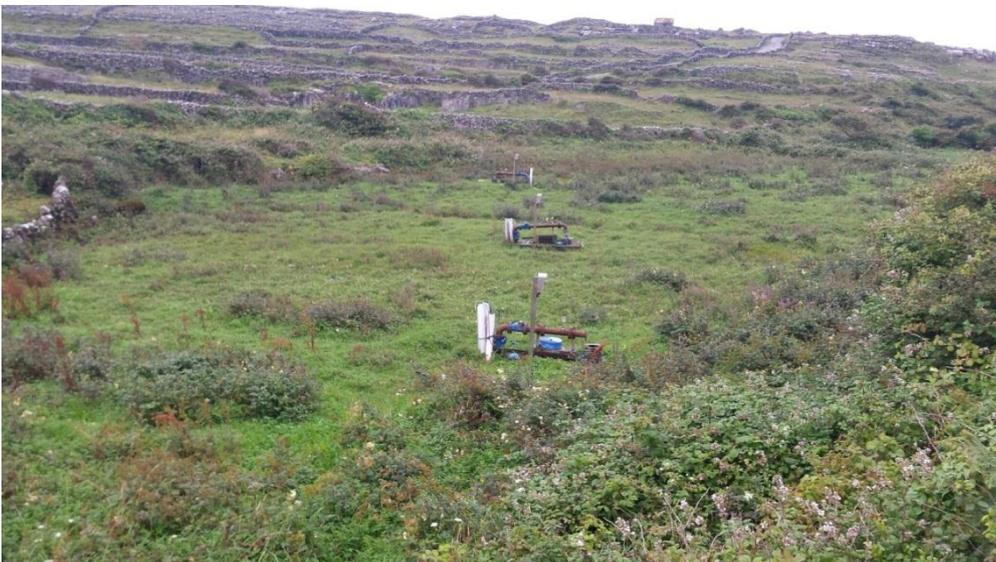
- c. Three shallow boreholes located in a turlough supplement the Kilcarna rainwater spring source when it runs low (see photo 2). Cattle have access to the turlough for grazing during dry periods. The boreholes are not capped and are vulnerable to contamination by surface water ingress (see photo 3).

Photo 2: Three supplementary boreholes located in a turlough.

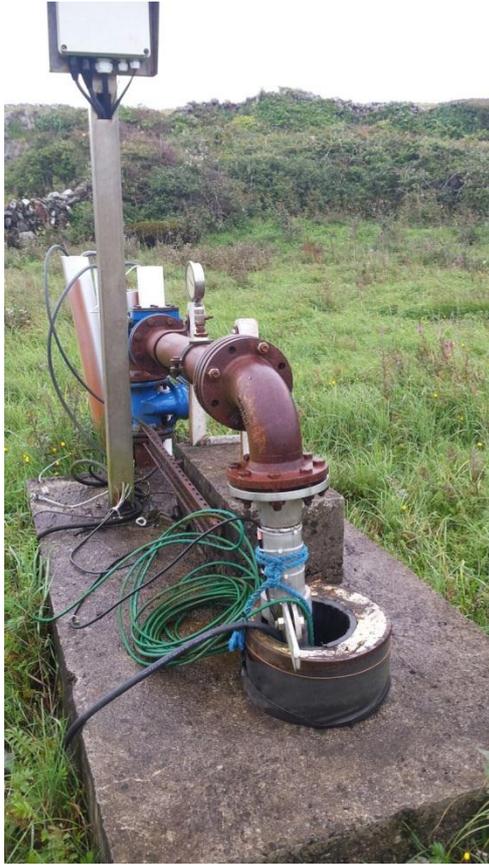
Photo 3: Uncapped borehole

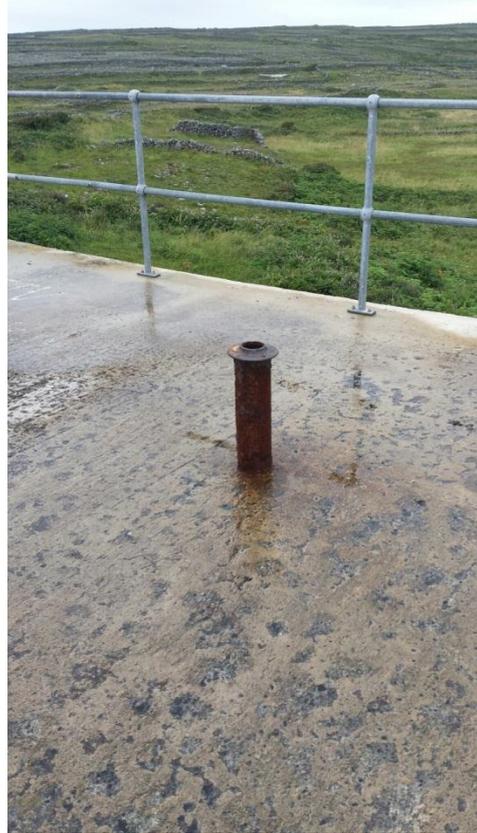
5.	<p>Treated Water Storage and Distribution Network</p> <ol style="list-style-type: none"> a. The open vents on Kilcarna reservoir pose a risk of entry of vermin (see photo 4). b. There is no regular programme of flushing and scouring of the distribution network.

Photo 4: Open vents at Kilcarna treated water reservoir

8. Irish Water should ensure that all vents on the reservoirs are secured against ingress of animals or deliberate introduction of any contaminant or acts of vandalism.

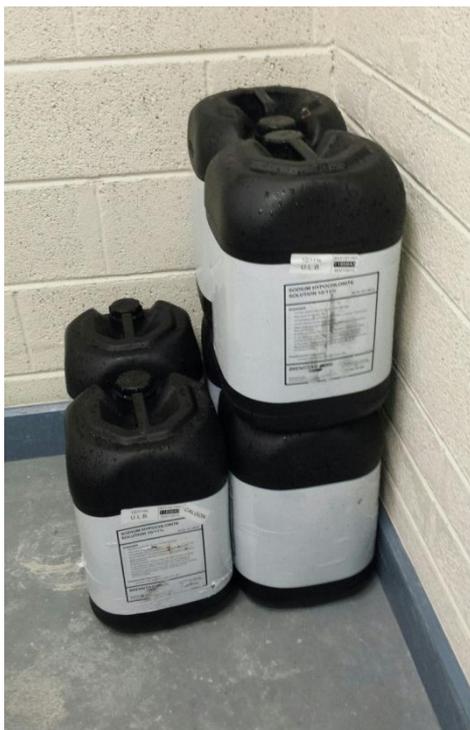
8.	<p>Chemical storage and bunds</p> <ol style="list-style-type: none"> a. Drums of sodium hypochlorite were stored in unbunded locations at Oghill and Cregacareen WTPs (see photo 5).

Photo 5: Chemical drums stored in an unbunded area at Oghill WTP

11. Irish Water should ensure that chemicals are stored in bunded areas capable of containing at least 110% of the volume of chemicals stored therein. Fill points for storage tanks inside the bunds should be within the bunded area.
