Drinking Water Audit Report

County:	Galway	Date of Audit:	21 st August 2015
Plant(s) visited:	Inisboffin PWS, Scheme code 1200PUB1024	Date of issue of Audit Report:	1 st September 2015
		File Reference:	DW2015/125
		Auditors:	Ms Aoife Loughnane
Audit Criteria:	<ul style="list-style-type: none"> • The <i>European Union (Drinking Water) Regulations 2014 (S.I. 122 of 2014)</i>. • The <i>EPA Handbook on the Implementation of the Regulations for Water Services Authorities for Public Water Supplies (ISBN: 978-1-84095-349-7)</i> • The recommendations specified in the <i>EPA Drinking Water Report</i>.

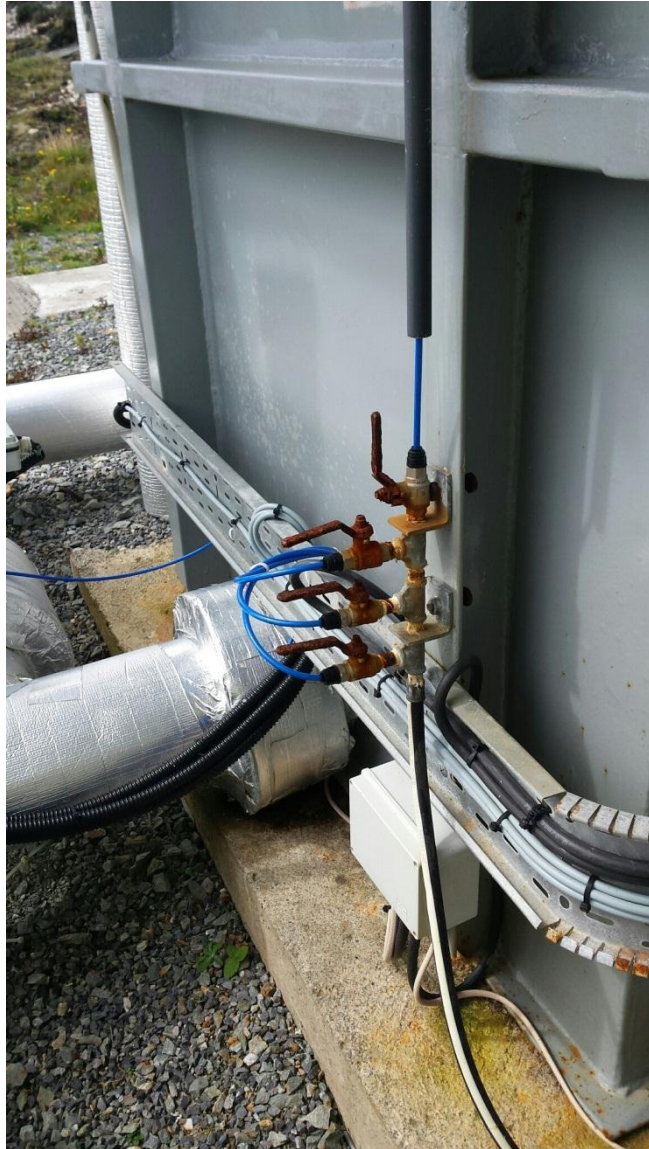
Photo 1: Corrosion of chemical injection points into the DAFF unit

6. Irish Water should investigate the feasibility of fully enclosing the DAFF unit to prevent the corrosion of chemical injection points, valves and instruments, in order to safeguard the operational performance of the plant.
