# Drinking Water Audit Report

<b>County:</b>	Galway	<b>Date of Audit:</b>	19 <sup>th</sup> December 2016
<b>Plant visited:</b>	Kilconnell PWS Scheme code 1200PUB1030	<b>Date of issue of Audit Report:</b>	23 <sup>rd</sup> December 2016
		<b>File Reference:</b>	DW2015/209
		<b>Auditors:</b>	Aoife Loughnane Criona Doyle
<b>Audit Criteria:</b>	<ul style="list-style-type: none"> <li>• The <i>European Union (Drinking Water) Regulations 2014 (S.I. 122 of 2014)</i>.</li> <li>• The <i>EPA Handbook on the Implementation of the Regulations for Water Services Authorities for Public Water Supplies (ISBN: 978-1-84095-349-7)</i></li> <li>• The recommendations specified in the <i>EPA Drinking Water Report</i>.</li> <li>• EPA Drinking Water Advice Notes No.s 1 to 15.</li> <li>• The recommendations in the EPA's previous audit report (9<sup>th</sup> December 2015).</li> </ul>

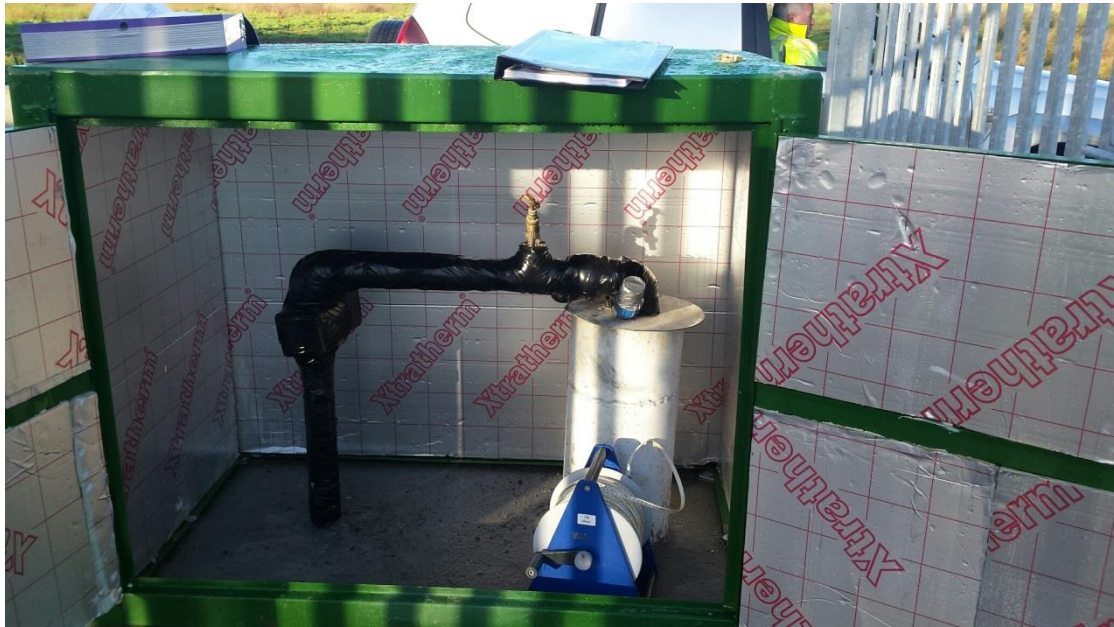
**Photo 1: High standard of wellhead protection at the borehole source**
