Drinking Water Audit Report

County:	Galway	Date of Audit:	26 th November 2015
Plant visited:	Kilconnell PWS Scheme Code 1200PUB1030	Date of issue of Audit Report:	9 th December 2015
		File Reference:	DW2015/209
		Auditors:	Mr Darragh Page Ms Aoife Loughnane
Audit Criteria:	<ul style="list-style-type: none"> • The <i>European Union (Drinking Water) Regulations 2014 (S.I. 122 of 2014)</i>. • The <i>EPA Handbook on the Implementation of the Regulations for Water Services Authorities for Public Water Supplies (ISBN: 978-1-84095-349-7)</i> • The recommendations specified in the <i>EPA Drinking Water Report</i>. • The recommendations in any previous audit reports.

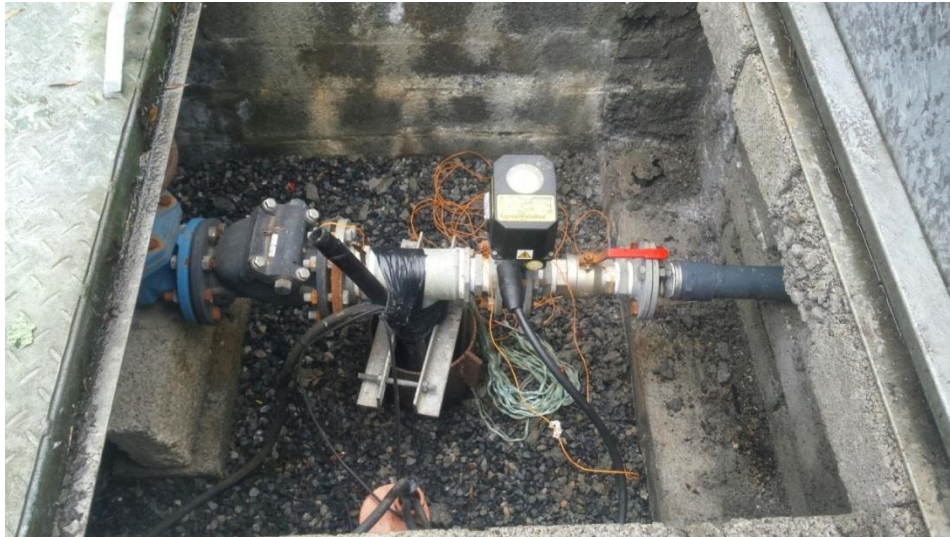
1.	<p>Source Protection</p> <ul style="list-style-type: none"> a. The source is a groundwater borehole at the water treatment plant. No borehole construction records were available during the audit, however Galway County Council (GCC) representatives stated that it is approximately 80 feet (25 metres) deep and was constructed approximately 40 years ago. b. The wellhead is located in a locked chamber above ground level, however the borehole is not adequately capped and sealed (see photo 1). c. The surrounding land use is mainly agricultural. Cattle were grazing in the adjacent field and a water trough was located in close proximity (<5 m) to the borehole chamber (see photo 2), which draws the animals into the immediate vicinity of the abstraction point. The ground was poached in the vicinity of the trough. d. GCC could not confirm if any source protection work has been carried out, including whether farmers had been notified of setback distances under the <i>European Union (Good Agricultural Practice for the Protection of Waters) Regulations 2014 (SI No. 31 of 2014)</i>. e. The borehole source is vulnerable to contamination, as proven by the detection of <i>Cryptosporidium</i> (13 oocysts in 1617 litres) in the final water on 17th November 2015. However, no raw water monitoring had been carried out on the borehole recently.

Photo 1: Uncapped borehole at Kilconnell water treatment plant

1. Irish Water, in conjunction with Galway County Council, should undertake the following source protection measures at Kilconnell PWS:
 - (i) Ensure the borehole is adequately sealed and capped in order to prevent contamination of the groundwater source.
 - (ii) Examine the feasibility of moving the animal water trough away from the immediate vicinity of the abstraction point.

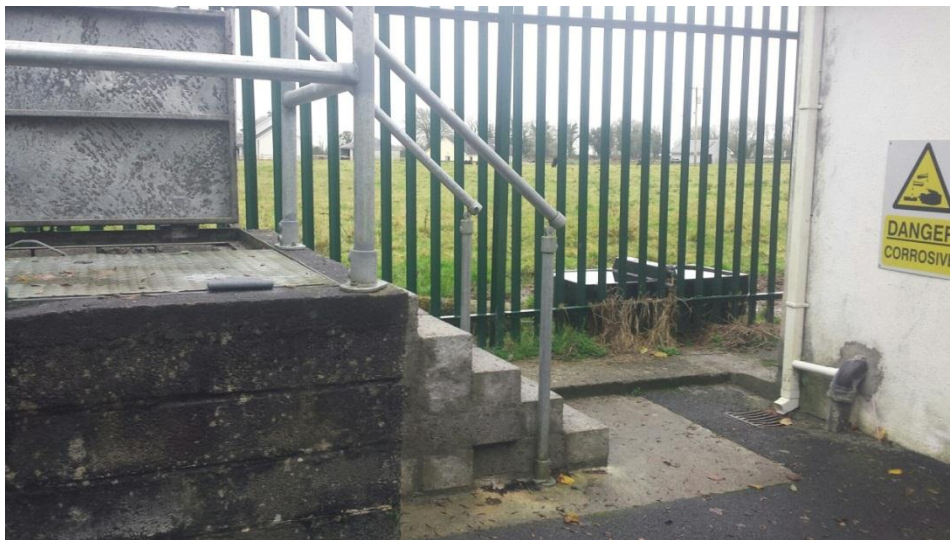
Photo 2: Proximity of water trough in adjacent field to the borehole chamber.

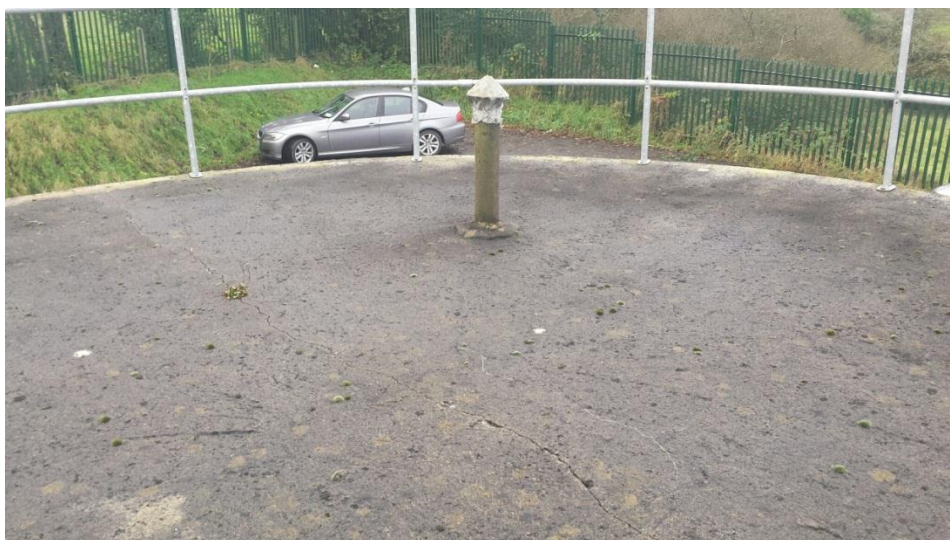
Photo 3: Cracks on roof of Kilconnell reservoir.

- 6. Irish Water should carry out an integrity assessment of Kilconnell reservoir to ensure that there is no ingress into the reservoir. Any maintenance and repairs should be completed as soon as possible after the need has been identified.
