Drinking Water Audit Report

County:	Galway	Date of Audit:	31 st August 2016
Plant visited:	Kilkerrin-Moylough Water Treatment Plant (scheme code 1200PUB1031)	Date of issue of Audit Report:	23 rd September 2016
		File Reference:	DW2010/106
		Auditors:	Aoife Loughnane Emer Cooney
Audit Criteria:	<ul style="list-style-type: none"> • The <i>European Union (Drinking Water) Regulations 2014 (S.I. 122 of 2014)</i>. • The <i>EPA Handbook on the Implementation of the Regulations for Water Services Authorities for Public Water Supplies (ISBN: 978-1-84095-349-7)</i> • The recommendations specified in the <i>EPA Drinking Water Report</i>. • EPA Drinking Water Advice Notes No.s 1 to 15. • The recommendations in any previous audit reports.

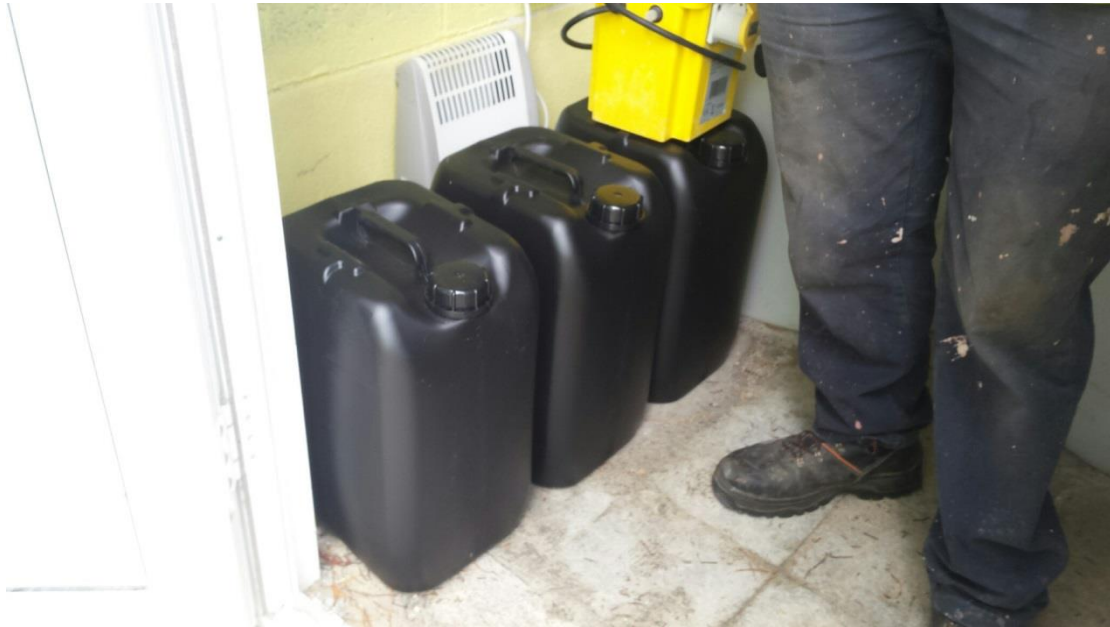
4.	<p>Chemical storage and bunds</p> <ul style="list-style-type: none"> a. Three drums of sodium hypochlorite were stored in an unbunded area in the chlorination room (see photo 1).

Photo 1: Sodium hypochlorite drums stored in an un-bunded area

4. Irish Water should ensure that all monitors at the plant are maintained and calibrated in accordance with the manufacturers' specifications.
5. Irish Water should review the chemical storage arrangements at the treatment plant to ensure that chemicals are stored in bunded areas capable of containing at least 110% of the volume of chemicals stored therein.

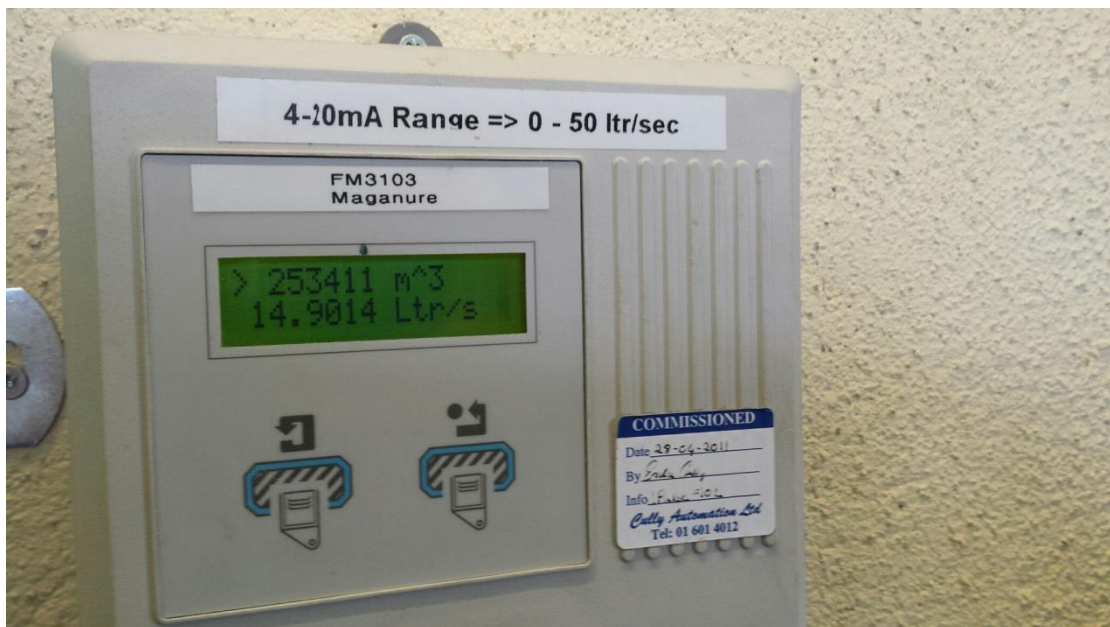
5.	<p>Management and Control</p> <ol style="list-style-type: none"> a. Turbidity and UVT monitoring data for the period 8th June to 8th August 2016 demonstrates satisfactory plant performance and verifies the effectiveness of the plant upgrade works in providing a 3-log <i>Cryptosporidium</i> barrier. b. The control set-points which activate an automatic shut-down of the plant are final water turbidity > 1 NTU and UVT < 70%. The 15 minute delay in automatic plant shutdown triggered by elevated turbidity presents a risk of shielding of pathogens in the UV system. c. The label on the flow meter indicated that it has not been calibrated since it was commissioned in 2011 (see photo 2).
-----------	---

Photo 2: Flow meter label - no record of calibration/service since it was commissioned in 2011
