Drinking Water Audit Report

County:	Galway	Date of Audit:	8 th February 2016
Plants visited:	Loughrea PWS, scheme code 1200PUB1037	Date of issue of Audit Report:	12 th February 2016
	Lake Road & Knockanima treatment plants	File Reference:	DW2016/29
		Auditors:	Aoife Loughnane
Audit Criteria:	<ul style="list-style-type: none"> • The <i>European Union (Drinking Water) Regulations 2014 (S.I. 122 of 2014)</i>. • The <i>EPA Handbook on the Implementation of the Regulations for Water Services Authorities for Public Water Supplies (ISBN: 978-1-84095-349-7)</i> • The recommendations specified in the EPA <i>Drinking Water Report 2014</i>.

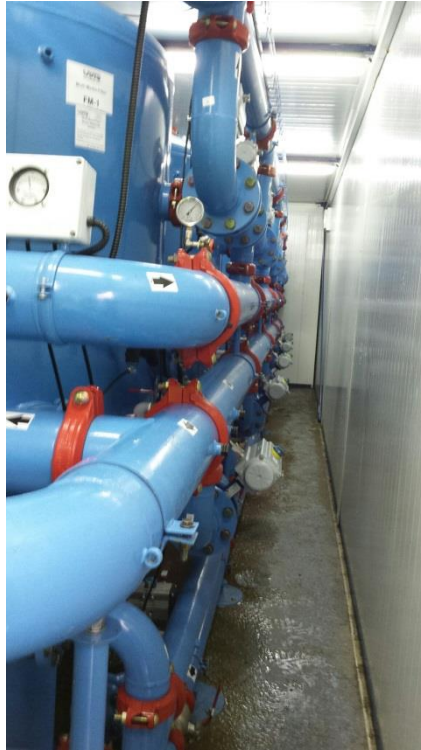
Photo 1: Sand on the floor in the pressure filter room at Lake Road WTP

8. Irish Water should review the operation and condition (including sand depth) of the pressure filters in order to optimise the filtration process and ensure that the levels of turbidity in the filtered water are as low as possible. Following backwashing, the filters should be run to waste for an appropriate period of time, or there should be a slow start when the filters are brought back into use.

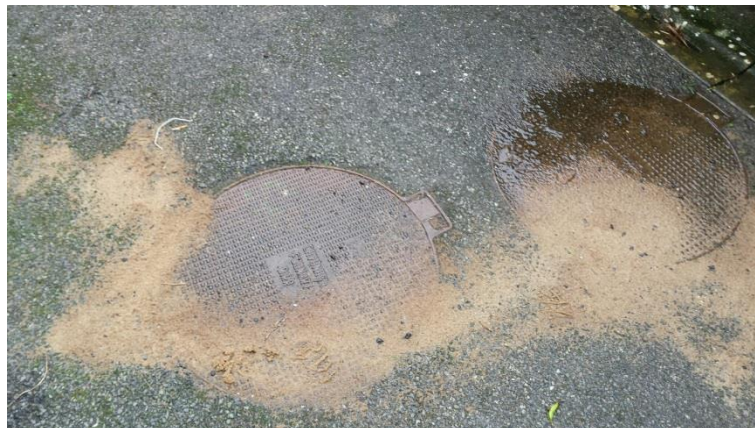
Photo 2: Sand on the ground beside the filter backwash pipework/manholes at Lake Road WTP

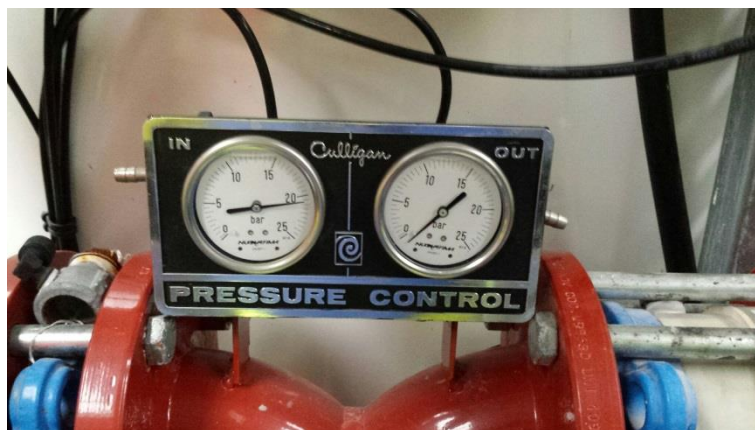
Photo 3: Broken outlet pressure gauge on Culligan Filter No. 2 at Knockanima WTP.

6. Irish Water should ensure that all control gauges on the filters are maintained in working order.
7. Irish Water should install continuous turbidity monitors on each filter and the final treated water at both water treatment plants. These monitors should be linked to a recording device and generate an alarm in the event of a deviation from the acceptable operating range of the filters.
